**Phase 2 Geotechnical Stability Study  
Detailed Risk Analysis  
The City of North Vancouver, BC**

**Document No. T30-2009  
GES Project No. 10002**

Submission Date: December 2011

Submitted by:  
**GES Geotech Inc.**

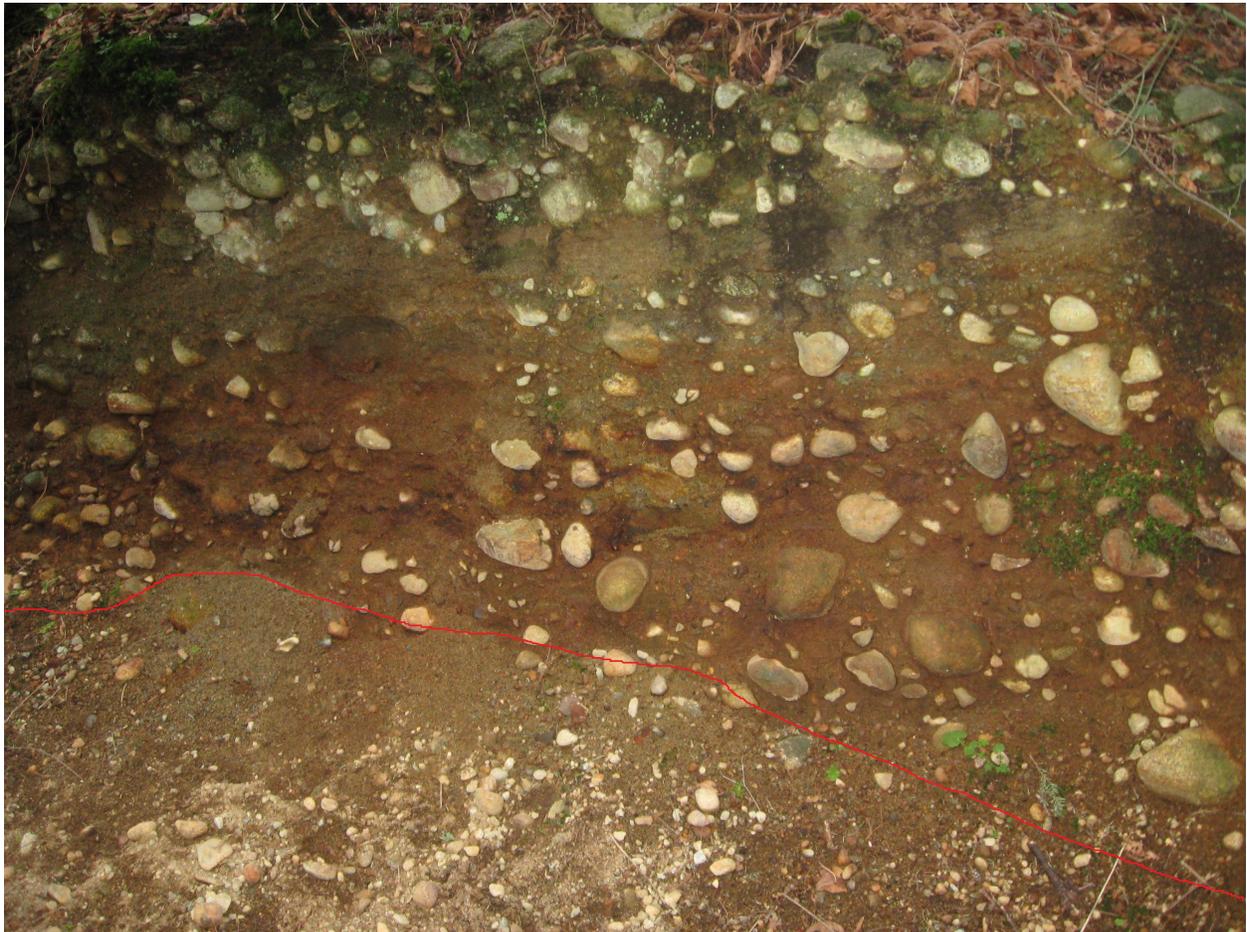
Based on our site review at MacKay Creek and our observation of an exposed area where a small landslide scarp exists to the north of the property at 2158 MacKay Avenue (See Appendix A, Dwg. 2, BGC drawing) the subsurface soil conditions consist of Capilano Formation Sediments that comprise deep water marine silts and clays overlain by sand to coarse cobble channel-fill deltaic sediments. Our site observation shows that there is layer a of cobble and boulder (close to ground surface at about El 40 m) with sand and gravel as shown in the following photograph. Sand and gravel content increases with depth and becomes the dominant soil at depth.

**Photograph 1: Exposed scarp over the west bank of the MacKay Creek close to the property at 2158 and at about Elevation 40-45 m**

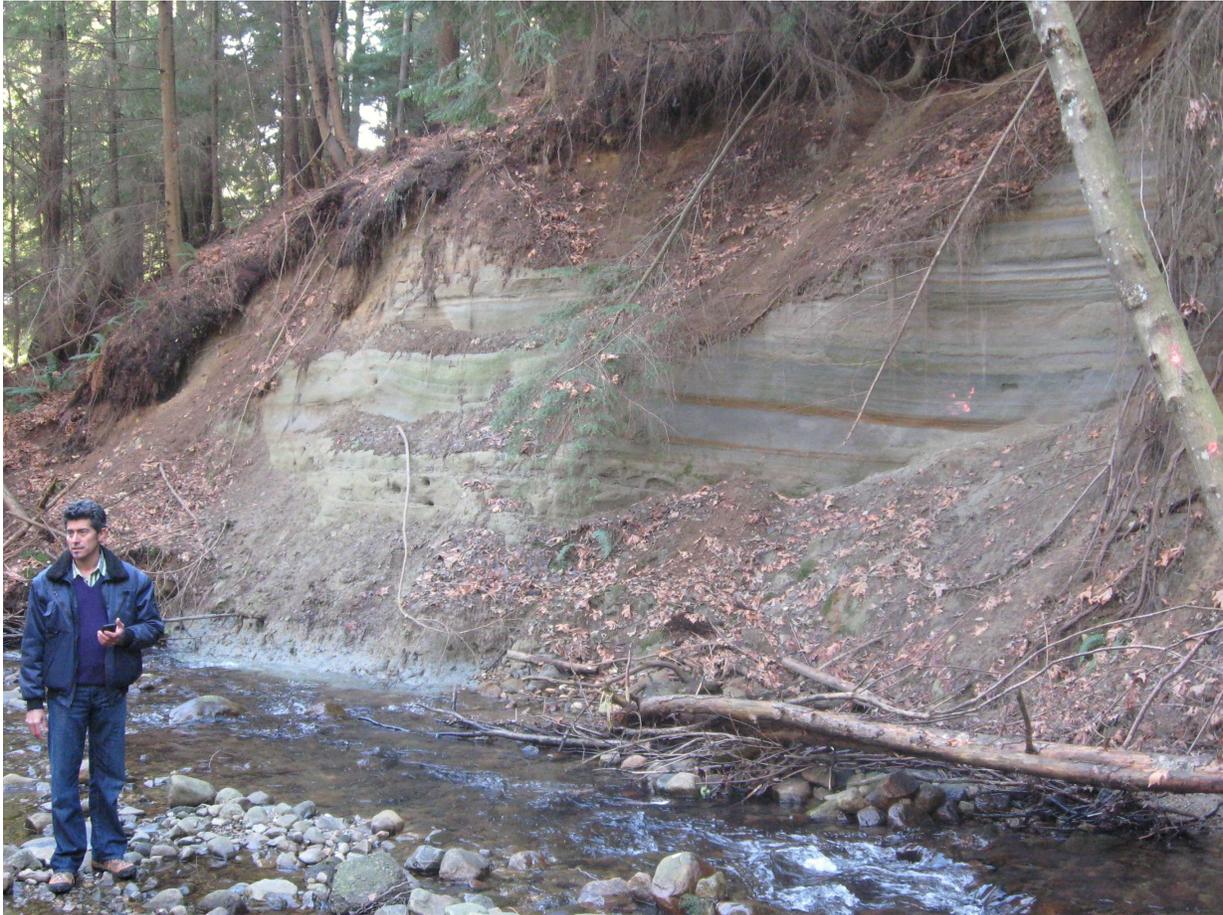
**Photograph 2: Thain Creek near Cypress Gardens, west bank.**

As shown in Photographs 2 and 3 the subsurface soil profile from the ground surface is sand to cobble size deposits that is underlain by alternate layers of marine silt and clay sediment that is over a layer of till like material that is exposed at elevations close to streambed.

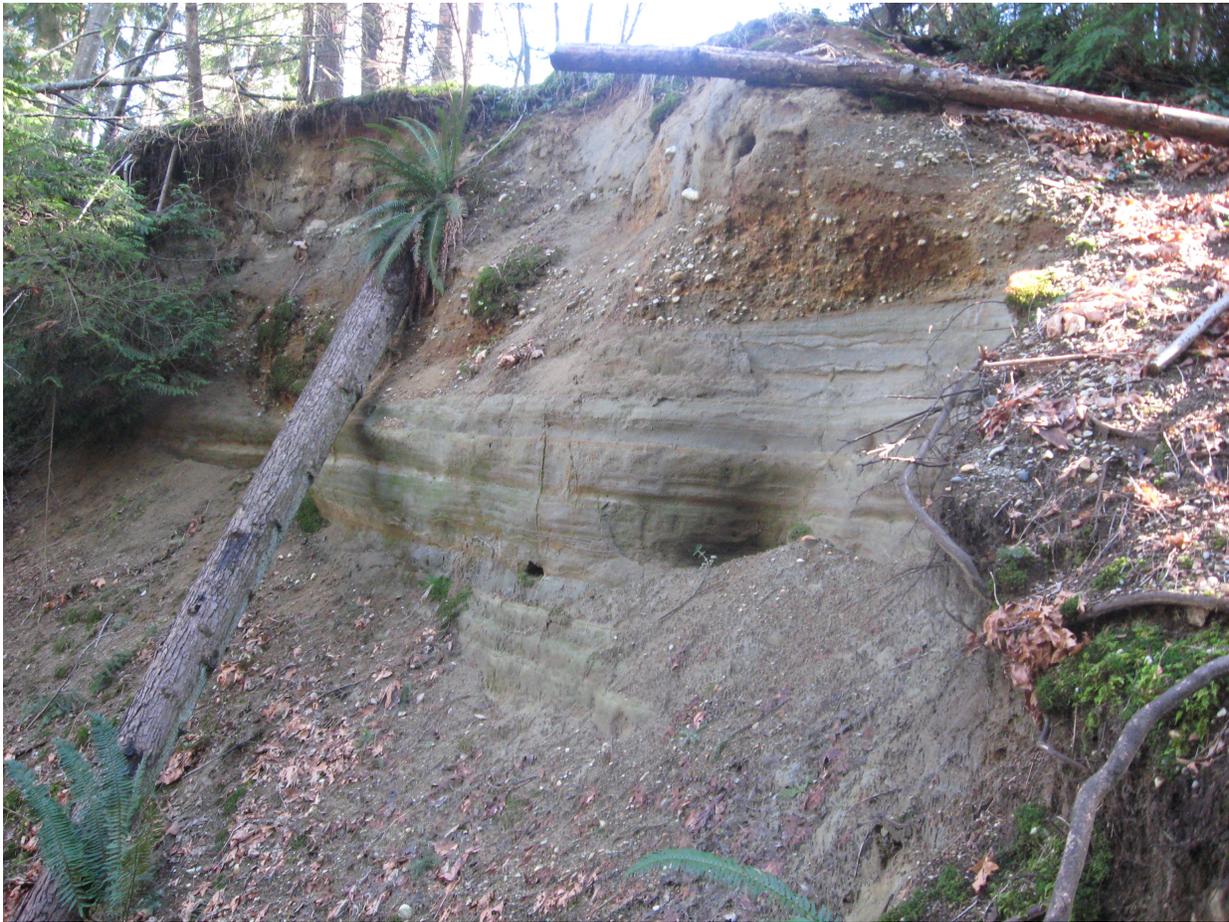
**Photograph 3: Sand and gravel deposit that is underlain by alternate layers of marine silt and clay, Thain Creek near Cypress Gardens, east bank.**

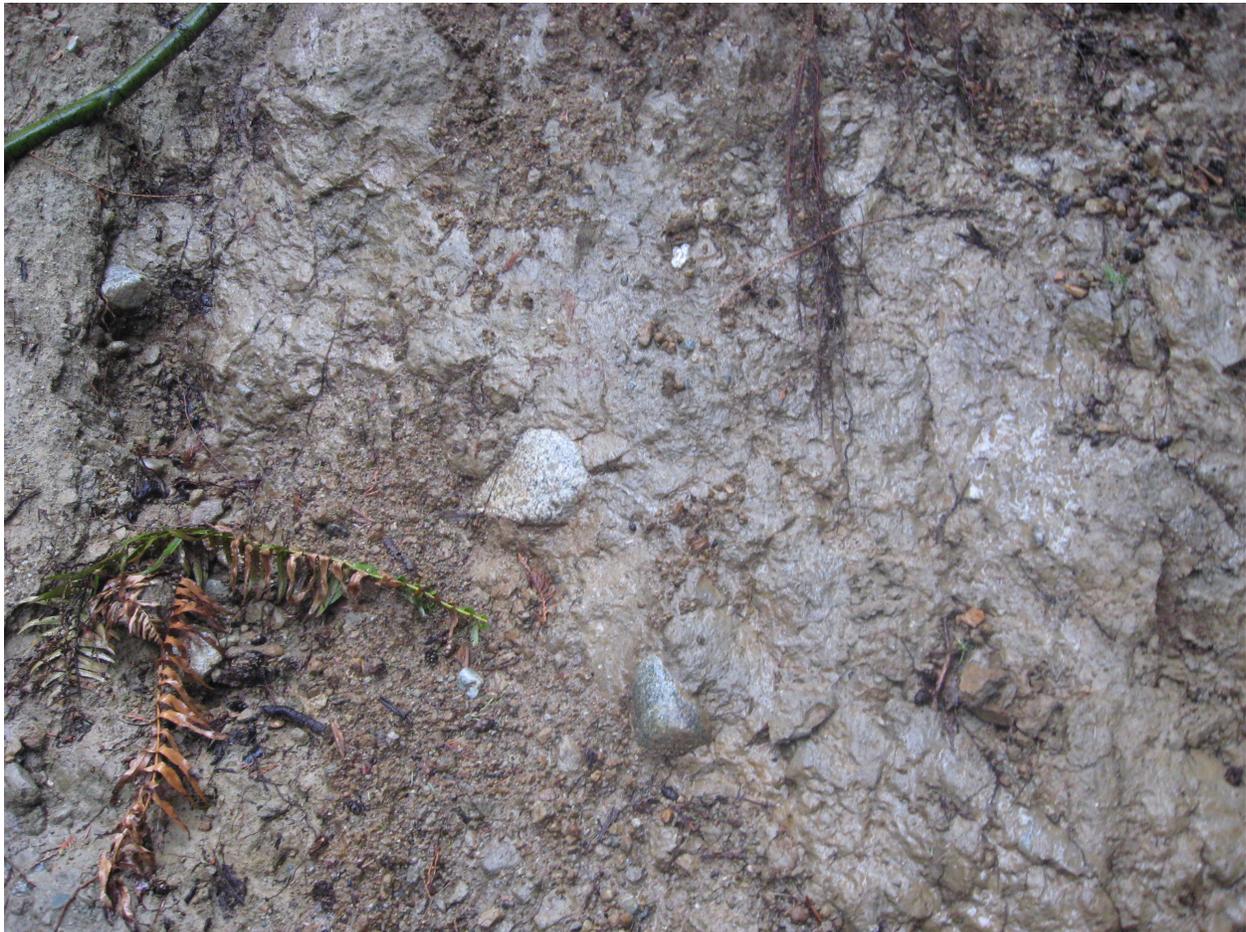
At Lower Mission Creek and adjacent to Wolfe Street, downstream of the property 1956 and on the east bank, there is an exposed scarp at about 10 m below the ground elevation of that property that consists of firm to stiff clayey silt with gravel (till like material) as shown in the following photograph.

**Photograph 4: Exposed scarp at Lower Mission Creek next to Wolfe Street, east bank.**

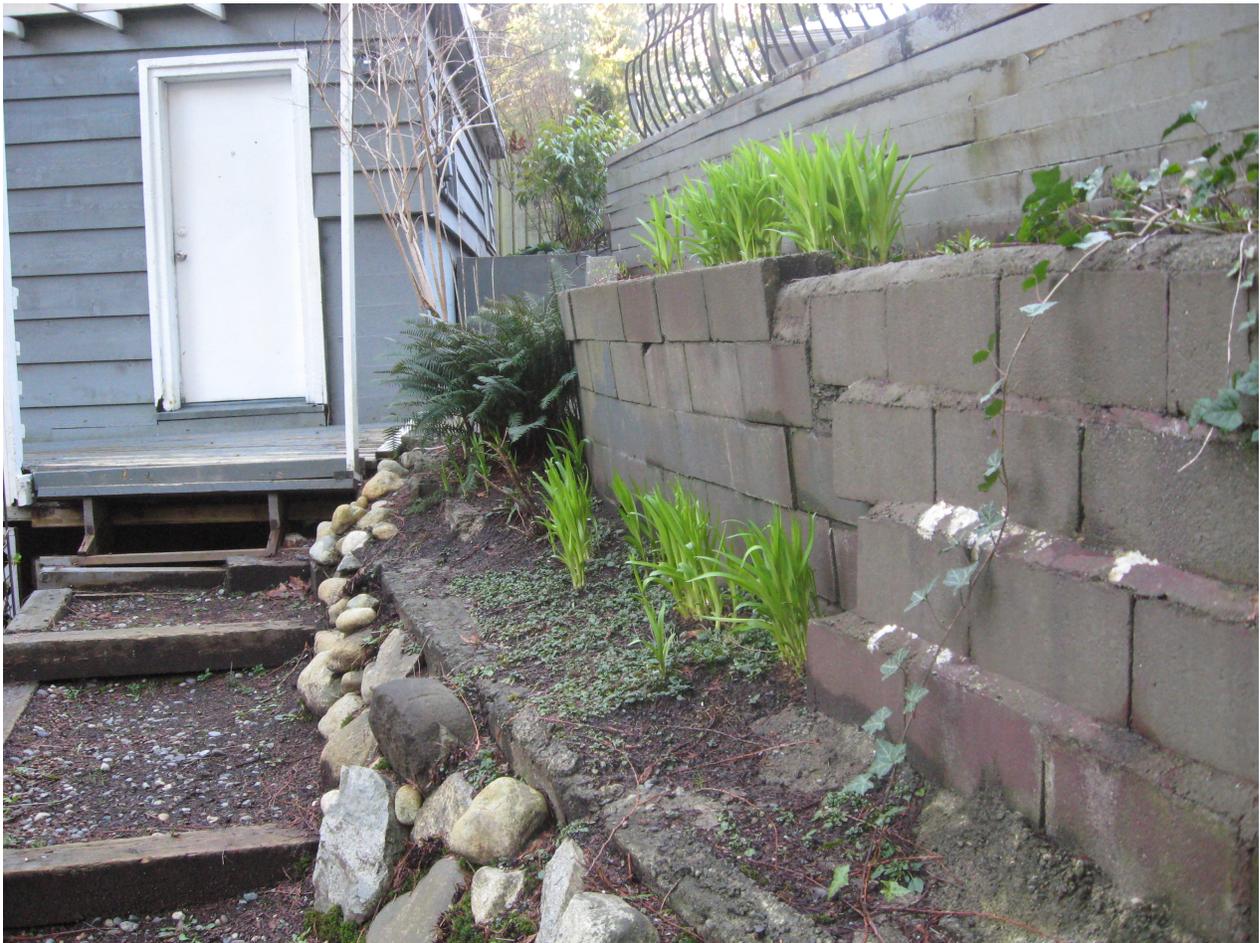
This property is a wood frame single-family residence with a wooden deck that is located at about 2.1 m from the edge of the slope crest. There is an accessory wooden building adjacent to the deck that overhangs the edge of the slope and is being supported by wood posts that rest over shallow concrete pads. Shallow concrete pads are over fill material that has a slope of about 45° degrees atop of a natural slope of 38° degrees. The deck of the main building is retained by non-engineered wood-logs, concrete blocks and river rocks; and some deformations were noted during the time of our site review as shown in the following photograph.

**Photograph 5: Non-engineered retaining structure in front of the wooden deck at 2052 MacKay Ave.**

In order to mitigate the specific risk level it is our recommendation that the homeowner make sure that the secondary structure is not habitated, to the satisfaction of the City officials, and the property is connected to the city storm sewer collection or an engineered drainage collection system. In addition, we recommend replacing the existing retaining wall (Photograph 5) with an engineered retaining wall that is approved by a qualified Professional Geotechnical Engineer. This recommendation is offered in response to the deteriorating condition of the existing retaining wall even though it is not a safety issue that would affect the risk rating.

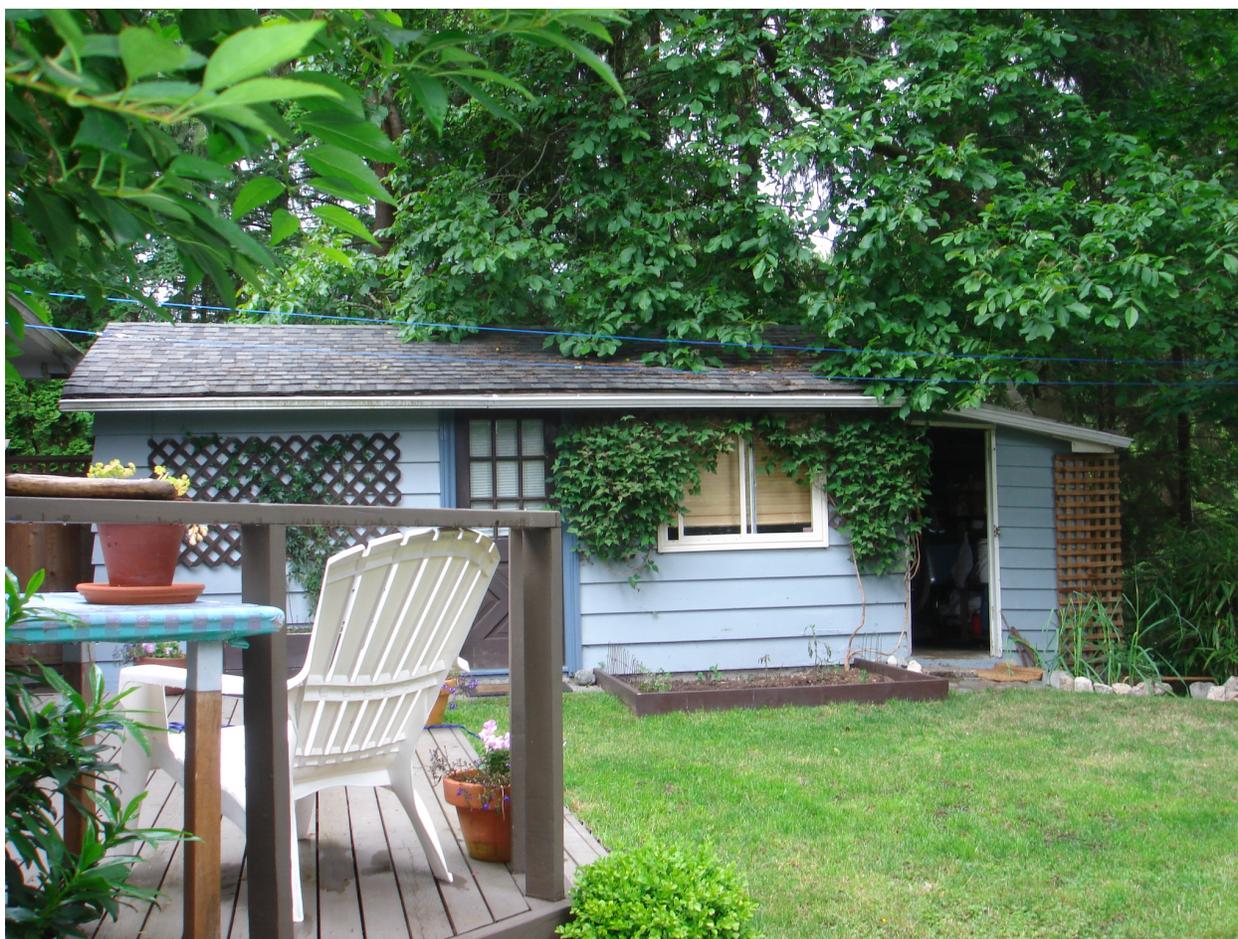
The specific risk of the accessory building is rated as "**Extreme**" however for the main building it is rated as "**Moderate**". The specific risk level can be decreased to "Moderate" level if the homeowner demonstrates that the accessory building is uninhabitable, to the satisfaction of the CNV. The main and the accessory buildings should be connected to the City storm sewer collection or an engineered storm sewer collection system to decrease the specific risk rating of the property to "Low".

**Photograph 6: Accessory building at 2024 MacKay Avenue.**

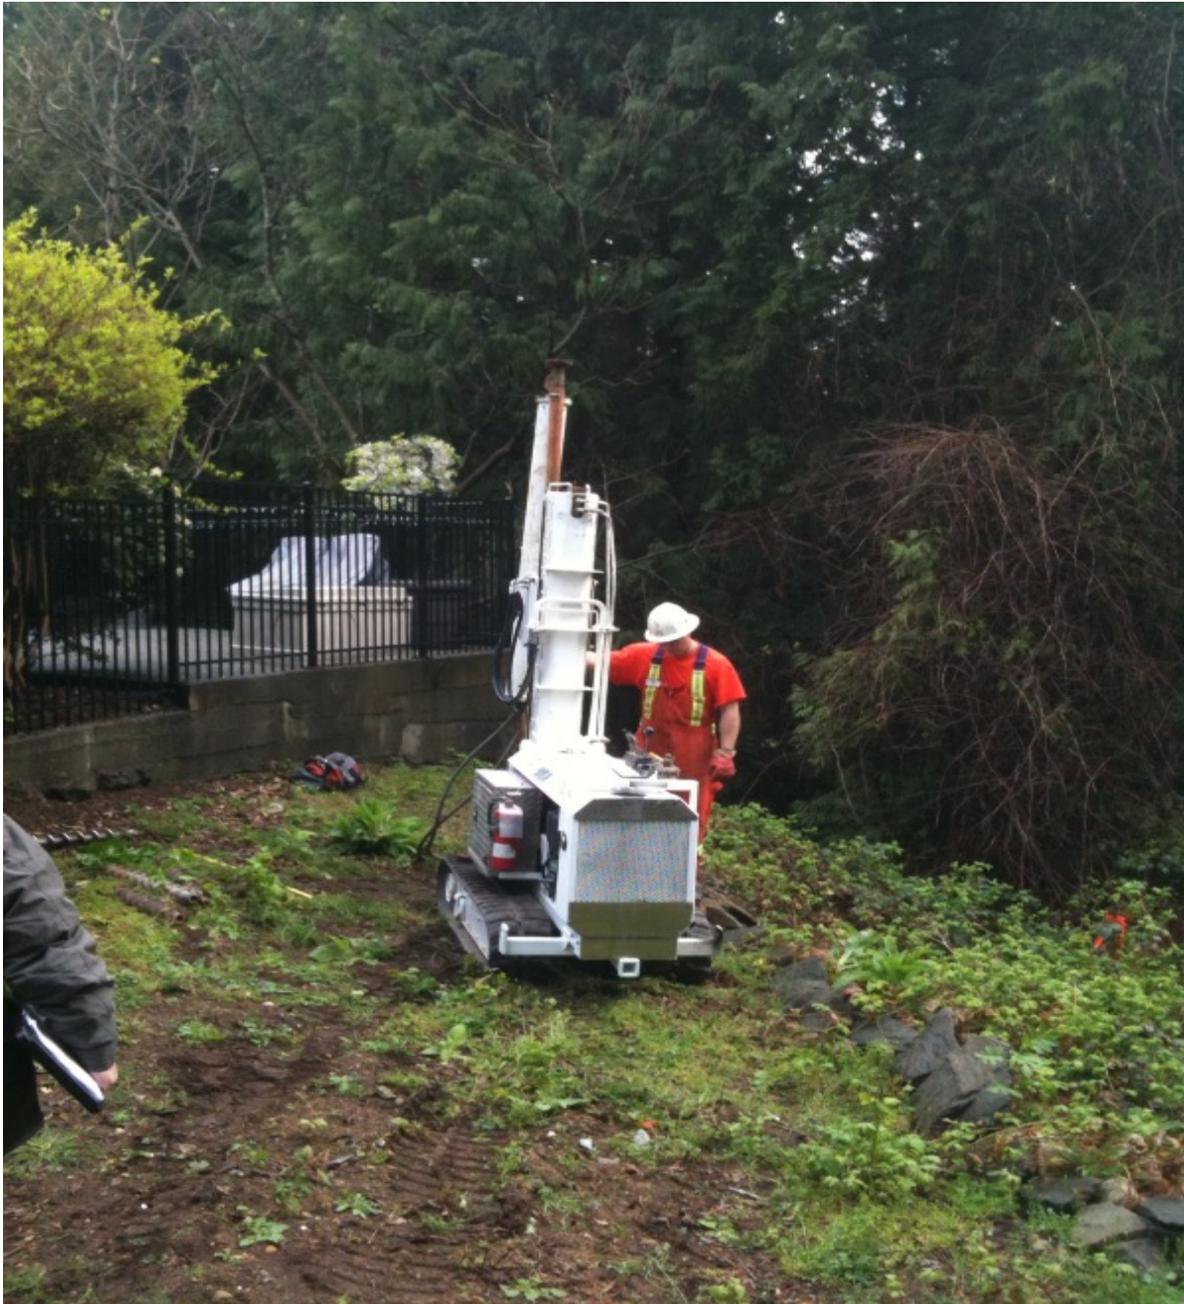
**Photograph 7: Site investigations at 1900 MacKay Avenue**

The property drainage collection system (ie, the main building, concrete deck at the patio area and the pool area) should also be connected to the City storm sewer system or an engineered storm sewer collection system to decrease the specific risk rating of the property to "Low".

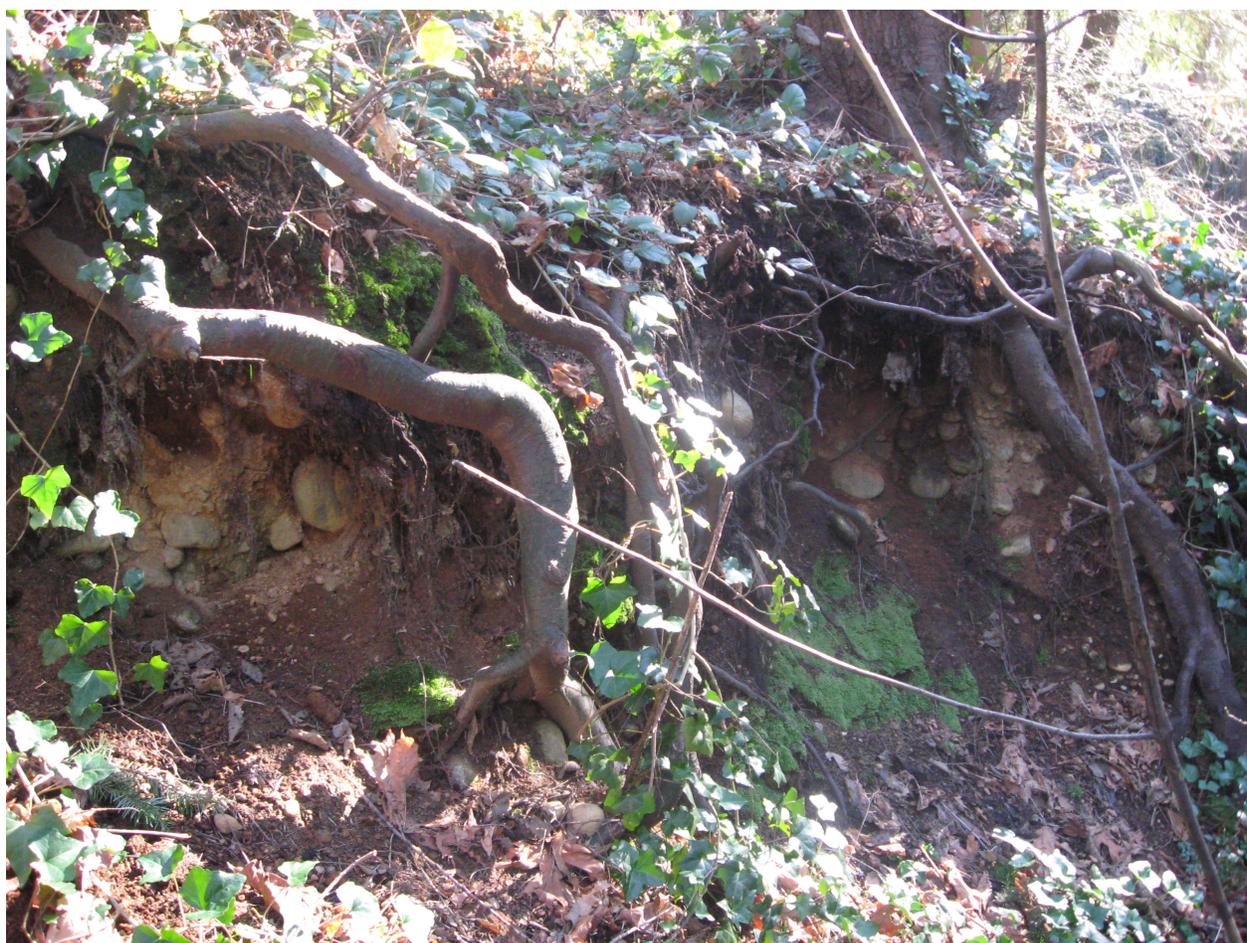
Based on our review of earlier topographic maps provided by CNV and our field investigations carried out close to units 811-823 and earlier observations by EBA during the installation of the inclinometer, the site was reclaimed for further development by placement of loose to compact fill material at variable depth. The observed ground displacement may be attributed to the existence of loose random and organic fill material.

**Photograph 8: Bank erosion along the east bank of Thain Creek and adjacent to the properties at Cypress Gardens**

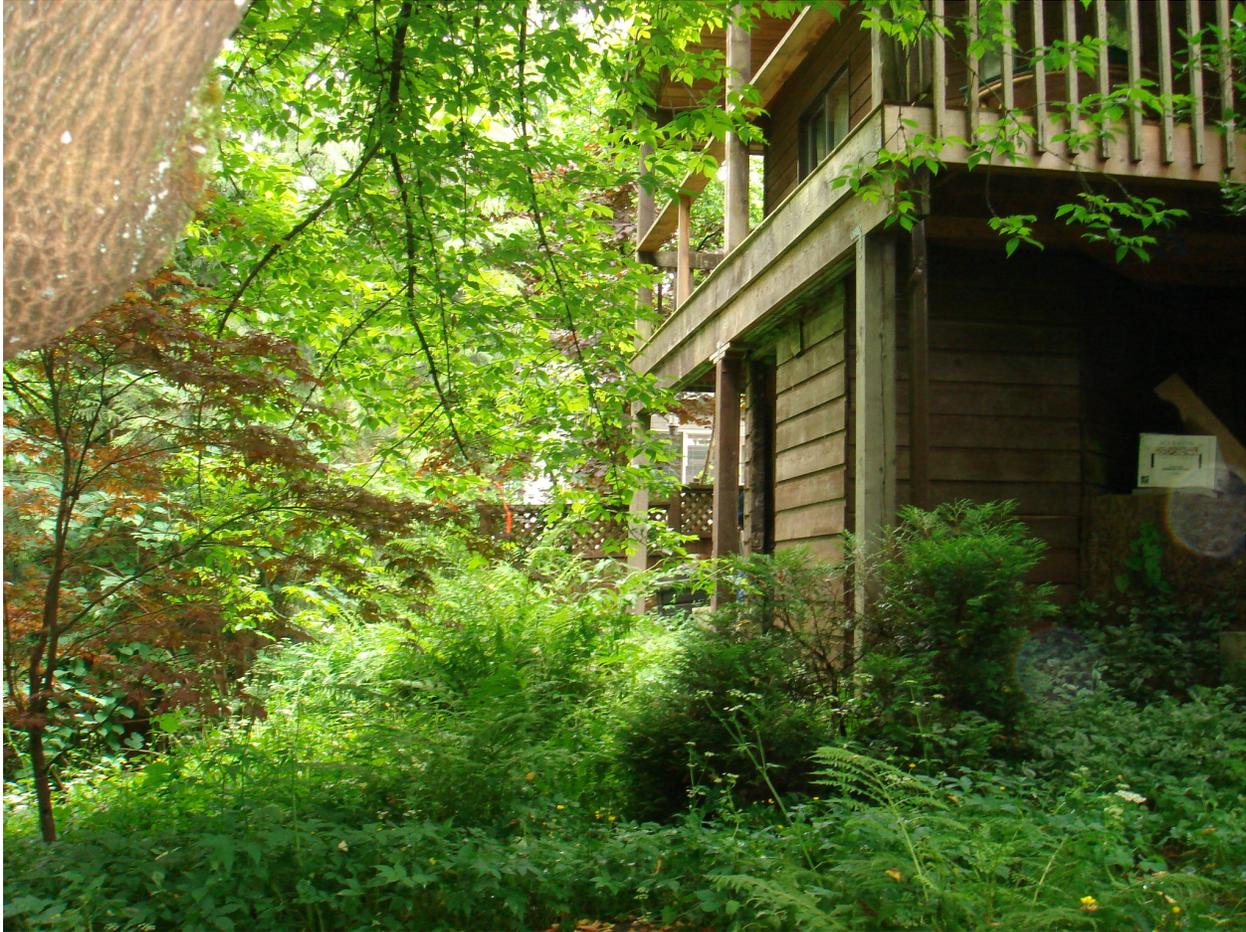
**Photograph 9: Façade of the building facing the adjacent slope at property 1716 Wolfe Street**

Other than the required structural stability requirements that will be evaluated and recommended by a structural engineer, our recommended landslide stability mitigation measure includes removal of fill materials at the backyard and down-slope from the wooden posts of building (see Photo 10) together with installation of an engineered retaining wall covering the width of the property.

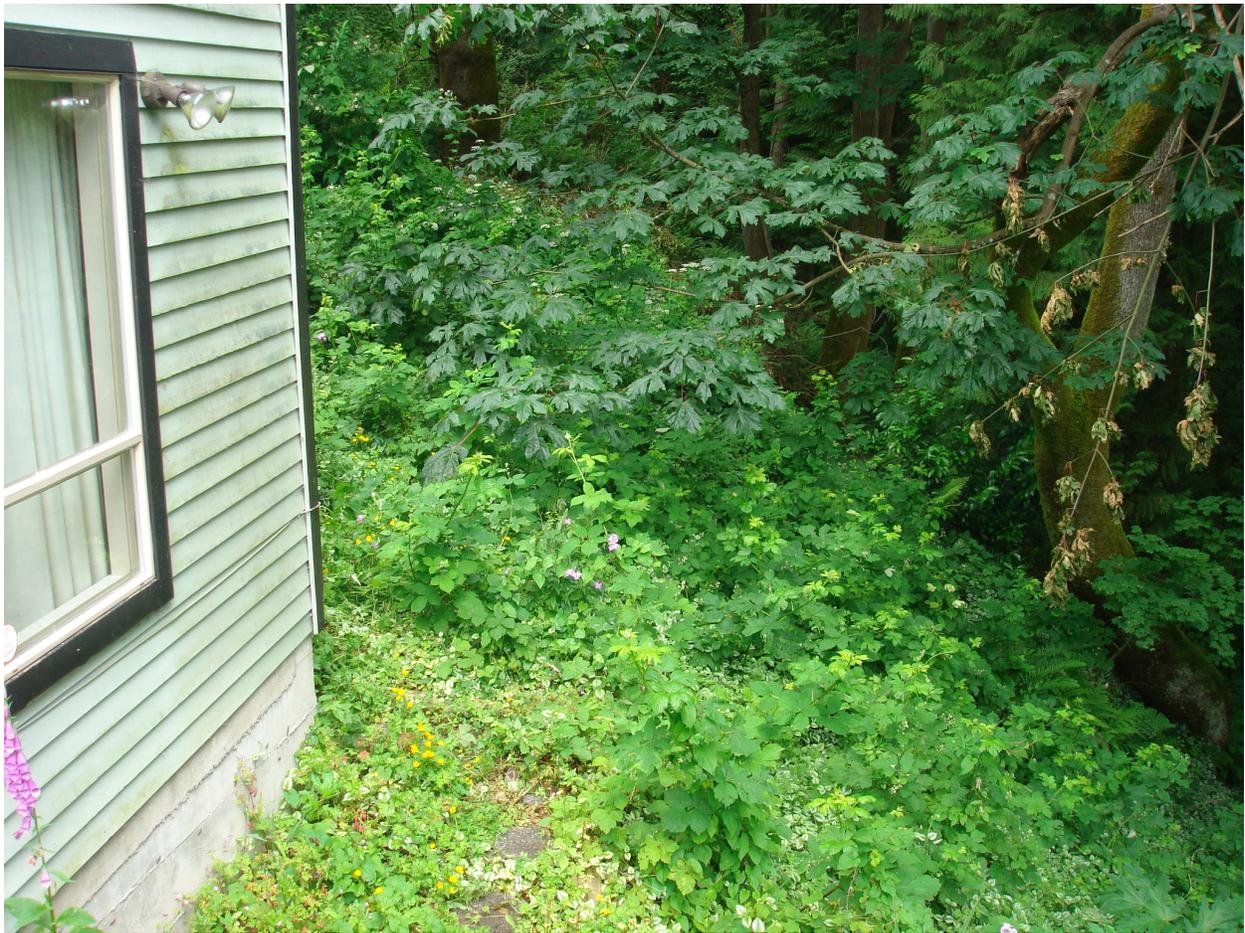
This building unit is a three-storey wood frame structure that rests on concrete retaining wall all around the building. Limited fill material may exist at the site and it is expected to be less than 1m.

**Photograph 10: Building unit located to the north of the property at 620 West 15<sup>th</sup> Street**

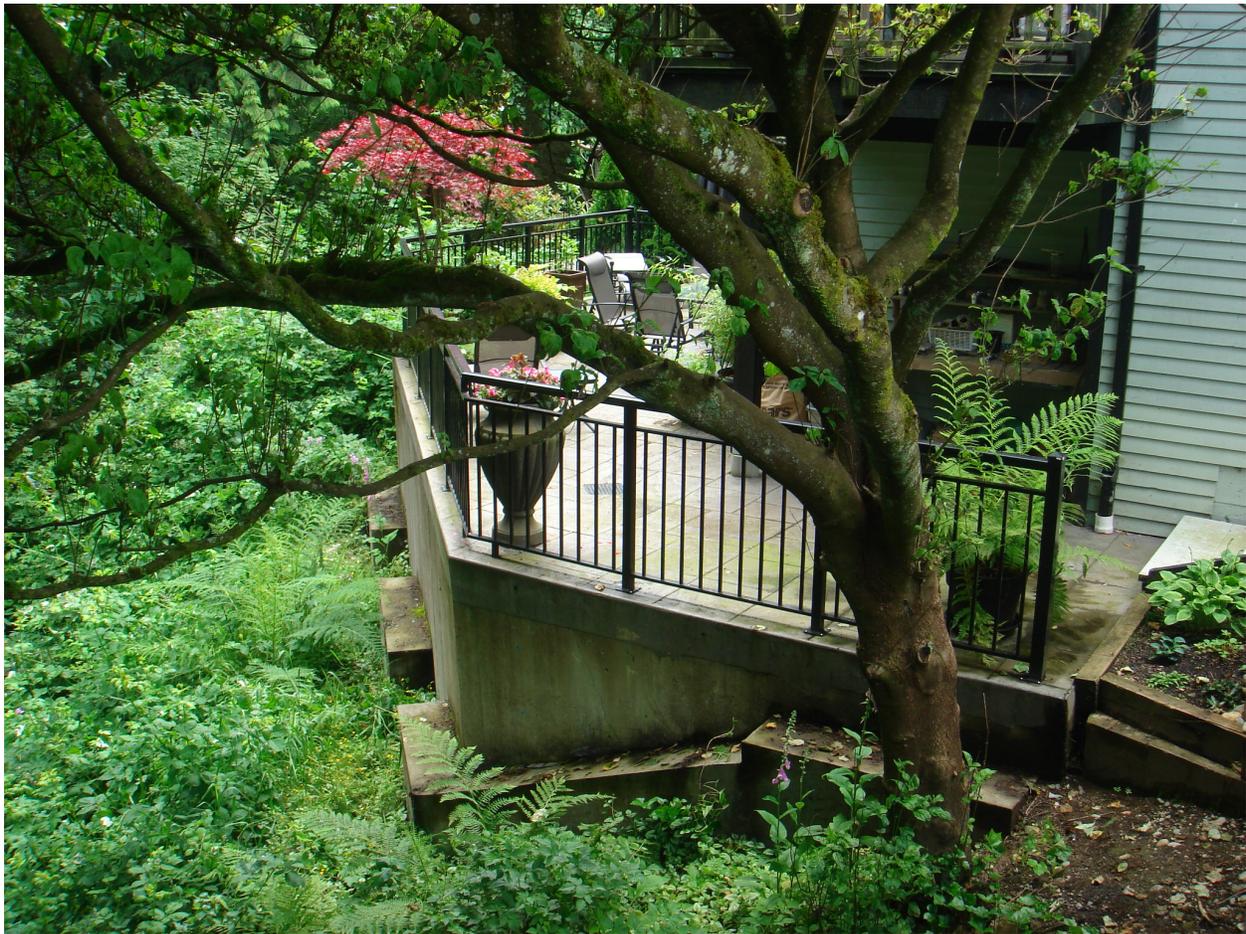
The building unit located to the southeast of the property is at close distance from the adjacent slope (Photograph 12) and is protected by a concrete retaining structure. GES did not find any cracks or evidence of displacement over the retaining structure or the deck that rests on this retaining wall.

**Photograph 11: Building unit located to the south of the property supported with a concrete retaining wall at 620 West 15<sup>th</sup> Street.**

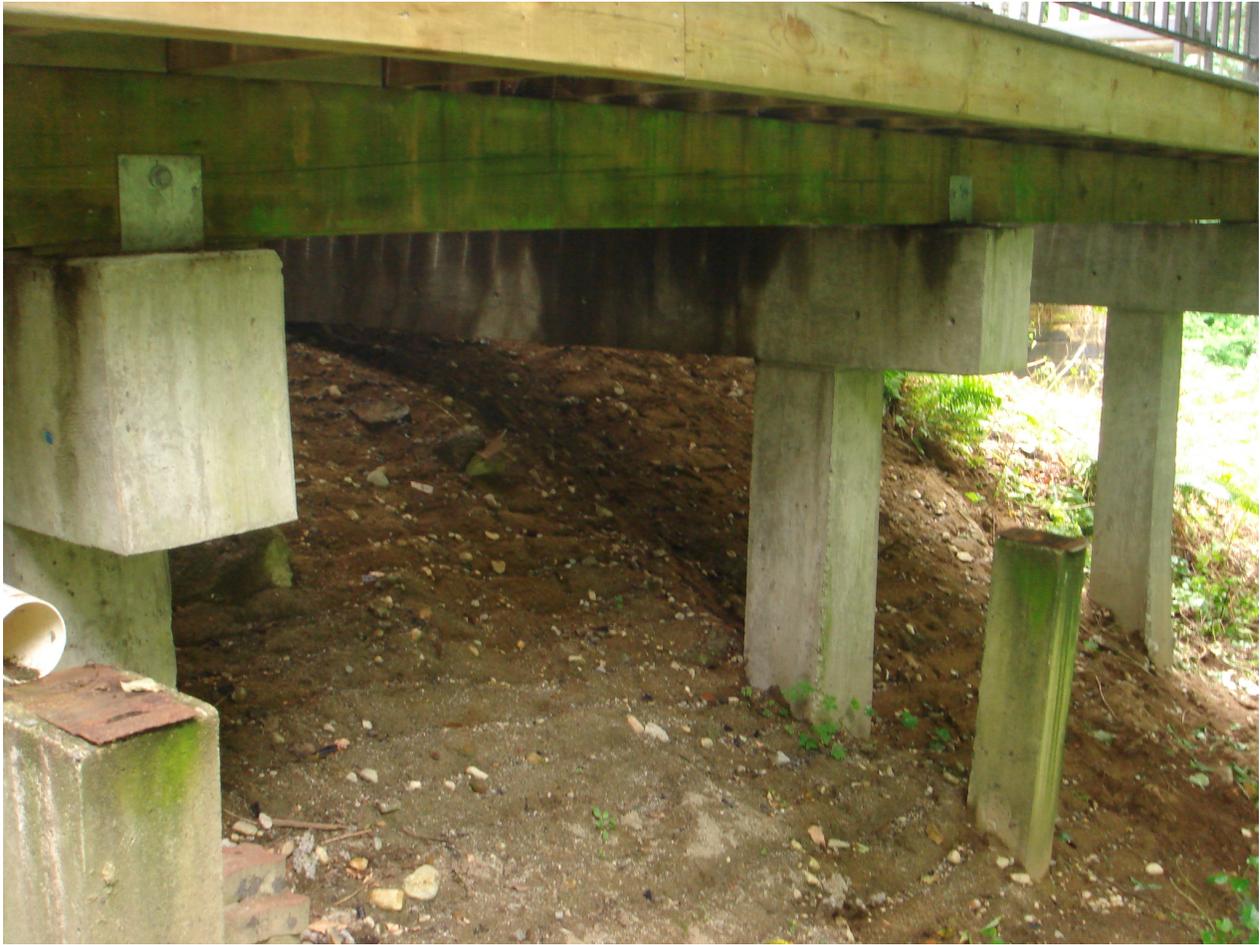
**Photograph 12: The deck that connects the three building units at 620 West 15<sup>th</sup> Street was built on concrete columns and girders.**

In order to decrease the risk level to "Low", connection to the City storm sewer system or an alternative engineered storm collection system is recommended.
