CITY OF NORTH VANCOUVER

GEOTECHNICAL STABILITY STUDY

PRELIMINARY PARTIAL RISK ANALYSIS

PROJECT NO: 0600-001
DATE: APRIL 24, 2009

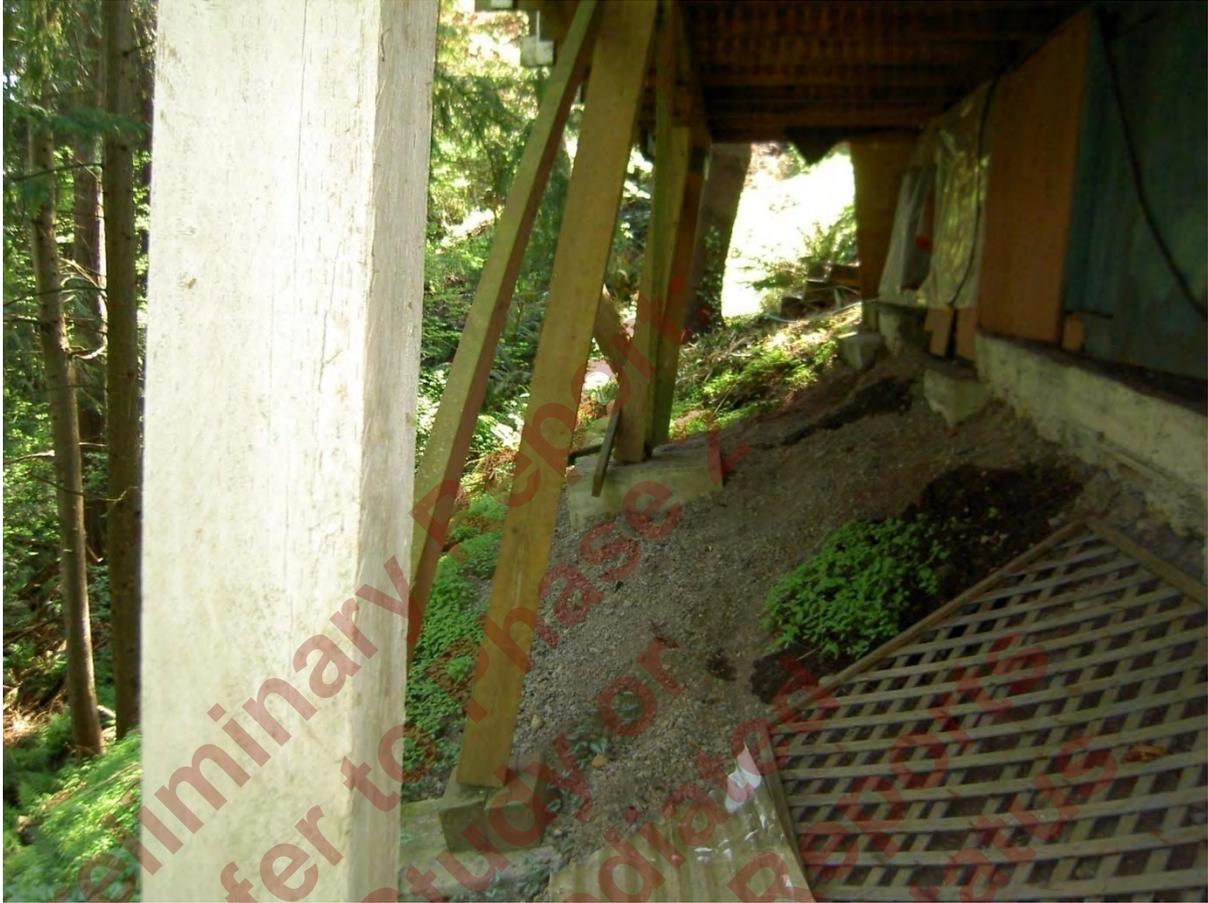
At the time of BGC's site visits, the fill supporting the accessory dwelling foundation showed signs of settlement and slope deformation. Foundation and structural elements were displaced and damaged: the wood posts were out of plumb, displaced over 0.3 m downslope; and the concrete footings were cracked and settled (Photograph 1). The roof and floor were off-level, and walls, doors and windows were out of plumb (Photograph 2), probably owing to foundation displacement. Roof gutter downspout outlets from the accessory dwelling were directed onto the failing fill beneath the structure.

Photograph 1: Downslope Side of Accessory Dwelling Foundation, 2052 Mackay Ave.

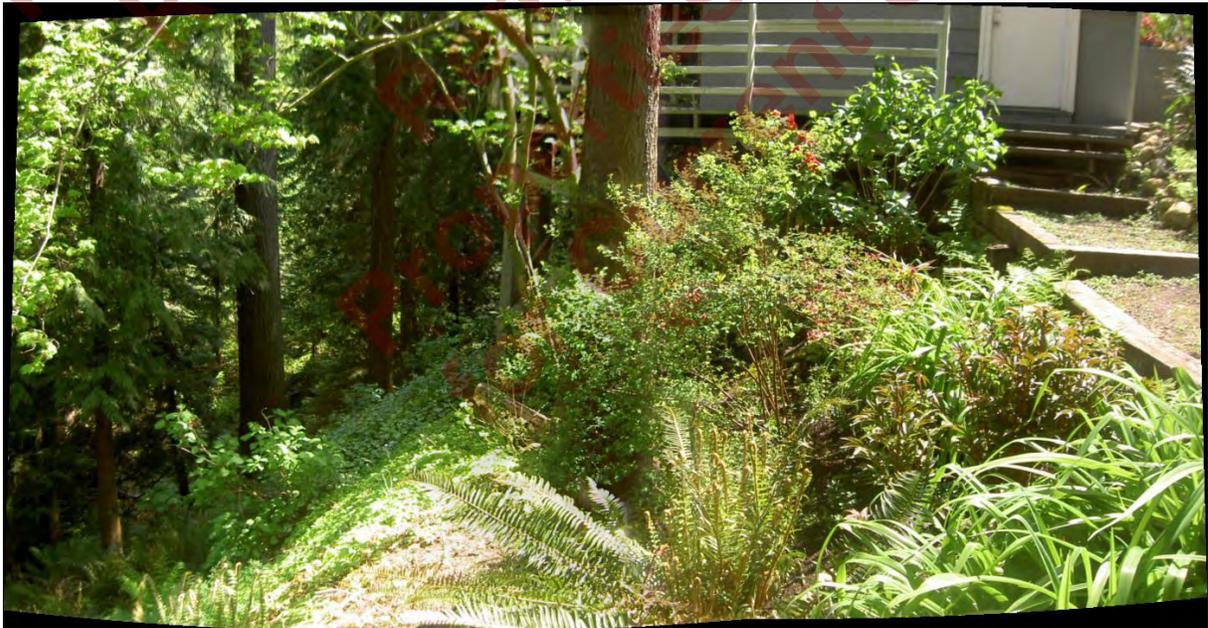
Photograph 2: Accessory Dwelling Unit Overhanging the Top of Slope, 2052 Mackay Ave.

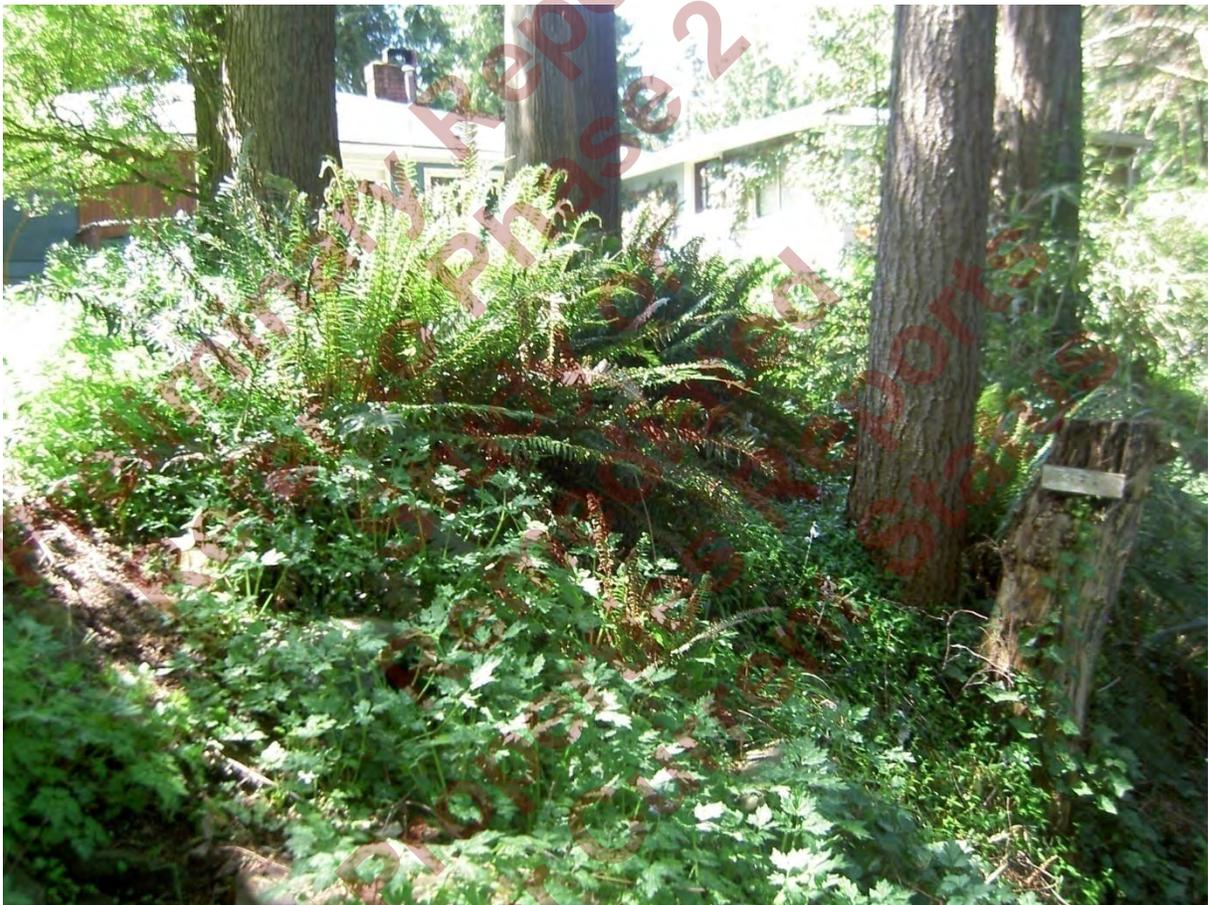
The slope is inclined at a 39° angle, and is about 20 m high. No instability was observed in historic aerial photographs or by BGC personnel during the ground reconnaissance. Some seepage was observed at the toe of the slope. The slope was assigned as having moderate hazard likelihood due to the presence of seepage and the steep slope angle.

The property was assigned to the high partial risk category because of the proximity of the detached accessory dwelling to the slope (warranting a high spatial probability rating), and because of the assumption that this structure was inhabited. The main residence would receive a moderate spatial probability rating, and consequently be assigned moderate partial risk.

Photograph 3: Main and Accessory buildings at 2024 Mackay Ave.

BGC recommends proceeding with any one of the following options within a 1 to 3 year time frame, listed in order of least to greatest probable cost:

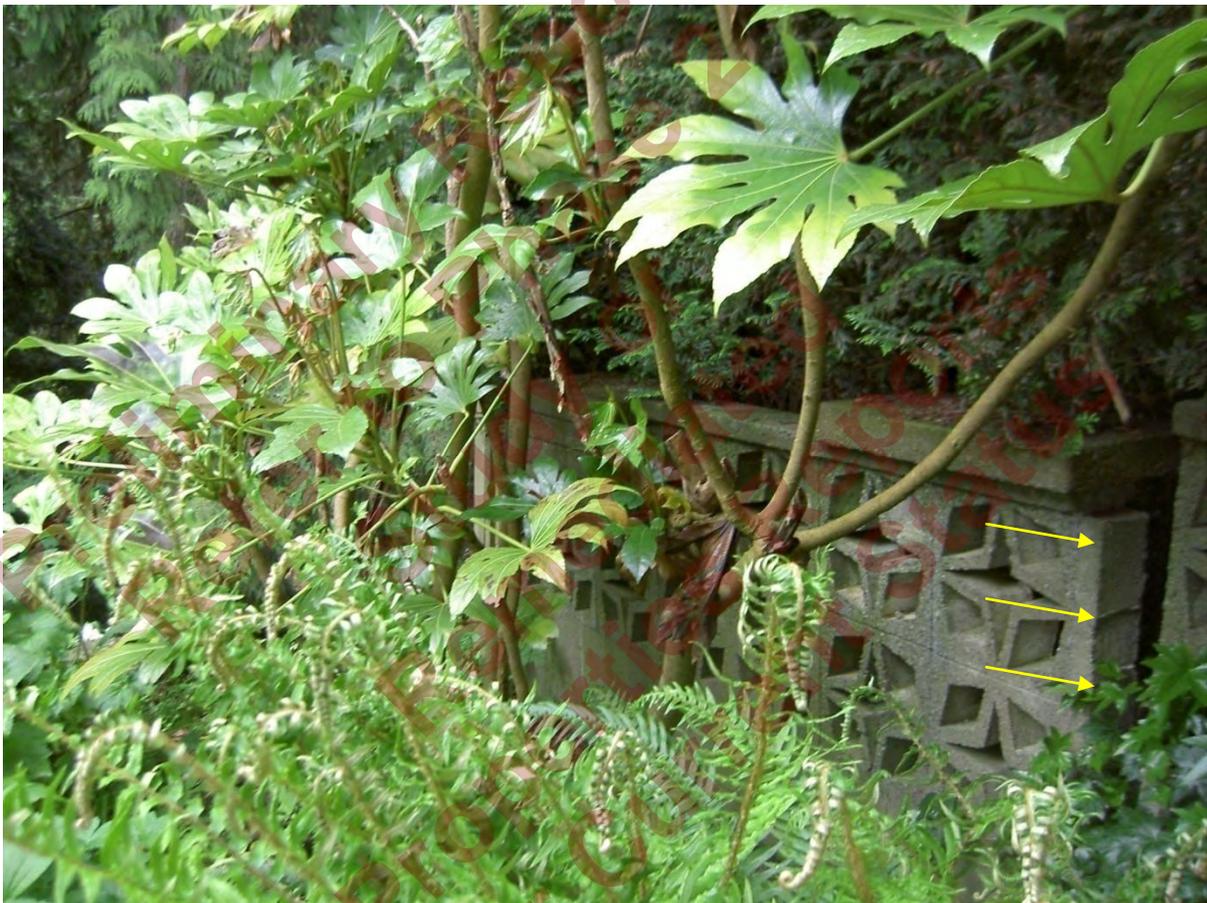
The single family residence at this site is set back 6 m from the crest of a 37°, 18 m high slope. A deck between the residence and slope crest appears to be detached. The property is not connected to the CNV storm drainage system.

Photograph 4: View of damaged concrete block fence between 1900 and 1928 Mackay Avenue (shown by arrows).

Aerial photographs indicate that fill was placed across the top of the slope prior to 1949, associated with construction of the residence at 1900 Mackay Avenue (see Section 7.2.4, below). During the ground reconnaissance, BGC identified evidence for earth sliding or fill settlement, including: downslope tilting of a concrete retaining wall that extends from 1900 Mackay Avenue; horizontal and vertical separation of a concrete block fence between 1900 and 1928 Mackay Avenue (Photograph 4); and a series of depressions and concrete cracks that appear to line up with the cracked fence. The property owner indicated that the slope

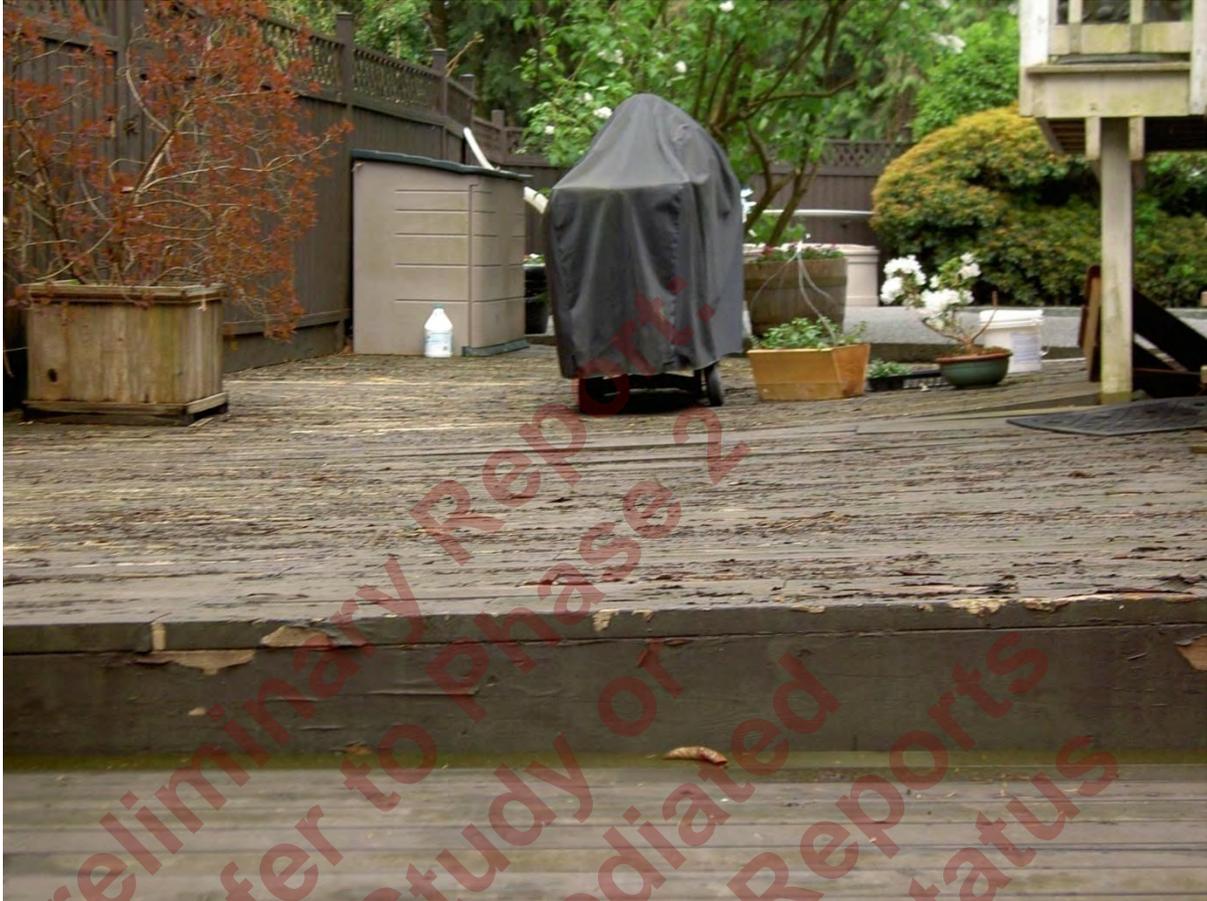
BGC observed severe distortion in detached wood decks and fences between the residence and the slope crest (Photograph 5). The concrete patio around the pool is cracked in several places. No cracks were observed in the pool; however, this does not preclude the possibility of leakage from the pool or related plumbing. The concrete retaining wall is cracked in several places, and is tilted downslope. The deformation suggests that fill settlement, earth sliding or some combination of the two is occurring beneath the site.

Photograph 5: Distorted wood decks at 1900 Mackay Avenue.

Hazard likelihood is high, based on the recent deformation observed at the site. The distance from the residence to the top of slope warrants moderate spatial probability, resulting in high partial risk to the residence. BGC recommends conducting a detailed investigation within 1 to 3 years to determine the fill thickness and extent, whether fill underlies the residence, whether the observed damage is due to fill settlement or earth sliding, whether leakage from the pool is having an effect on stability, and whether future sliding is likely to impact the residence.

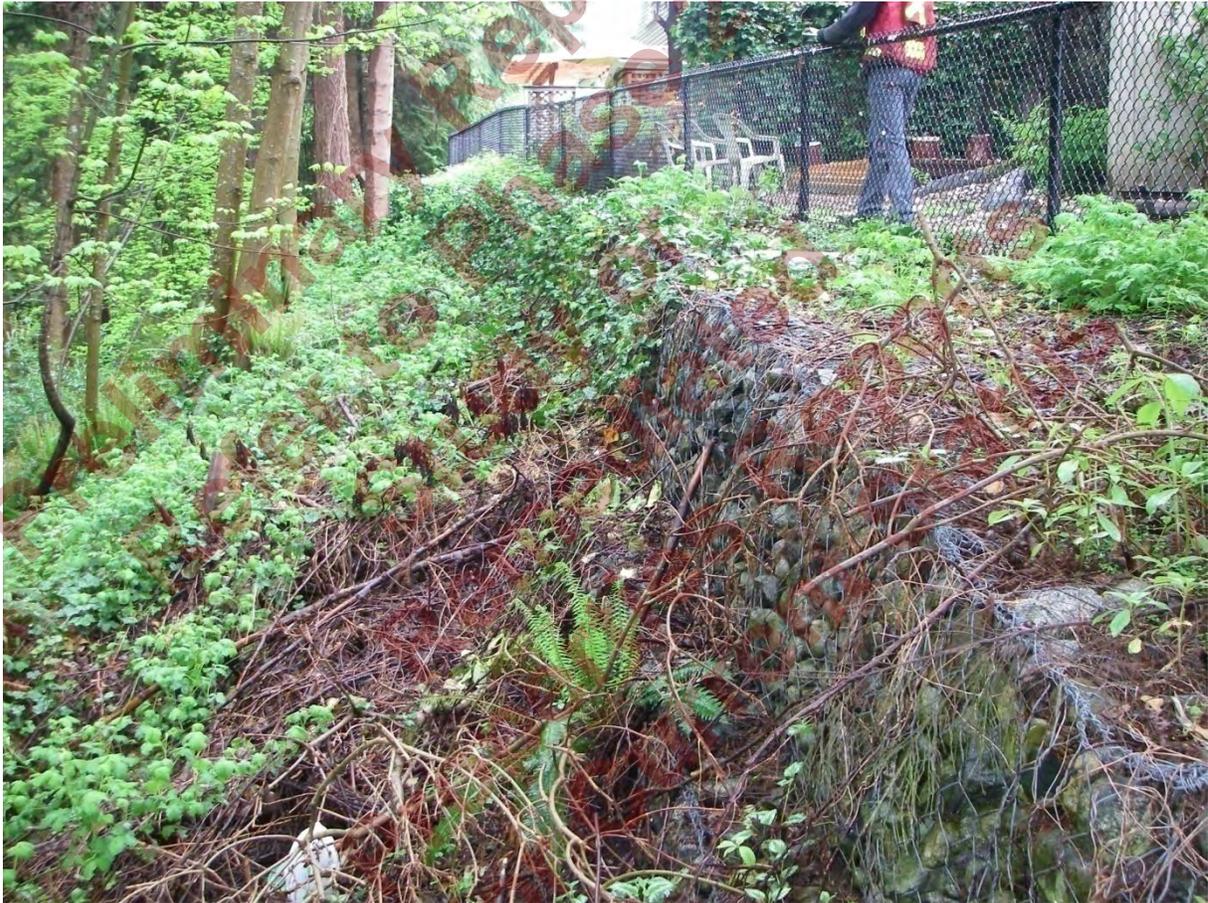
Photograph 6: Gabion wall at top of slope, 811-821 Westview Cres.

The closest townhouse to the ravine slope is Unit 821, 5.3 m away. The slope ranges from 28° to 37° near these units, and is up to 10 m high. Some tension cracks were visible in concrete patios. The slopes below the gabion wall have consistently back-tilted alders, and probably comprise the same earth sliding that was observed immediately south of this site. Because recent landslide activity is present on the slope, hazard likelihood is rated high. Spatial probability is rated moderate; consequently, partial risk is high.

BGC recommends a detailed landslide hazard analysis across the Thain Creek slopes, which would include:

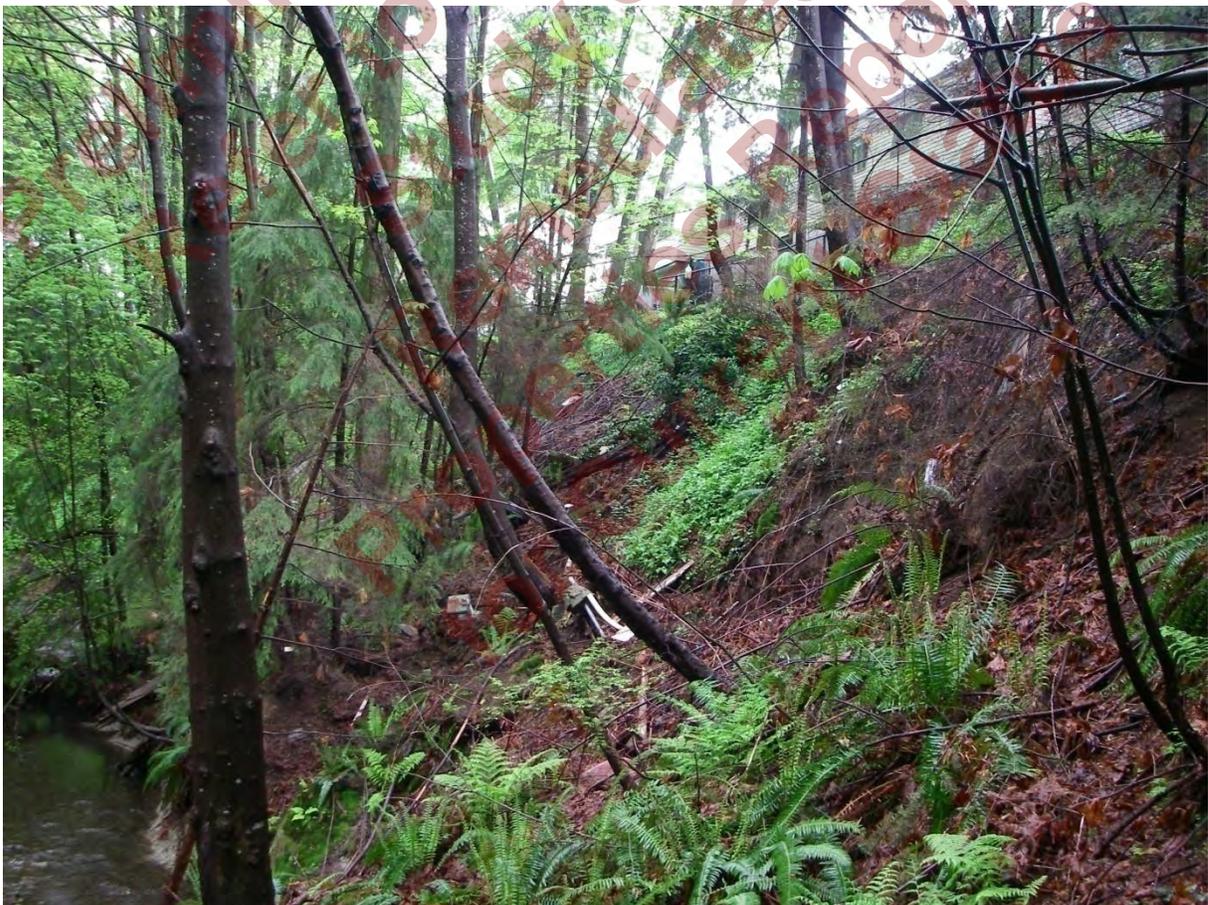
During the field reconnaissance, BGC observed shallow earth sliding across the slope, below all the townhomes in this building. A concrete patio behind Unit 843 was cracked and downdropped up to 0.3 m. The resident of this unit stated that the offset had increased within the past two years. A new fence, installed in 2007, did not appear to be offset. CNV mapping shows storm drains beneath roads within the Cypress Gardens complex, but does not show connections to individual buildings. BGC does not, at present, have sufficient information to confirm this building is connected to the storm drain system. BGC did not find any downspouts discharging toward the ravine slopes.

EBA's (2007) report suggested fill was present at the slope crest; however, no fill was identified in the inclinometer borehole. Consequently, the ground deformation at the site cannot be conclusively attributed to the presence of fill. Because ground displacement is present, BGC assigned high hazard likelihood to the slope adjacent to this building. Spatial probability is currently rated moderate; however, headward retrogression, particularly near Unit 829, could cause that rating to increase. Partial risk is currently high.

Photograph 7: Shallow earth sliding and stream erosion below Units 837-851, Westview Cres.

BGC recommends continued inclinometer readings to determine the depth of deformation near the site. The stability analysis should be refined as results from inclinometer monitoring are obtained. Consideration should be given to conducting additional subsurface work to locate areas of fill and refine the understanding of the native soil stratigraphy, toward refining the stability analysis.

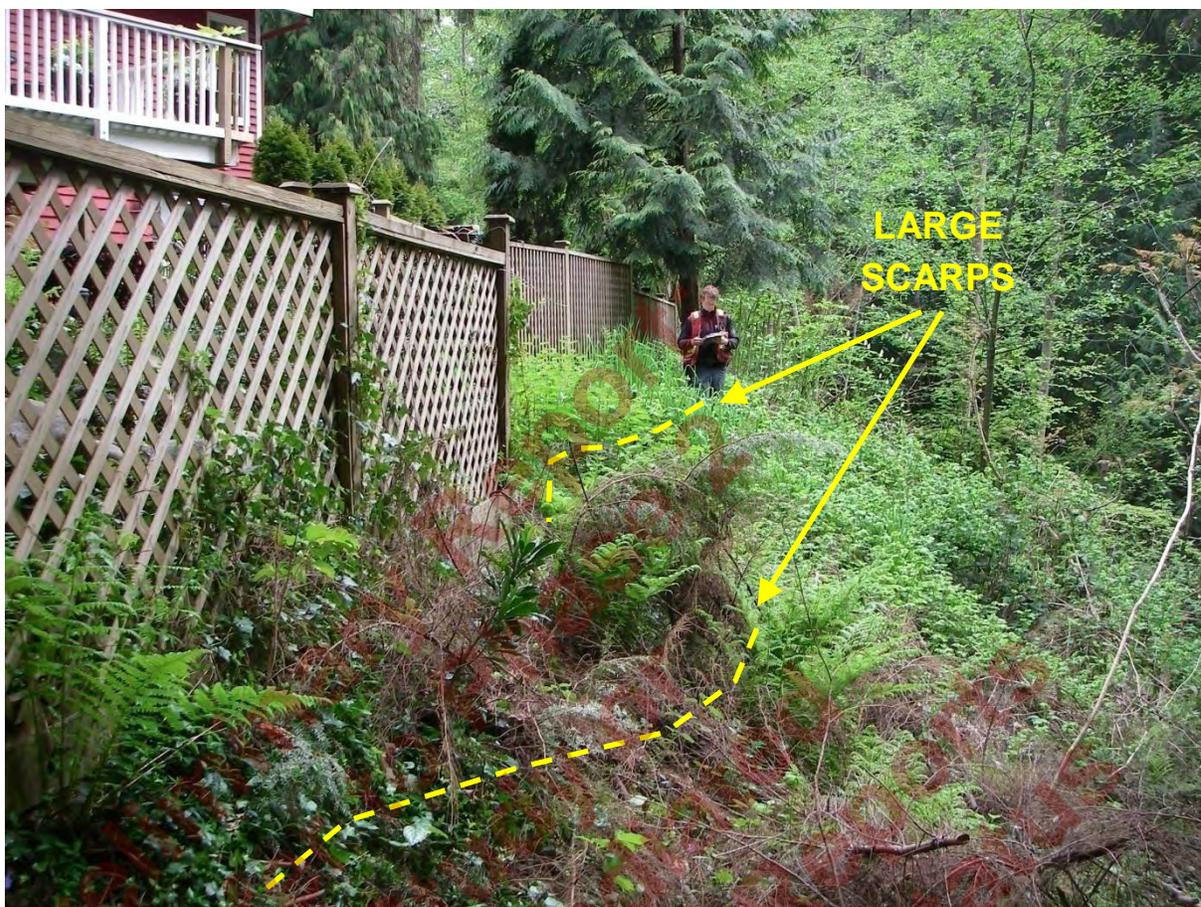
At the time of BGC's site visit, several large, fresh scarps and tension cracks were present along the top of the slope, approaching within 6 m of the residence (Photograph 8 and Photograph 9). These large scarps showed up to 0.5 and 0.2 m of vertical and horizontal separation, respectively, and could be followed for up to 20 m along the slope crest. A smaller step feature, defined by displaced patio stones, passed within 0.5 m of the residence (Photograph 10).

Photograph 8: View of Large Scarps along Crest of Slope, 1956 Wolfe St.

BGC interpreted these features as defining the crown of an active or suspended earth slide. The smaller step feature suggests that the crown may be retrogressing headward toward the residence. During BGC's site visits, there was no indication that the foundation was undermined: no structural distress was observed in the residence. Slide reactivation may begin to undermine the residence, particularly if headward retrogression extends beyond the smaller step.

Hazard likelihood was rated high, due to the presence of fresh landslide features on the slope. Spatial probability was rated moderate due to the 6.3 m distance between the residence and the top of the slope. Spatial probability is the factor most likely to change over the course of the next few years: if the landslide retrogresses toward the house, the top of slope measurement will decrease.

BGC recommends a detailed investigation to better define the landslide hazard and begin designing remedial measures, if the landslide investigations suggest that this is warranted. The detailed investigation should be carried out within one to three years, and should include: subsurface investigations to characterize site stratigraphy and groundwater conditions; detailed site mapping; slope profile measurements; and slope stability analyses. In the near term, BGC recommends connecting the roof downspouts and driveway drop inlets to the City's storm drain system, in order to reduce groundwater pressures and thereby lower the probability of landslide reactivation and retrogression.

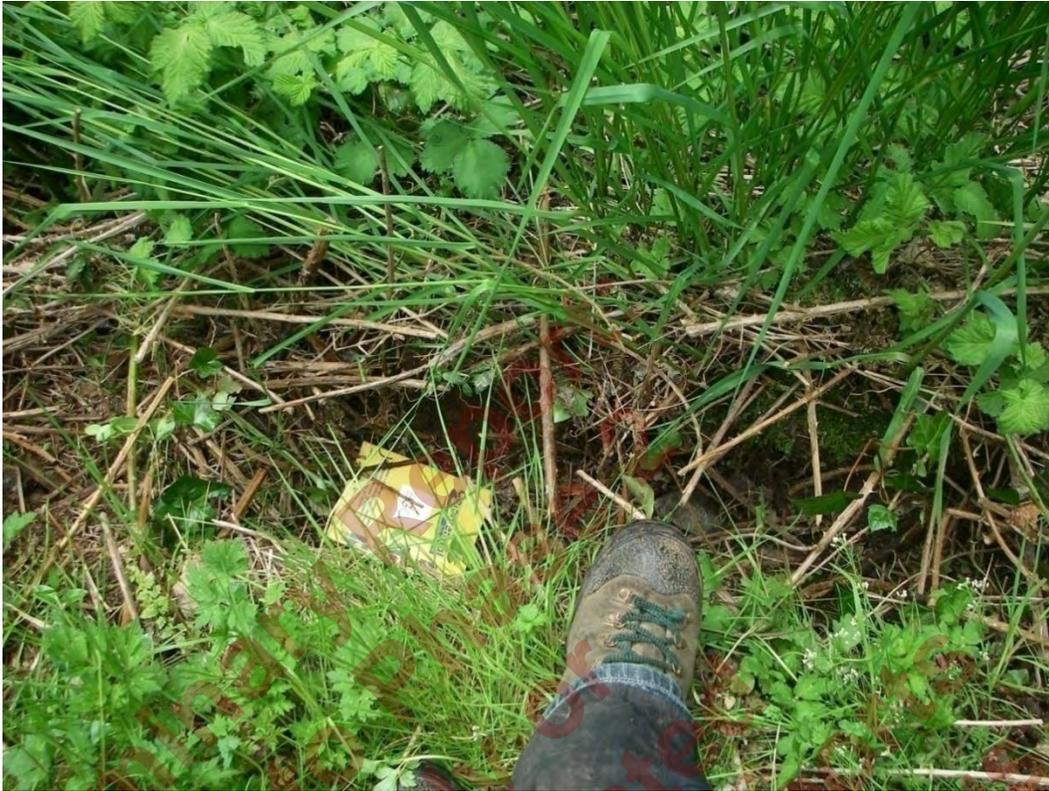
Photograph 9: Close-up of Large Scarp, 1956 Wolfe St.

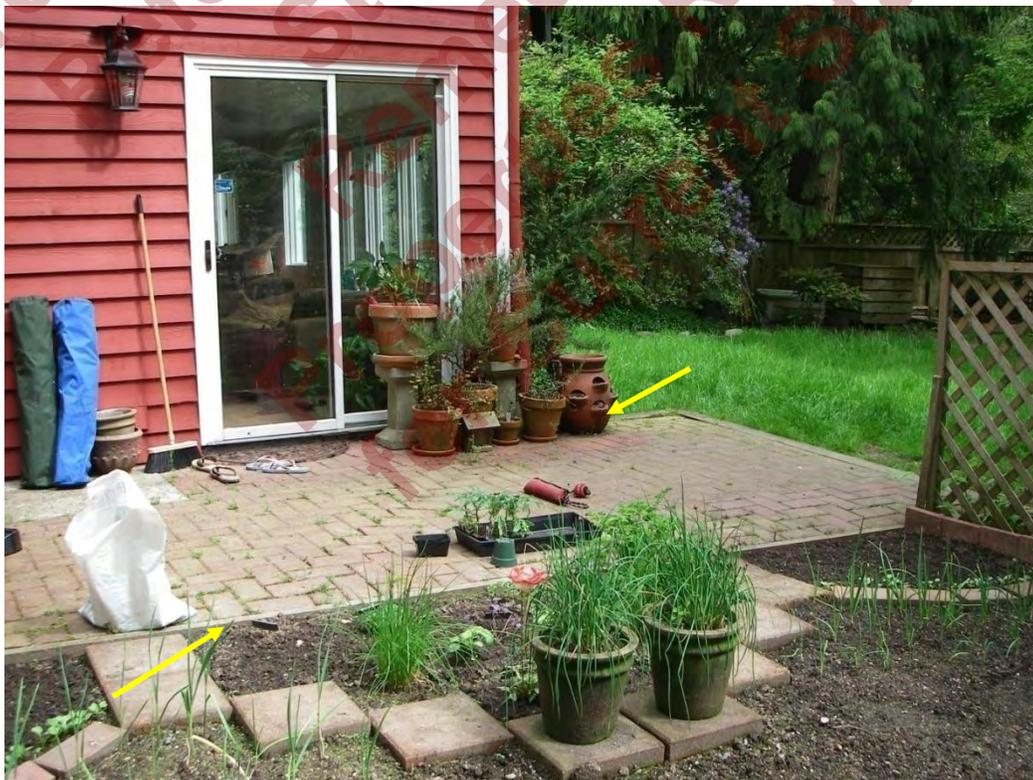
Photograph 10: Small Scarp across Patio Stones, 1956 Wolfe St.

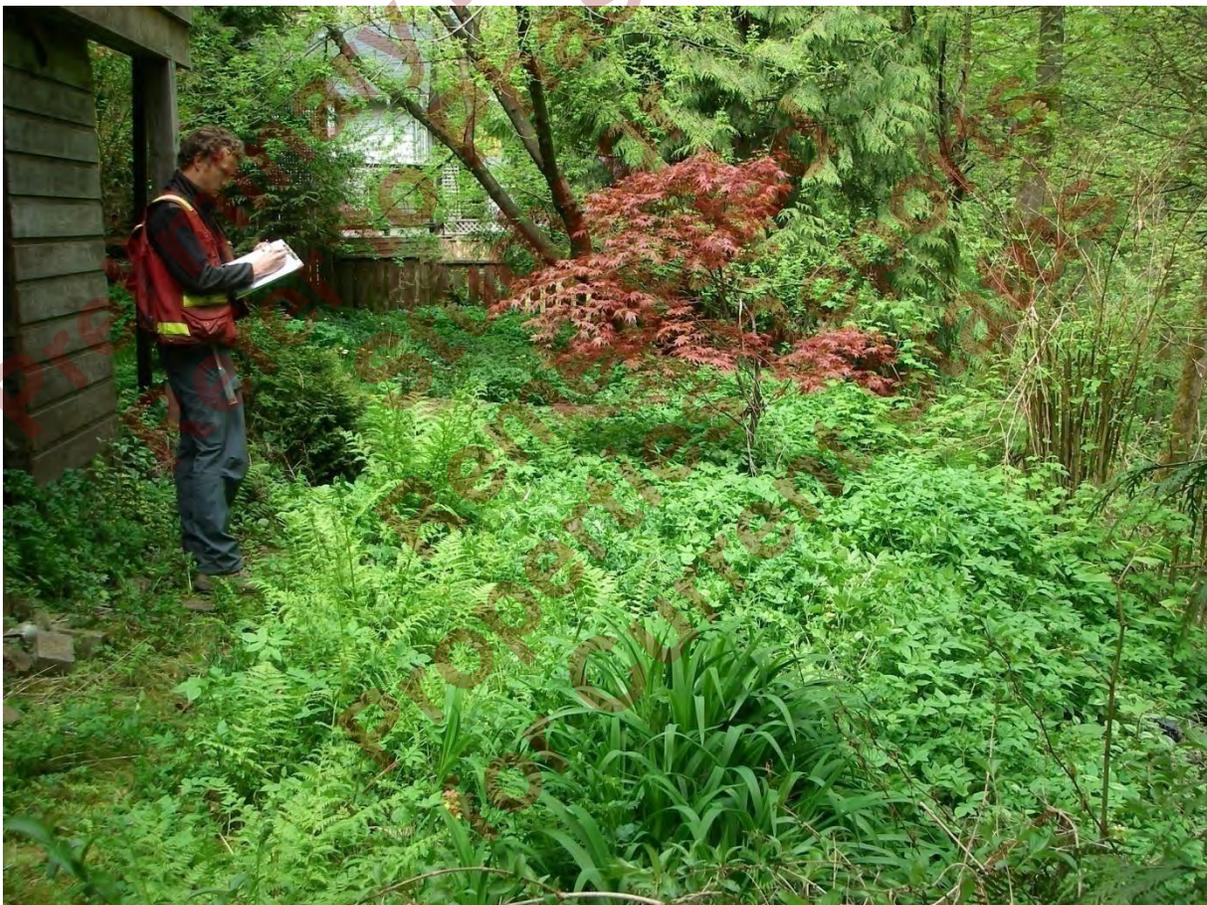
At this site, a single family residence is situated 3.2 m from a 37°, 12 m high slope. No significant grading or past instability was observed in aerial photographs. CNV records do not show a connection to the storm drain system for the property.

Photograph 11: View along Slope at 1716 Wolfe Street.

During site visits, BGC observed suspended to dormant earth sliding, expressed as: tension cracks and shallow (up to 0.1 m deep) depressions extending across the top of the slope; displaced paving stones between the residence and top of slope; deck supports out of plumb (Photograph 11); and pistol-butted maple trees on the slope.

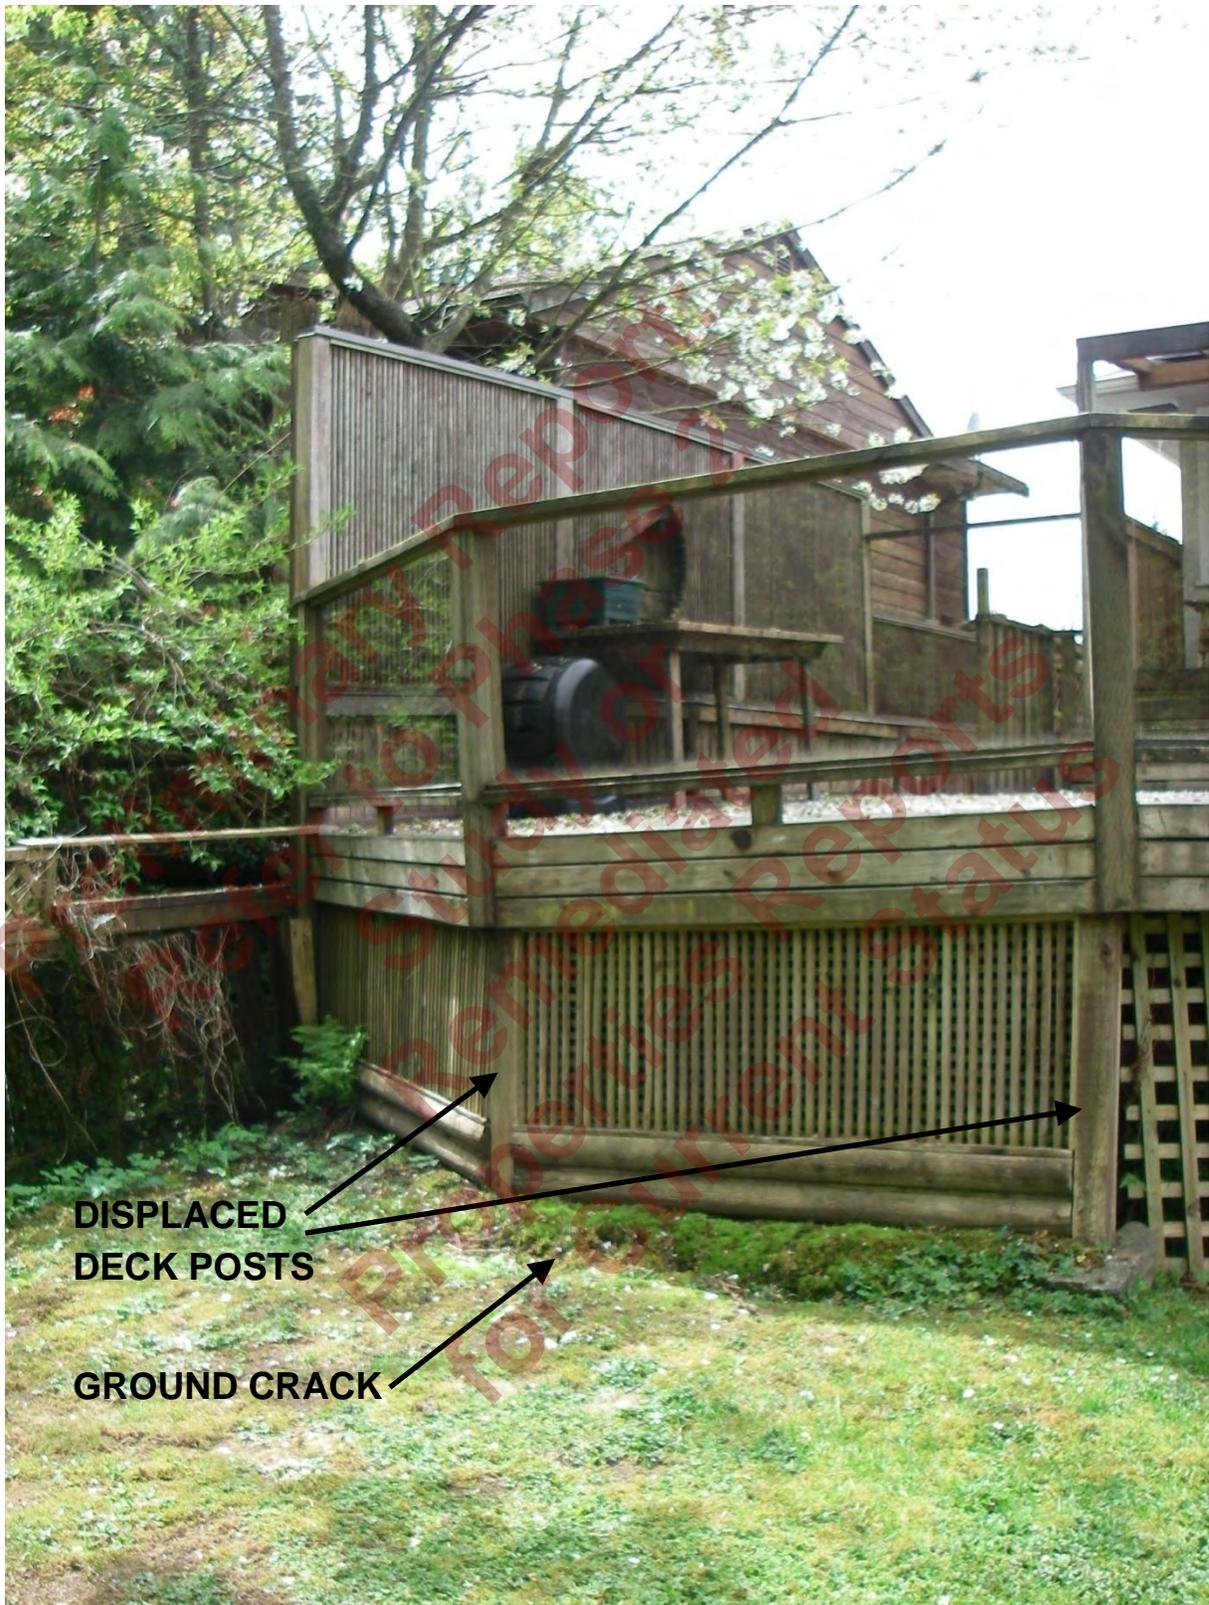
Hazard likelihood was rated high, due to the signs of recent instability discussed above. Spatial probability was rated moderate, due to the 6 m distance from the residence to the top of the slope. Consequently, partial risk was rated high. BGC recommends a detailed investigation within 1 to 3 years, directed toward better evaluating the nature of slope instability so as to better assess risk and design suitable mitigation if necessary. To reduce risk to the moderate category, the owner might consider either removing the deck or replacing it with a free-standing deck, not structurally attached to the residence.

Photograph 12: Deck at 1732 Wolfe Street.

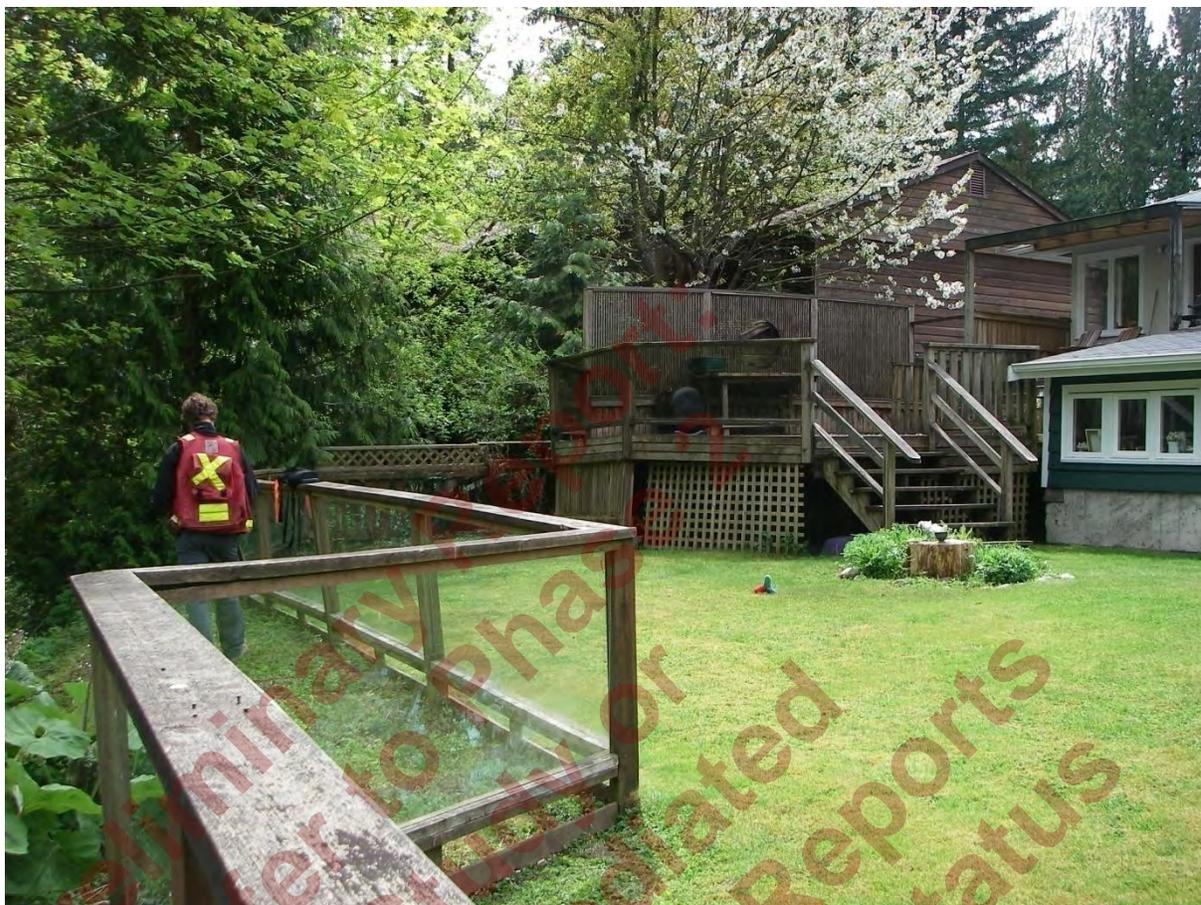
Photograph 13: View across back yard at 1732 Wolfe Street.

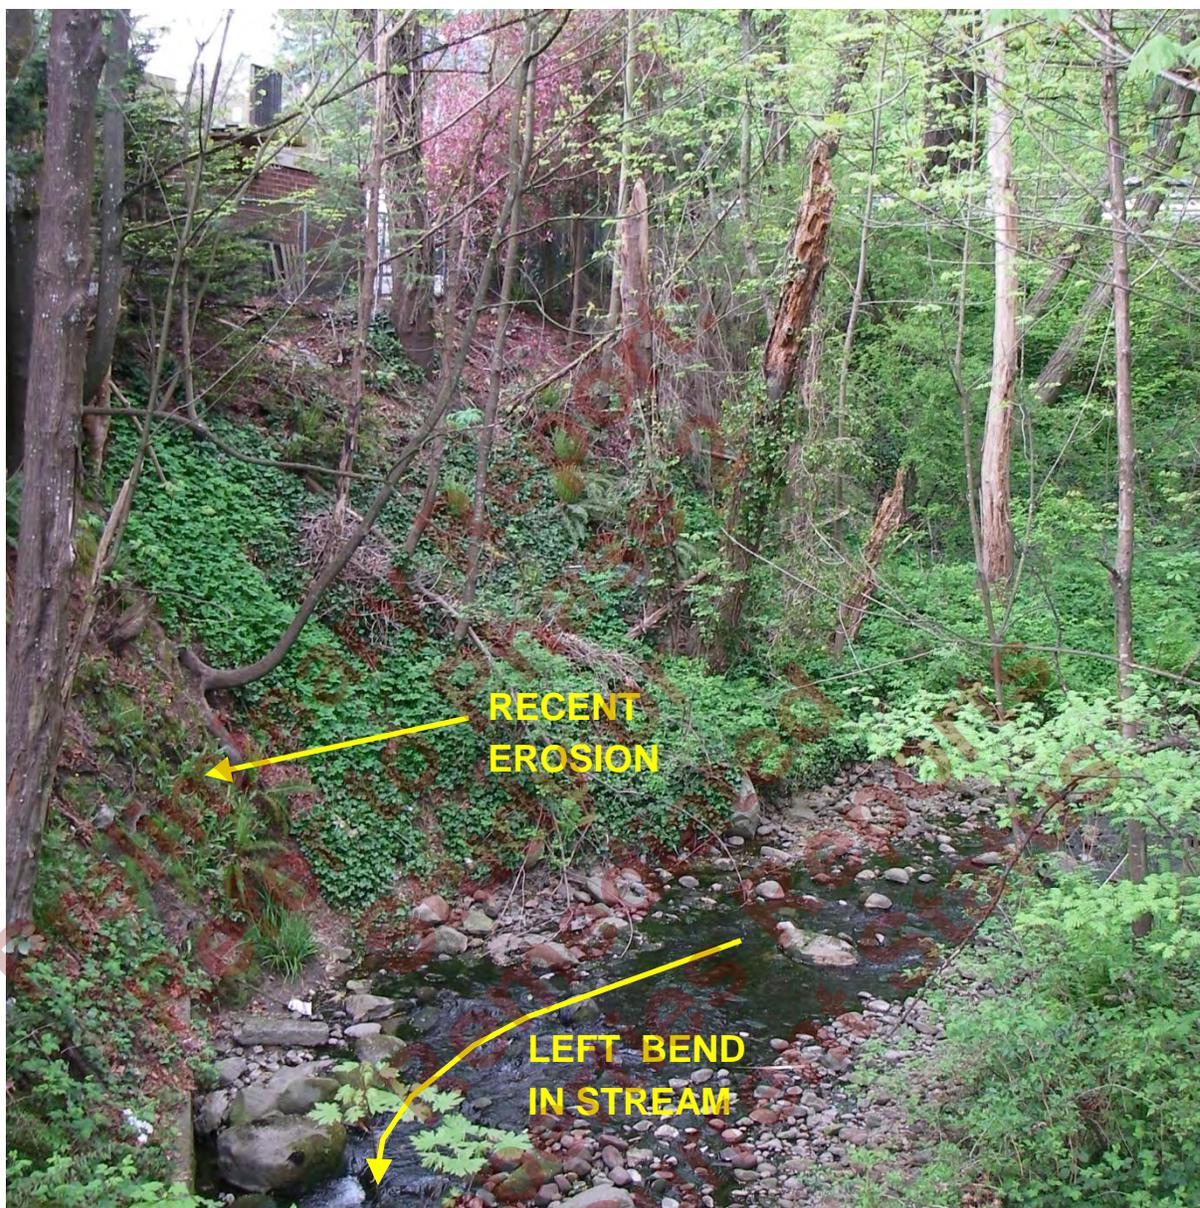
Hazard likelihood was rated moderate, owing to the steep slope angle and the presence of active erosion. The small distance between the store and the slope crest warrants a high spatial probability rating; consequently, the partial risk is rated high.

Photograph 14: View of Wagg Creek and slope below 660 West 3rd Street.

BGC recommends detailed study to determine whether the building or slope is underlain by fill. A slope stability analysis should also be undertaken, using site-specific material properties and slope profiles. The results of these studies should determine whether proactive mitigation should be recommended.

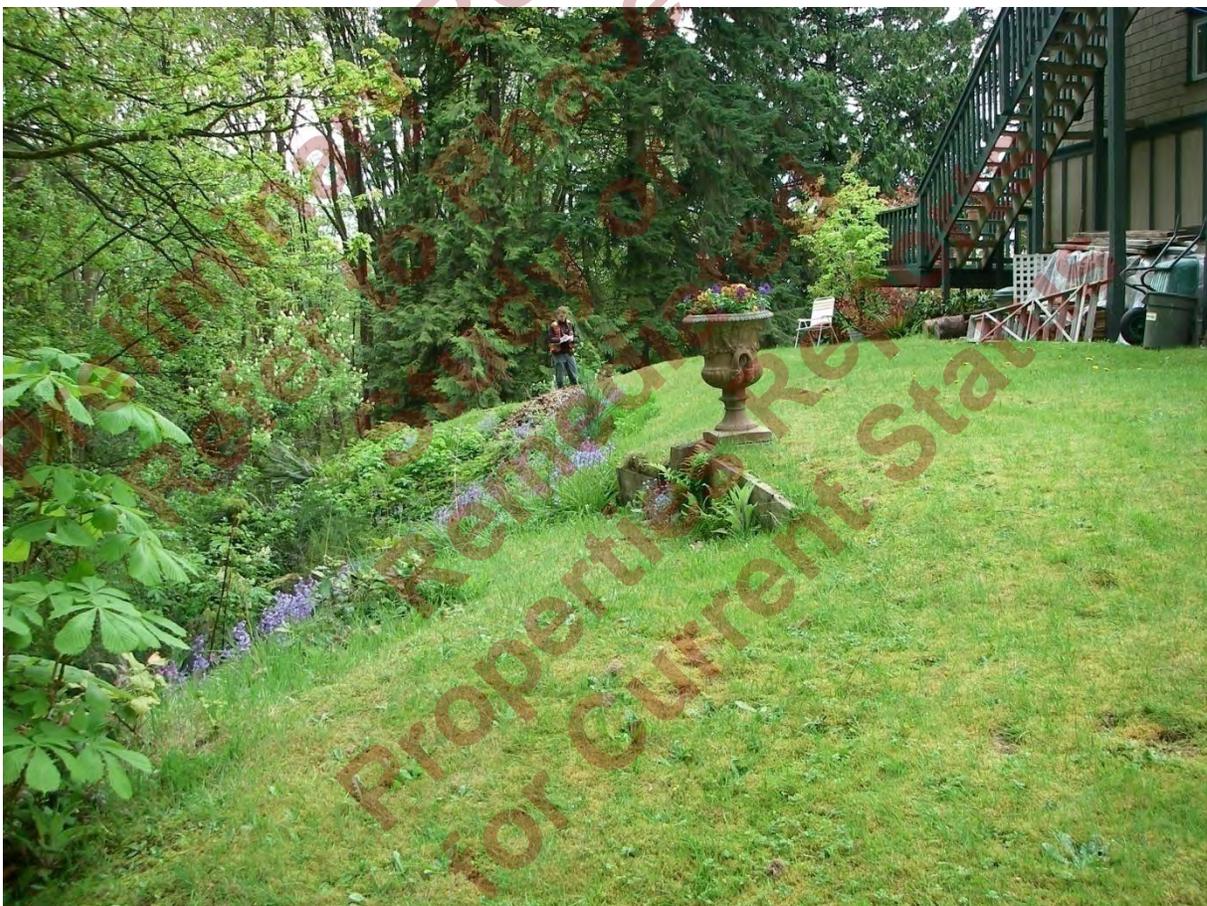
During the ground reconnaissance, BGC found benched ground and a series of scarps within a wide gully located southeast of the residence (Photograph 15), roughly coincident with the brown soil noted in the 1980 aerial photographs. BGC interpreted these features as representing suspended to dormant, shallow earth slide activity within the colluvium mantling the ravine slopes. Such activity is usually more likely to occur within gullies or hollows, owing to concentrated runoff. The closest distance between the crown of this slide area and the residence is 5 m.

Photograph 15: View across gully at 621 W 15th St.

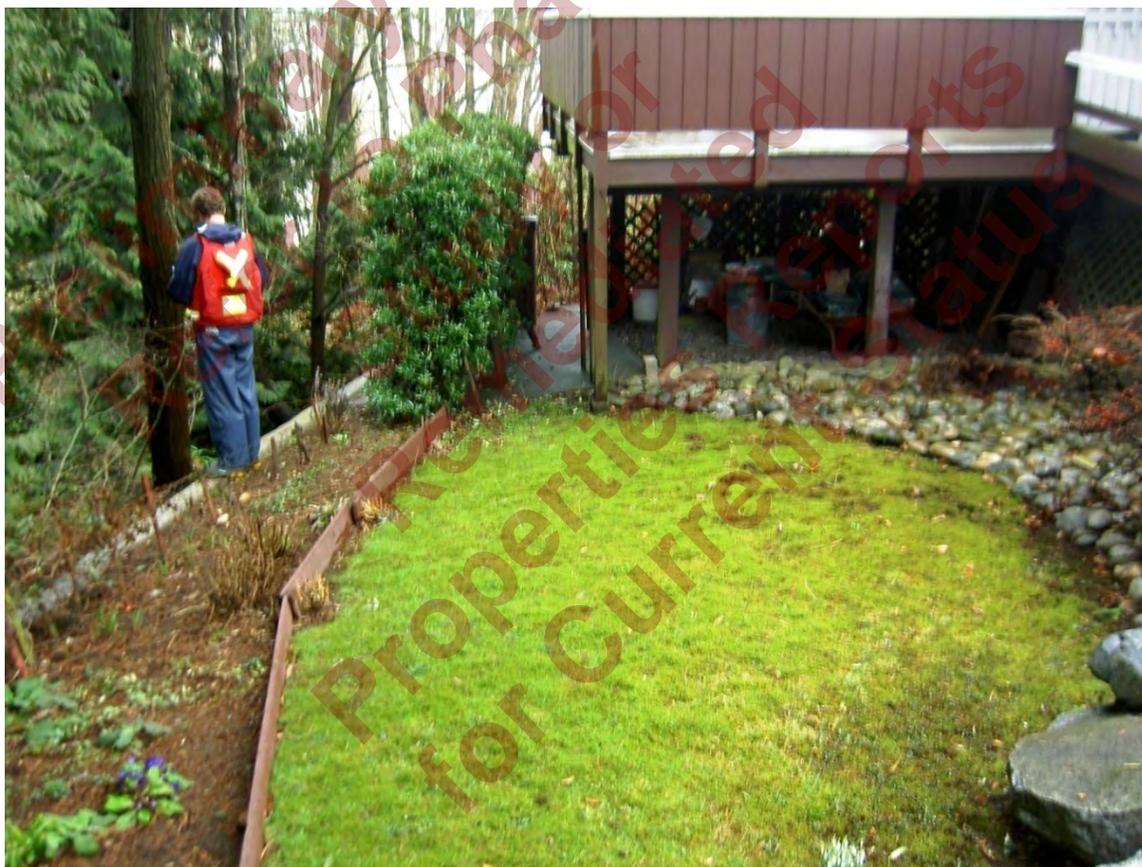
The single family residence at this property is situated 6 m from the crest of a 5 m high, 32° gully side slope. An attached deck approaches within 2 m of the slope crest. Minor fill and non-engineered unreinforced rock and masonry retaining walls, up to 1 m high, are present at the slope crest. No signs of past landsliding, significant settlement or foundation distress are present. CNV maps do not show a connection to the storm drain system.

Photograph 16: View facing south at 651 East 1st Street

The presence of non-engineered fill and retaining walls warrants a moderate hazard likelihood rating. Spatial probability is high based on the distance between the slope crest and attached deck. The resulting partial risk to the residence associated with the slope hazard is high.

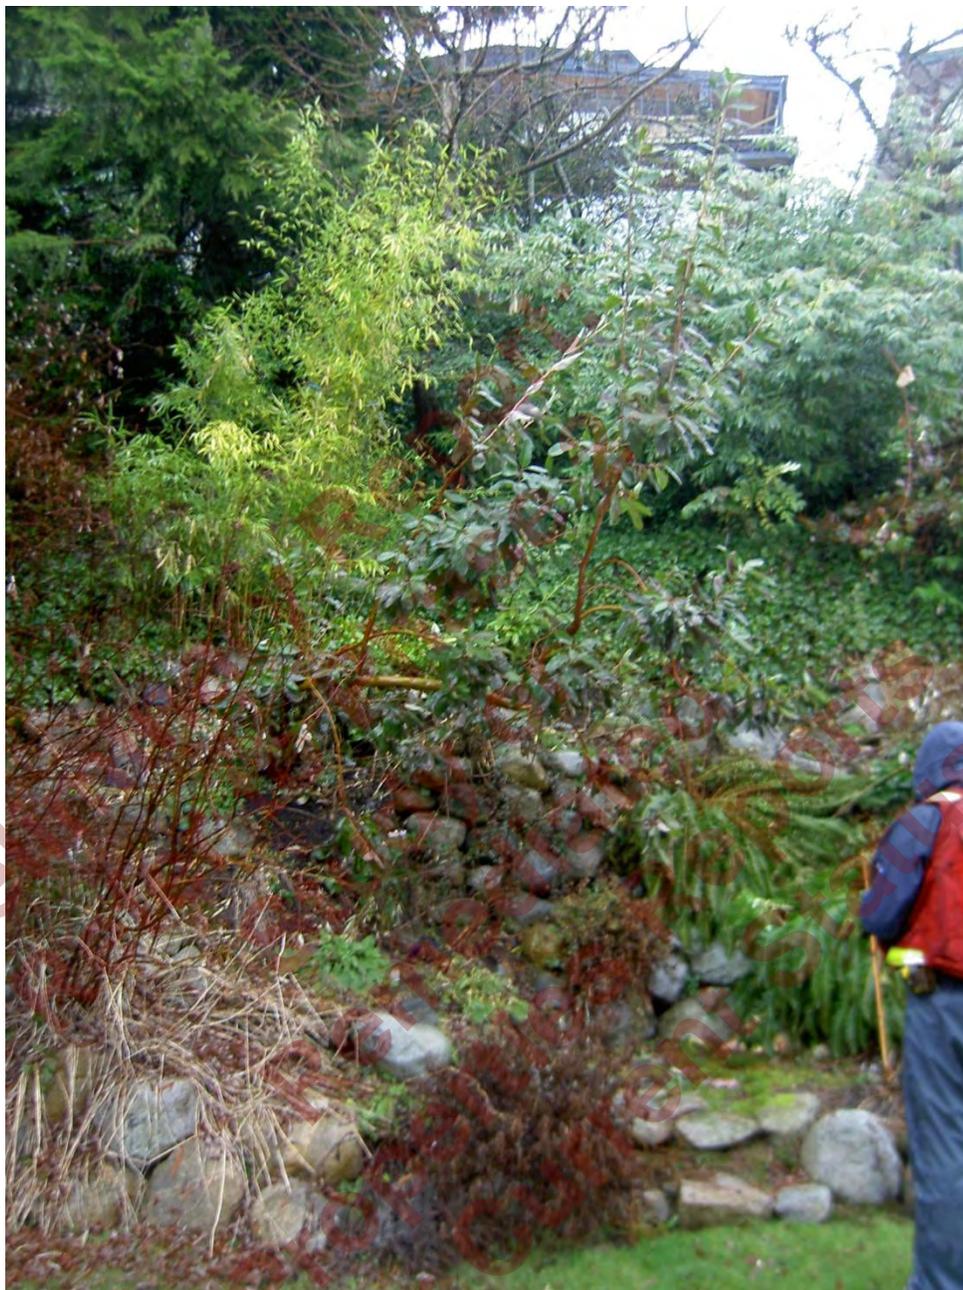
Photograph 17: View of landscaped fill slope beneath 2116 Grand Boulevard

BGC recommends that a detailed investigation be performed on the property, focused on better characterizing the landslide hazard below the home. If it can be demonstrated that the slope below the home is stable, or if engineered fill placement has been documented, a low hazard likelihood rating may be warranted, which would reduce the partial risk rating to moderate.
