Heritage Conservation Plan

311 West 14th Street, North Vancouver, BC :: The Follis House ~ 1907

Prepared by Elana Zysblat, CAHP :: Ance Building Services :: August 2022
Research & Analysis by Jurian ter Horst, MA :: ter Horst Research

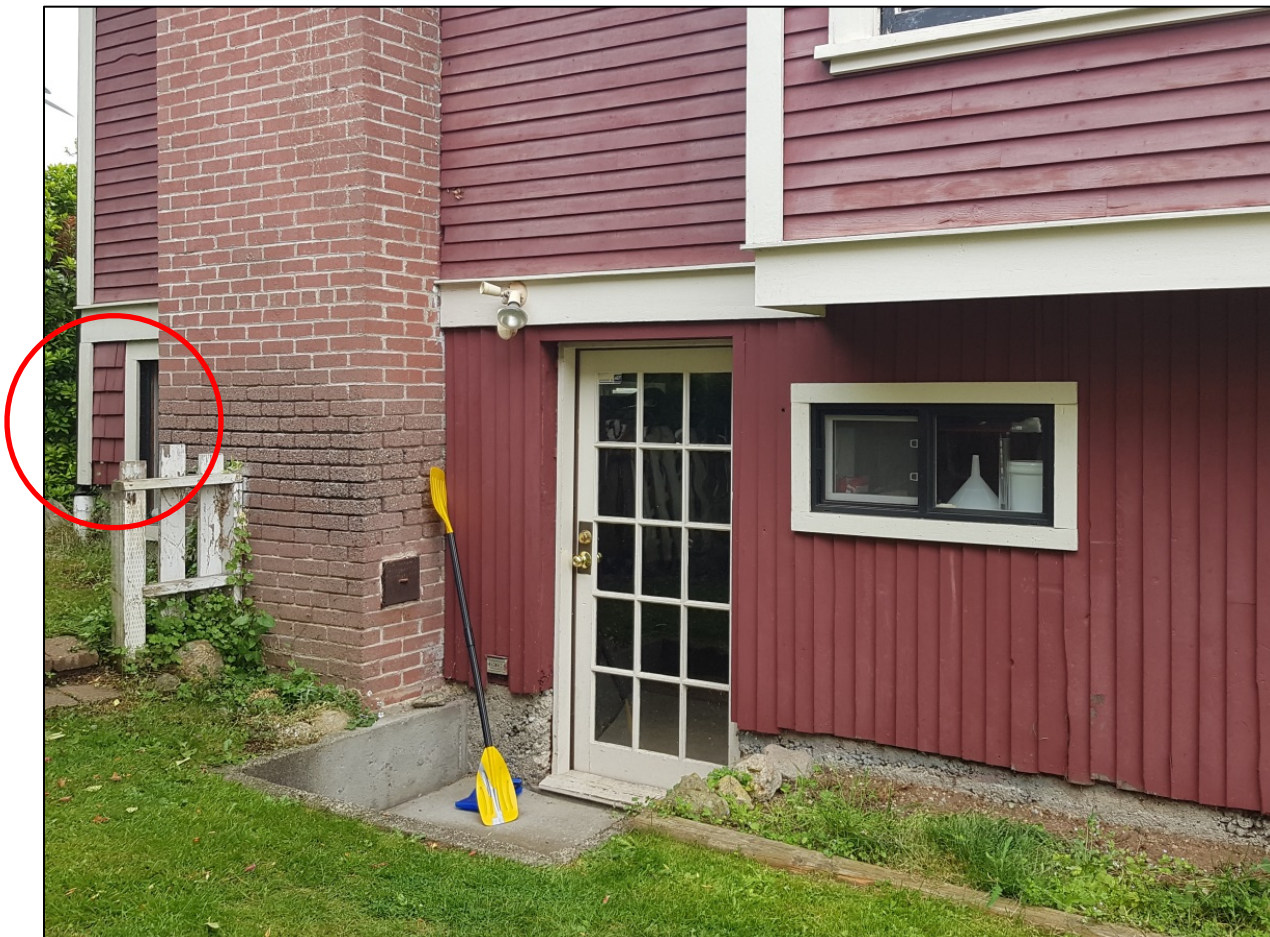
Note: the lapped wood siding installed vertically at the basement level is a later intervention and is in fair condition.

Note the horizontal (main floor) and vertical (basement level) lapped wood siding. The vertical siding is a later intervention, which may have replaced square cedar shingles, as indicated by the original shingles remaining at the basement level (left in the photograph, marked with a red circle).

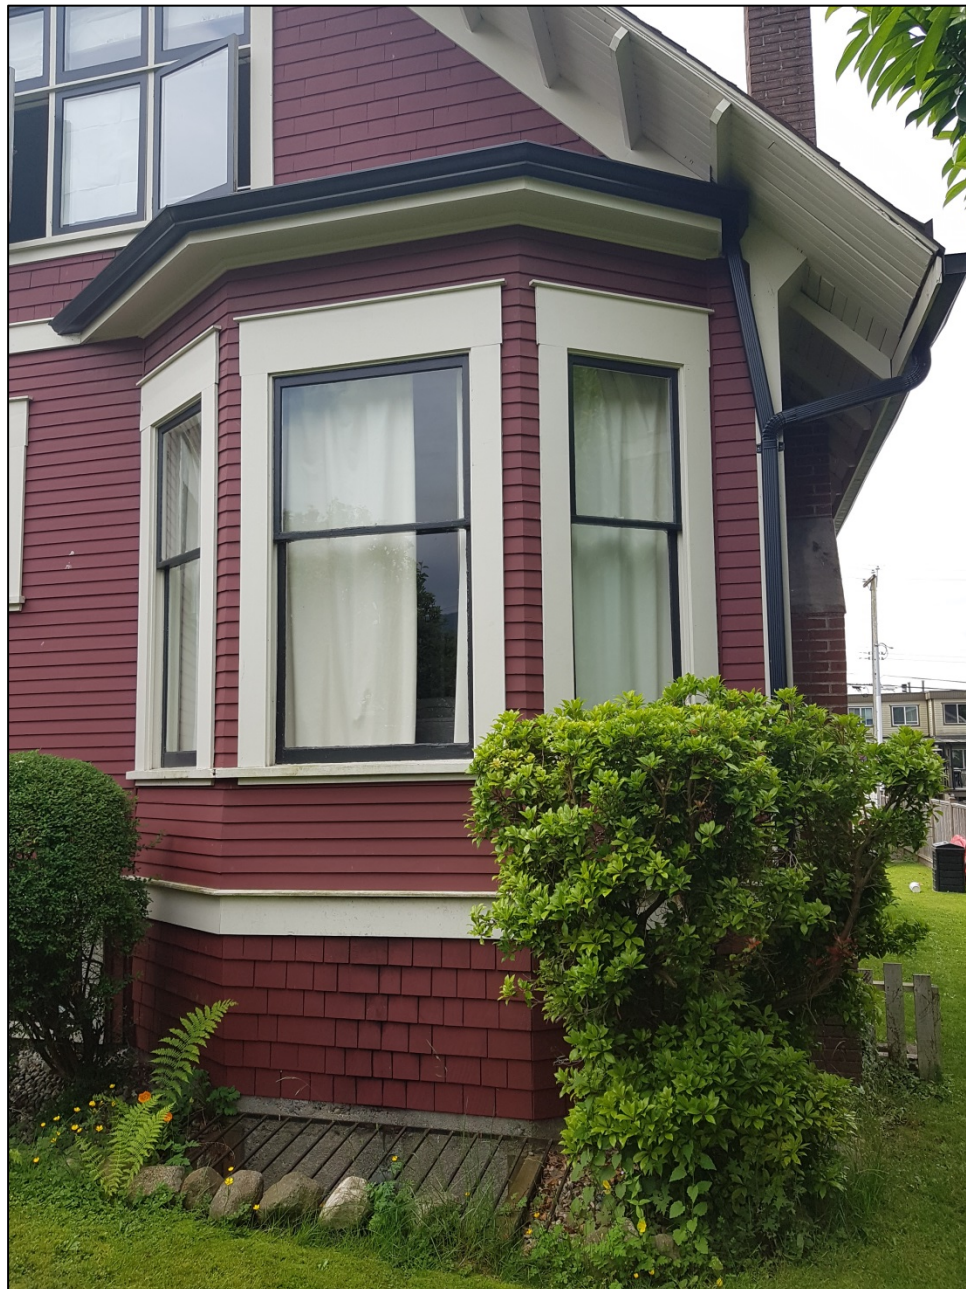
The bay window assembly is in good condition, although the operability of the windows was not assessed.

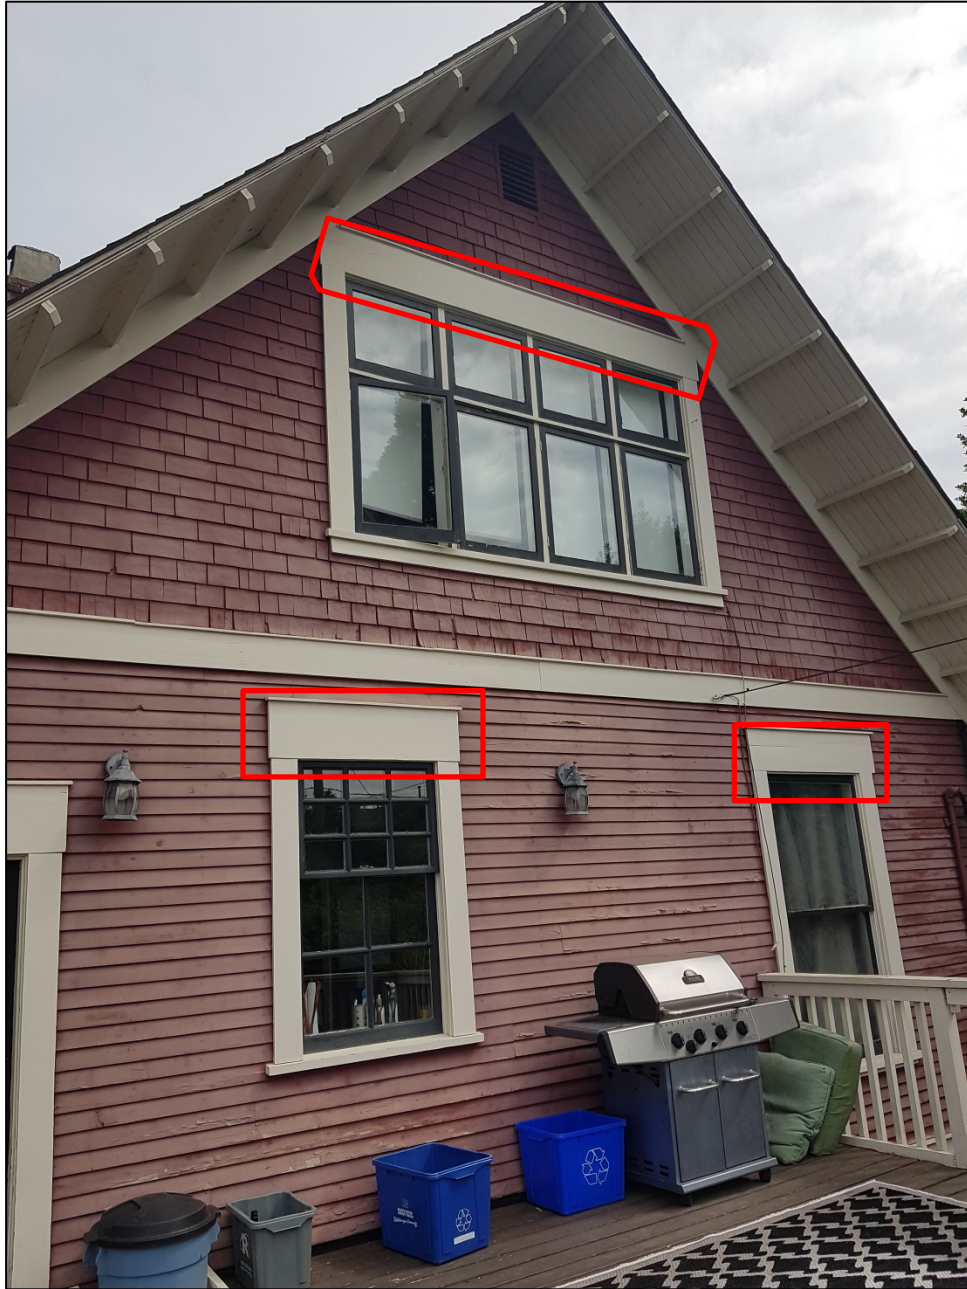
The window and door trim is overall in good condition. Note the extra large size of the casing heading board.

The casing header of the wood windows throughout the house (marked with red boxes in the photograph) is extra large large.

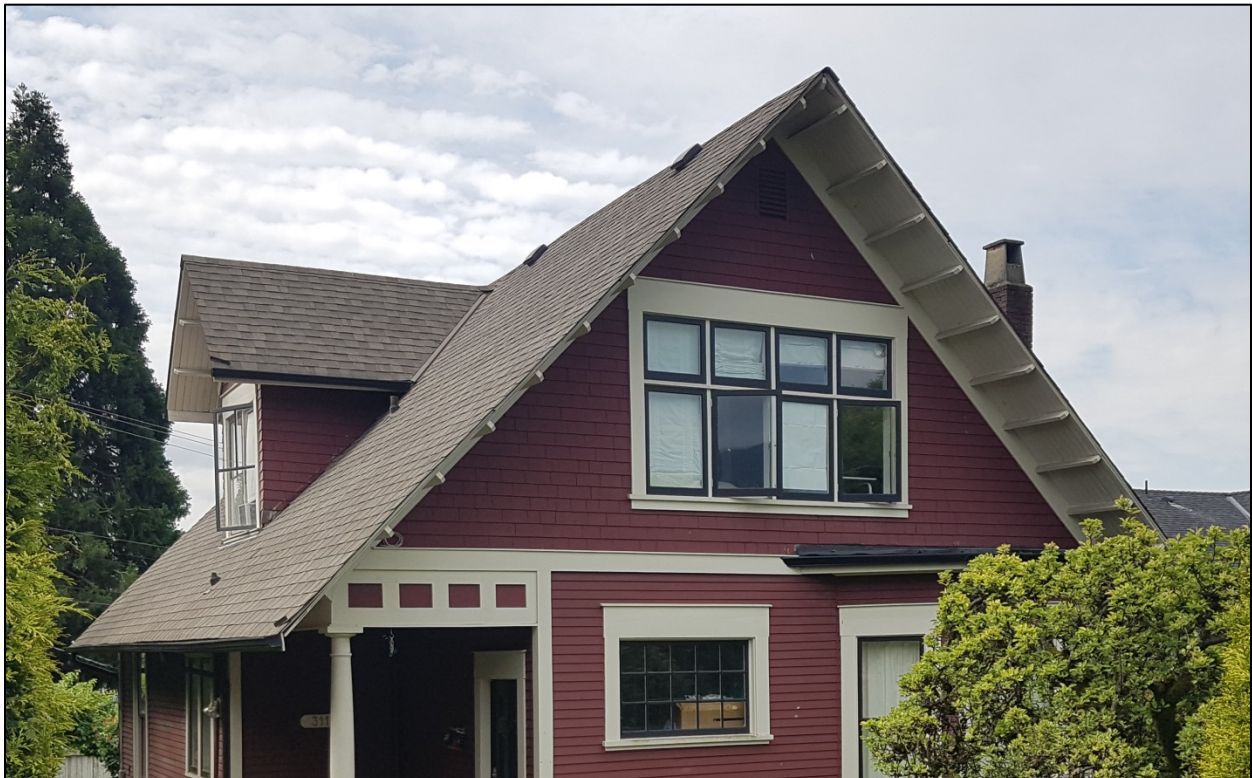
The asphalt shingle roof appears to be in good condition. The aluminum gutters and downspouts appear to be functioning adequately.

The house has a prominent, steep-pitched, front-gabled roof with deep eaves, tongue-and-groove soffits, exposed roof rafters, and two gabled dormers. All these elements appear to be in overall good condition.

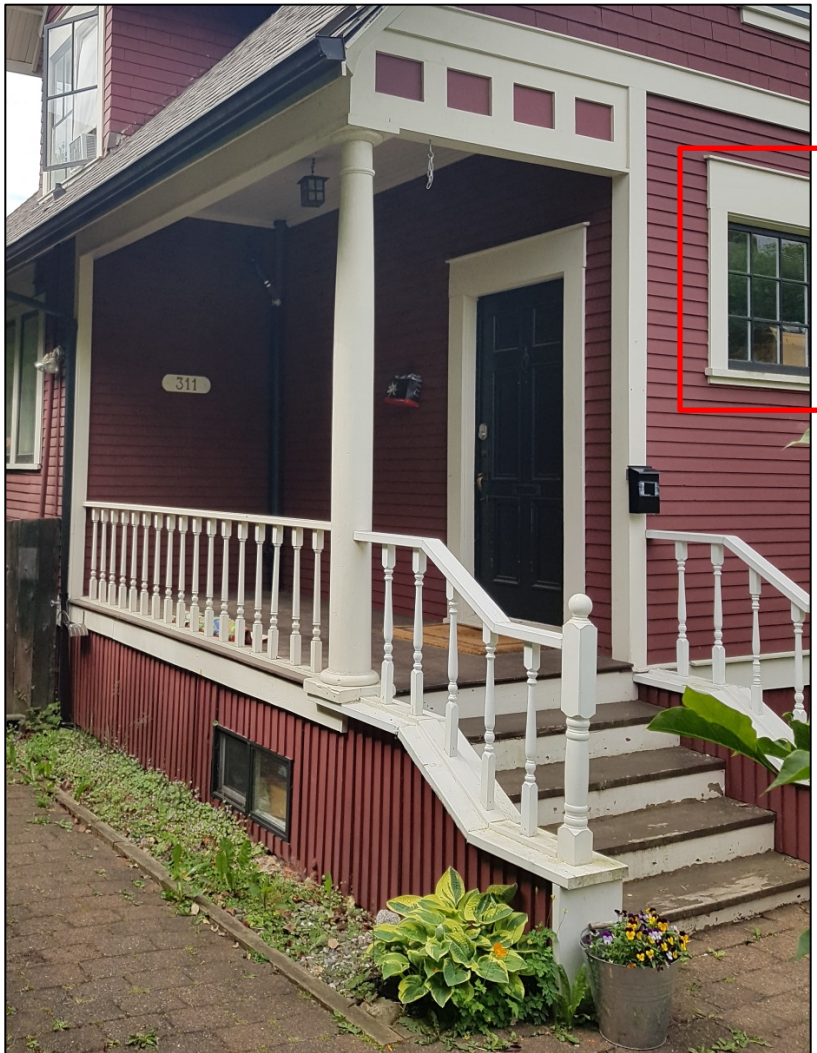
The subject house has an unusual entry, with a front door not facing the street and a square side light located on a separate wall from the door (marked with a red rectangle in the photograph).

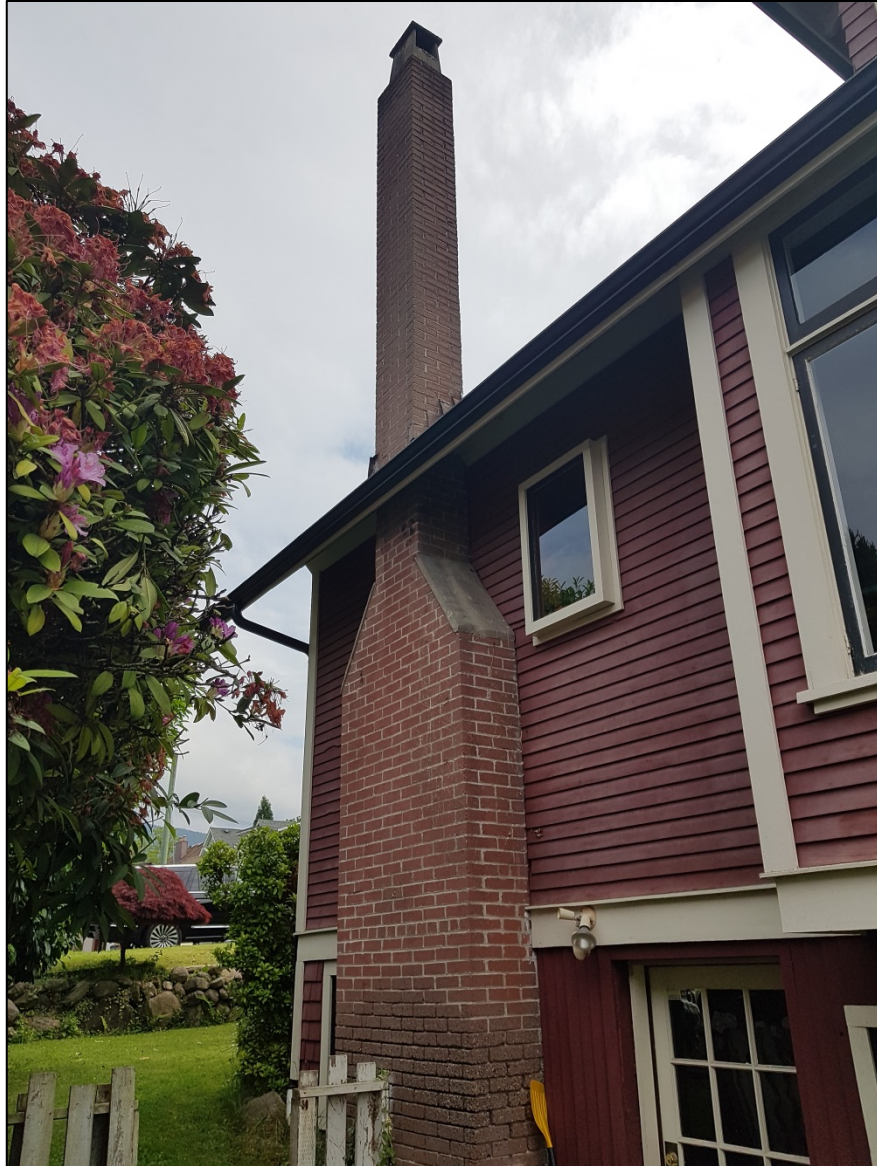
The red brick, end-wall chimney on the west elevation is in fair condition. There is evidence of interventions that impacted the integrity of the chimney. The internal chimney at the rear is in fair condition.

The end-wall chimney on the west elevation shows evidence of three different interventions at basement level.

- Review structural integrity for deformation, leaning, cracked or spalling bricks.
- Always work with a professional mason to conduct assessments and repairs on the chimney

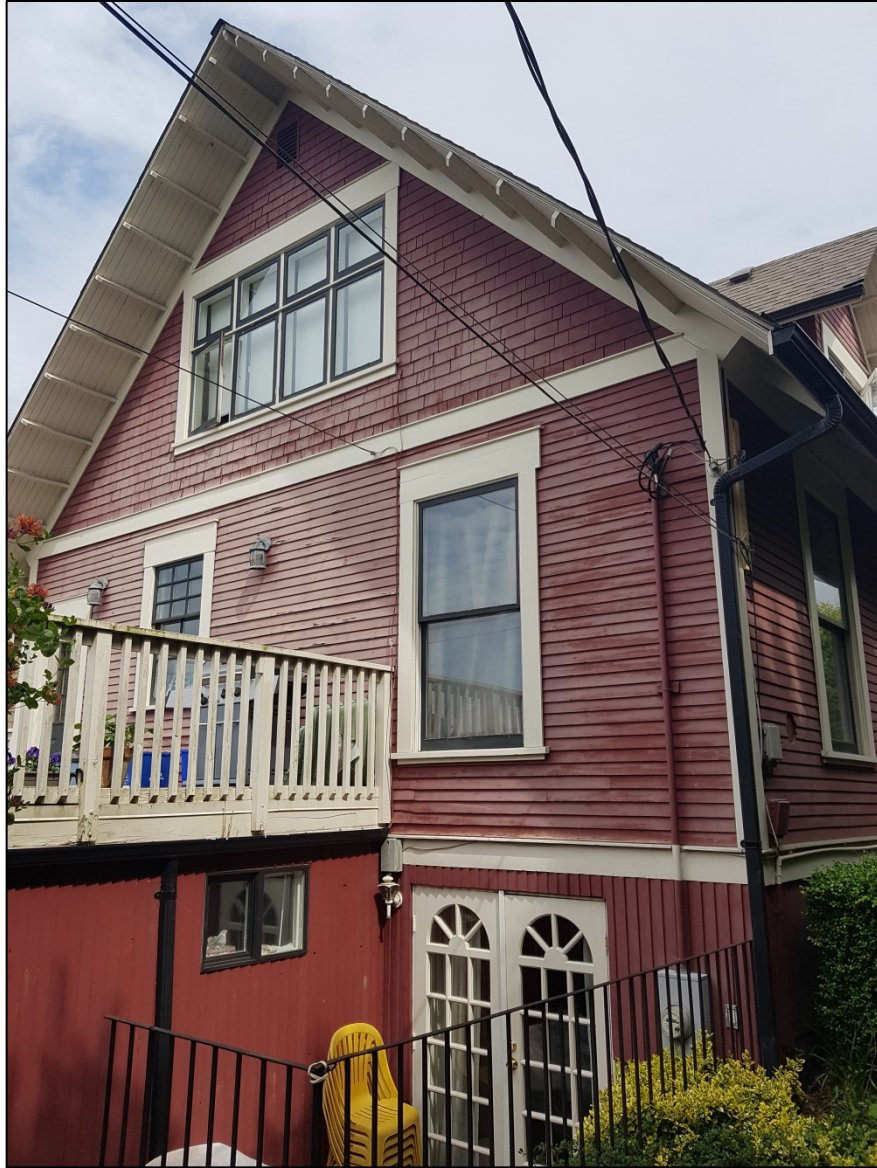
The painted finish on all wood elements is overall in fair to good condition, except for the wood siding and shingles on the south and west elevations. The failing paint there is a result of exposure to sunlight. The overall painted finish appears to be at the end of its service.

The south elevation (rear) shows evidence of failing paint due to sun exposure.

Follow Master Painters' Institute Repainting Manual procedures, including scraping loose paint down to next sound layer (not bare wood), clean surface with mild TSP solution with gentlest means possible, and rinse with clean water; do not use powerwashing. Repaint using high-quality paints in correct historic sheens for the building part:
