Watercourse Setback Assessment at
2000 Wolfe Street, City of North Vancouver, BC

For: Streamside Protection & Enhancement Development Permit

March 22, 2022, Version 1.0
Project No. 21.0069

Client:
Great Owl Estates Ltd.

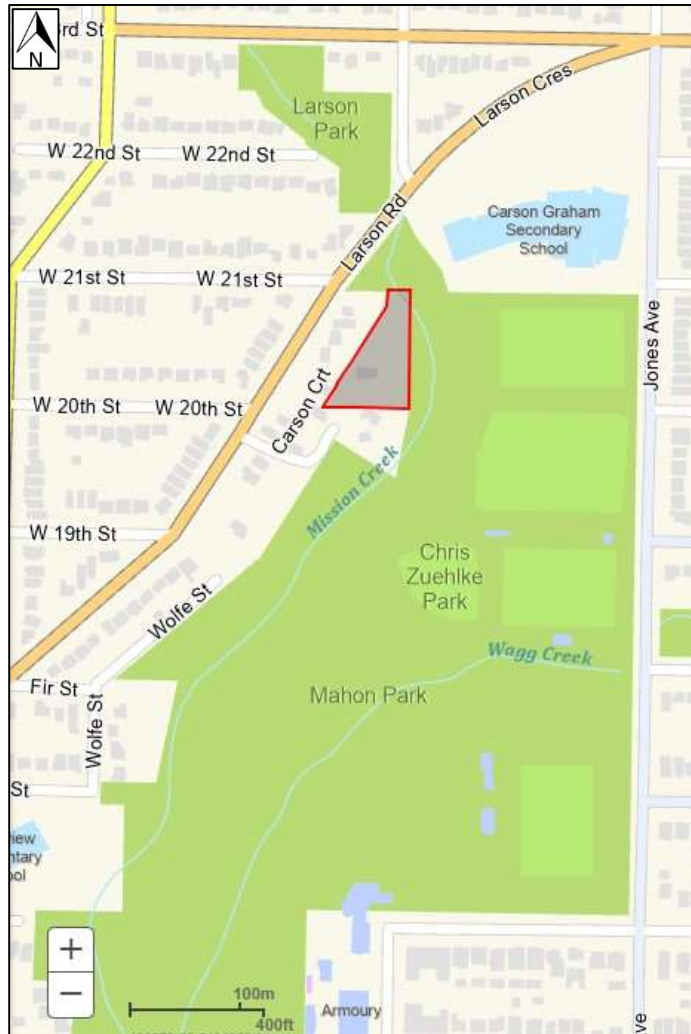
Figure 2. Overview mapping of the subject property and the surrounding neighbourhood.

The subject property is presently developed with one single-family home plus accessory buildings. The Client is proposing to redevelop the site into a five-lot subdivision for new single-family housing. Twain Creek (alias, Mission Creek) flows through a ravine in Mahon Park abutting the east boundary of the property (Figure 2). The proximity of the watercourse triggers CNV's requirement for an SPEDP permit application.

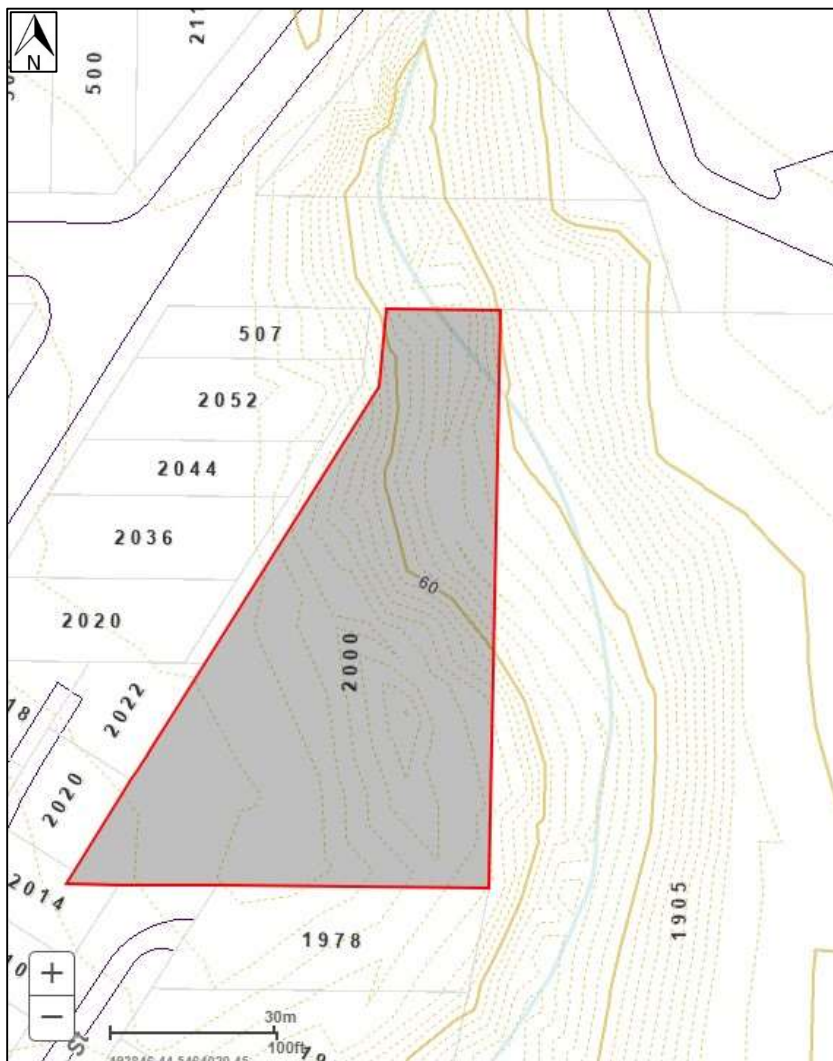
Figure 3. This is an overview map of the study area illustrating the presence of Thain Creek and the ravine. Obtained from CNV Webmap, 2022-03-11.

Thain Creek (alias Mission Creek) flows south on the east side of the property in a wide, deep and steep-sided ravine. Wagg Creek flows into Thain Creek from the east bank of the ravine (Figure 3). The streamside protection area of Wagg Creek does not encumber the subject property and is not discussed further in this report.

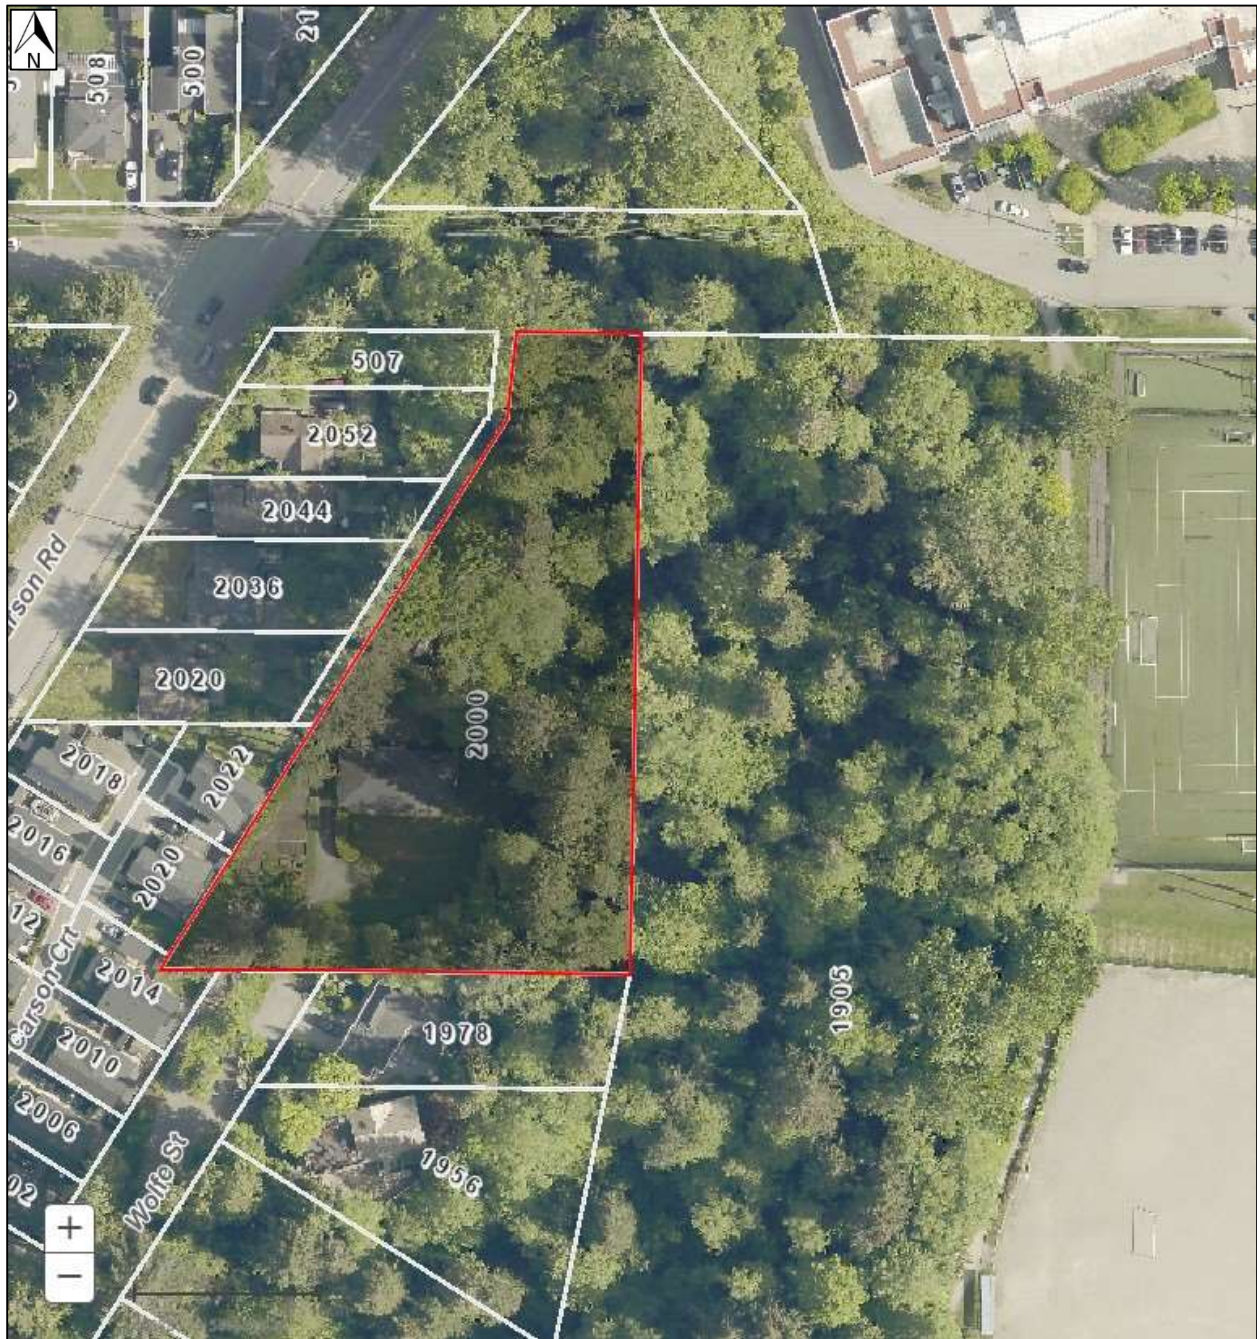
Figure 4. The subject property is highlighted in this 2021 air photo which shows the ravine forest canopy adjacent to the site. CNV Webmap, 2022-03-11.

The ravine of Thain Creek is a landmark feature in the study area; the ravine is an undeveloped greenfield, composed of very-mature second-growth forest (Figure 4). Outwards from top-of-bank the site is wholly altered, the terrain is flat and largely composed of turf-grass. One single-family home is present with one large out-building and a small shed and lean-to.

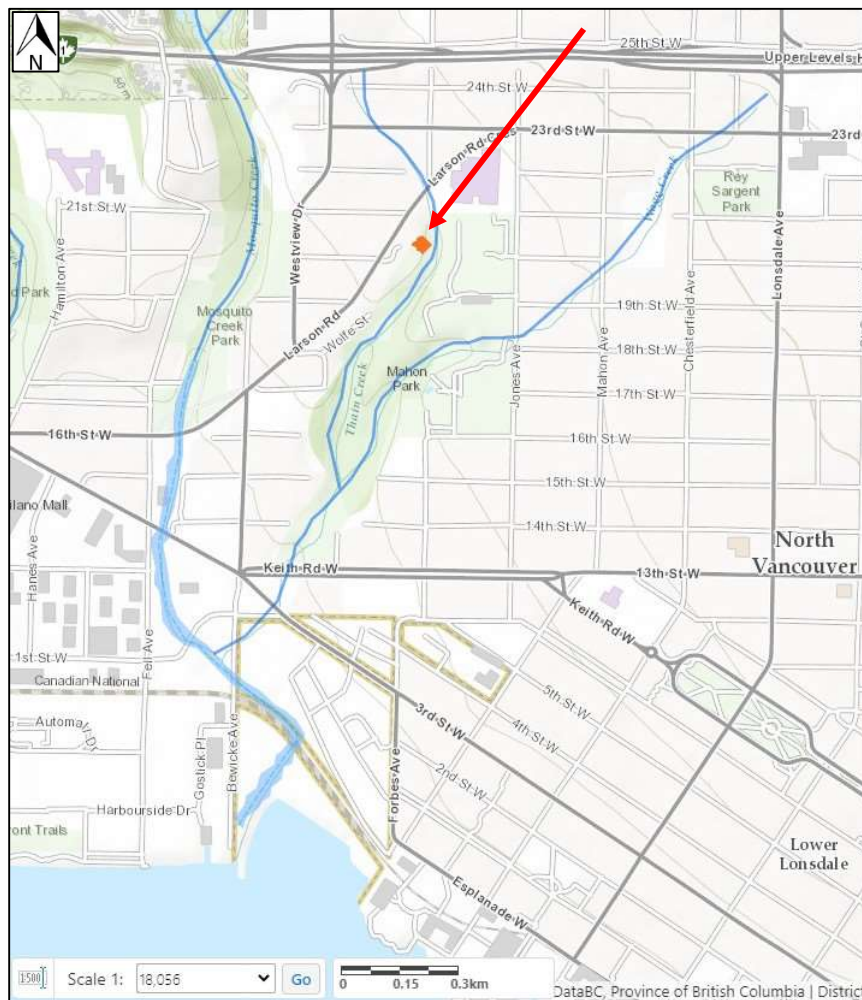
Figure 5. Watercourse mapping illustrating the headwaters and confluence with Mosquito Creek and Burrard Inlet. Obtained from Habitat Wizard, 2022-03-11.

The site is approximately 1200 m (channel length) upstream from the confluence of Mosquito Creek, Mosquito Creek flows into Burrard Inlet. The headwaters of Thain Creek are approximately 772 m upstream of the site.

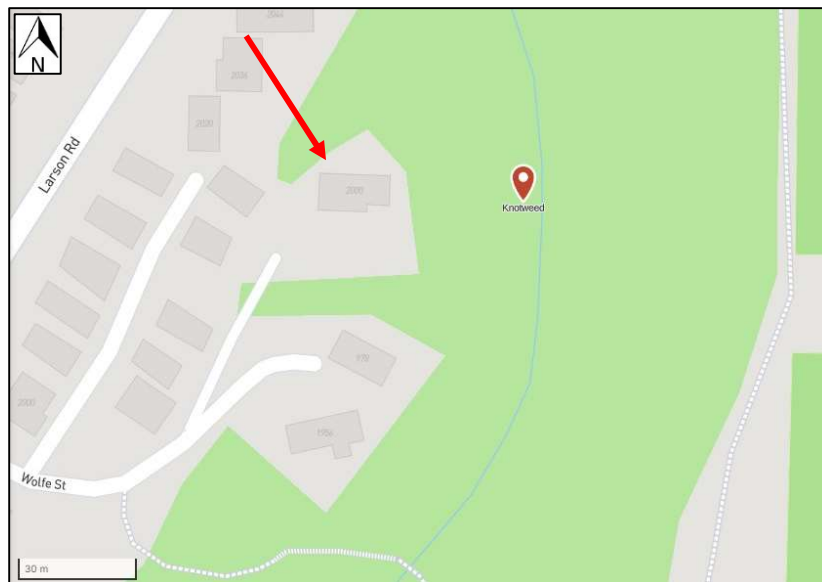
A knotweed species was observed on the west bank of the ravine. The observation is not on the subject property (Figure 6, Photo 3).

Figure 6. Knotweed species observation recorded by GPS: 49.32763, -123.08444

Noxious Weeds: CNV should act on the management and remediation of the knotweed occurrence in Mahon Park to as soon as possible.

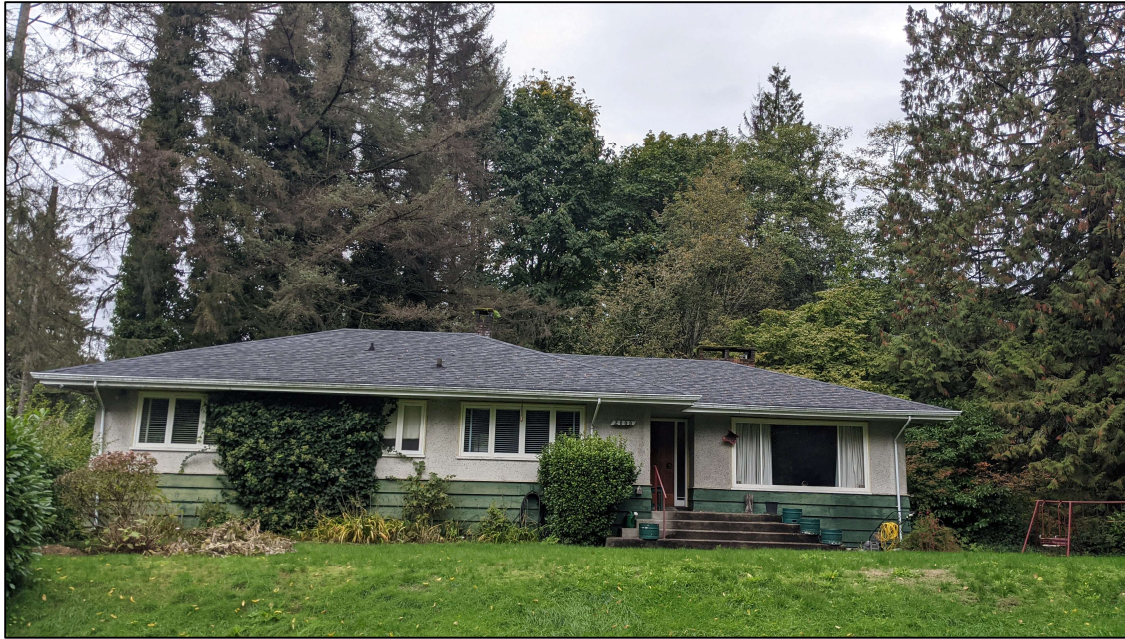
Photo 1. Viewing current developments on the site and riparian vegetation near the top of ravine bank on the right-hand side of the frame.

2. Any existing developments within 10 m of TOB should be removed.
3. Permanent fencing is necessary to identify and reduce encroachment into streamside protection area; to prevent encroachment during construction and by future users of the site. Fencing should be installed at the boundary of the streamside protection area.

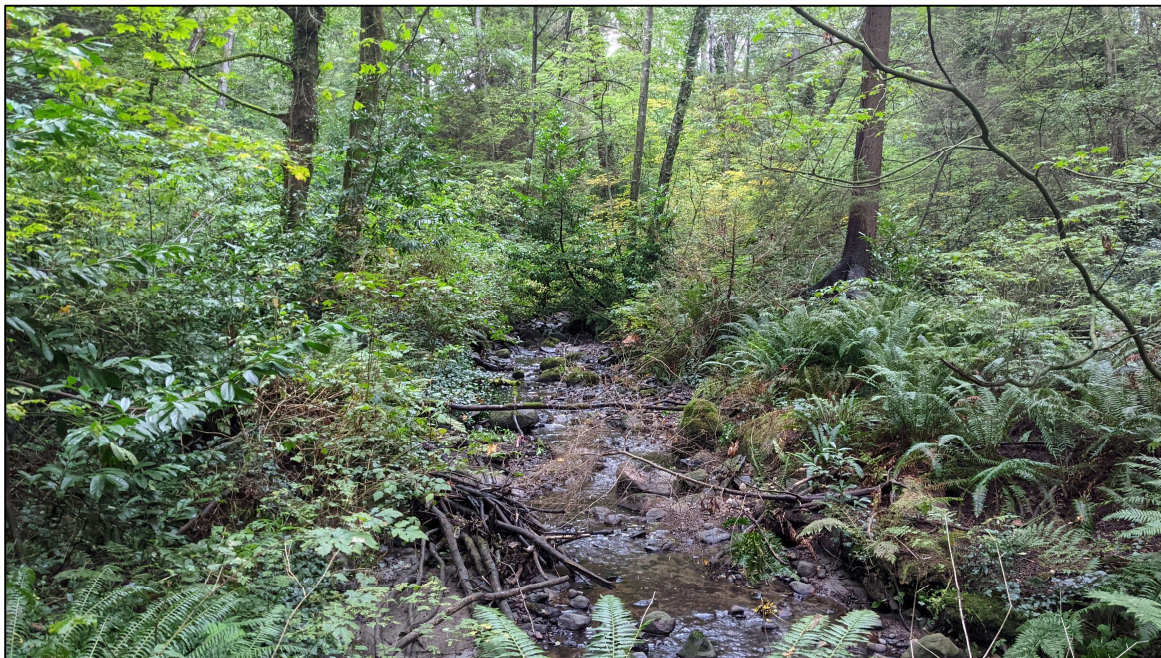
The subject reach of Thain Creek flows through a deep ravine; the difference in elevation between the streambed and TOB is approximately 10 m with the average ravine bank slope being 35 percent (west bank).

The average channel width is 4.4 m at bank-full width and the channel gradient on the subject reach is approximately 13.5 percent². The channel bed is primarily composed of gravel and small cobble with medium-cobble and boulder, and sand in the proportion of 60:30:10.

Riparian vegetation is dominated by western redcedar with bigleaf maple, red alder and vine maple. Sword fern and salmonberry are the dominant native plants in the understory.

Photo 2. Viewing Thain Creek and riparian vegetation.

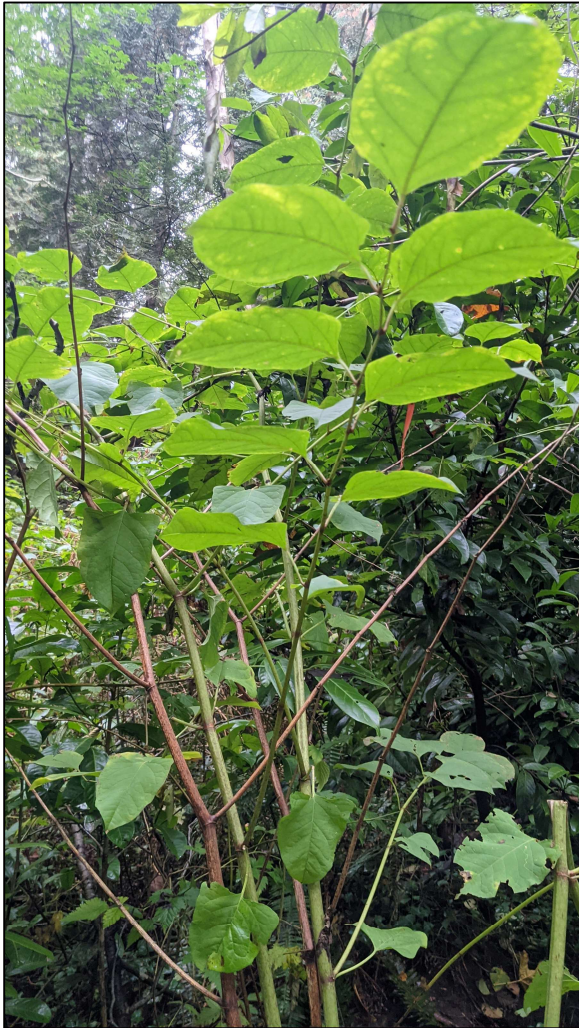
Photo 3. Viewing knotweed observed in the riparian zone of Thain Creek.
