MACLEOD RESIDENCE

364 EAST 14TH STREET, NORTH VANCOUVER BC

CONSERVATION PLAN

JUNE 2019

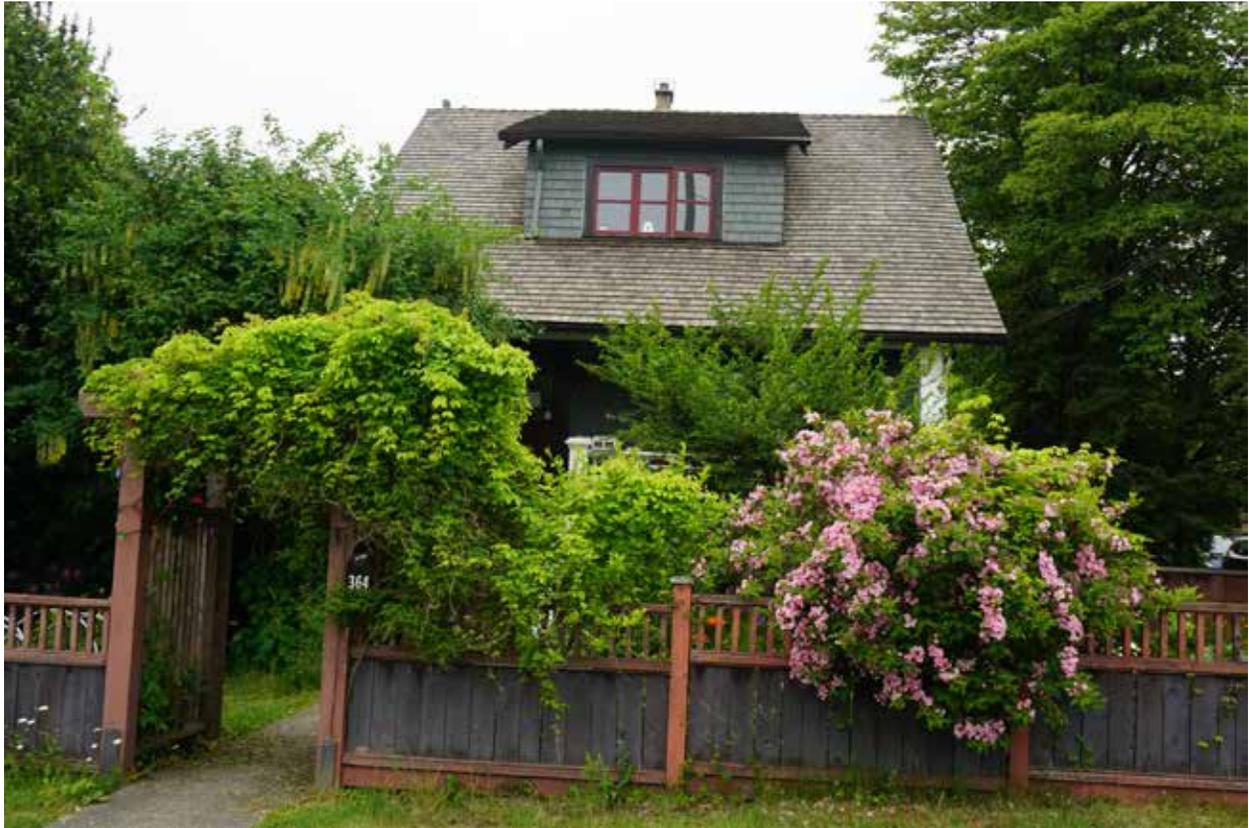
A condition review of the MacLeod Residence was carried out during a site visit on May 28, 2019. The recommendations for the preservation, restoration and rehabilitation of the historic site are based on the site review and archival research that provide valuable information about the original appearance of the historic building.

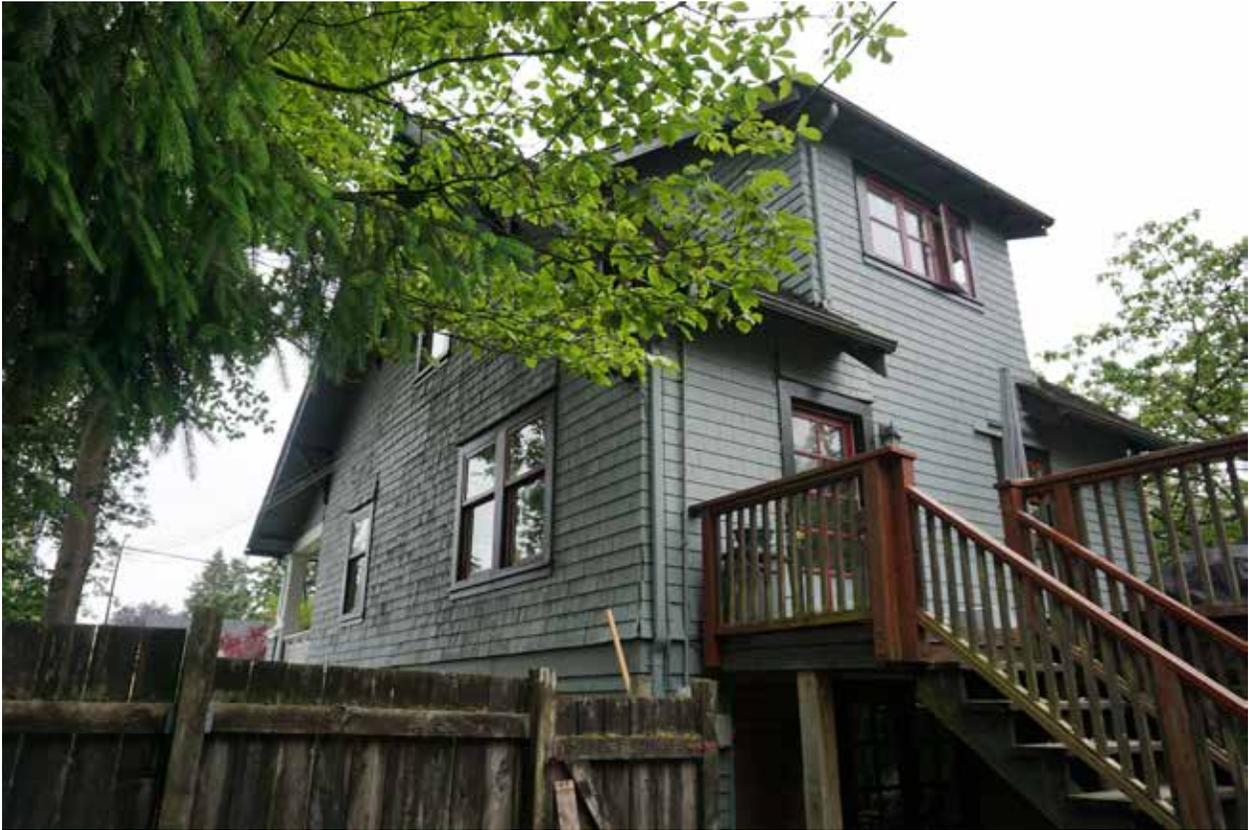
Conservation Strategy: Rehabilitation

- Preserve the original location of the building. All rehabilitation work should occur within the property lines. Retain the main frontage on East 14th Street.
- Any drainage issues should be addressed through the provision of adequate site drainage measures.
- Carefully salvage relevant material from original garage for use on main house prior to demolition.
- Design a new infill structure to the north of the historic structure that is “physically and visually compatible with, subordinate to, and distinguishable from the historic place” as recommended in **Standard 11**.

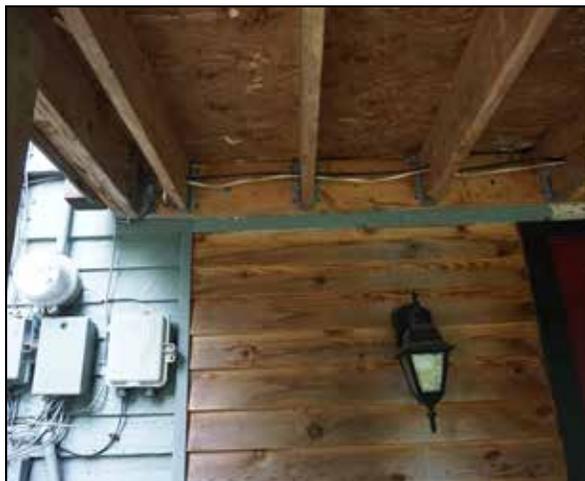
The MacLeod house has been maintained in good condition and features a Craftsman architectural style. Character-defining exterior elements include the overhanging eaves with exposed raftertails and triangular eave brackets pointed bargeboards, full-width front verandah with square wooden columns

at each corner and square newel posts on either side of the staircase, shingle clad tapered verandah piers, decorative open verandah balustrade, closed low stair balustrade, central shed roof dormer on front elevation and central shed roof wall dormer on rear elevation, wooden bellyband, and bellcast cedar shingle cladding of the main body with narrow lapped wooden siding on the foundation level. As part of the scope of work, character-defining elements will be preserved, and repaired where required. Exterior siding on the rear elevation below deck and where deck will be removed should be restored to match existing.

Conservation Strategy: Preservation

- Due to the integrity of wood frame structure, the exterior walls should be preserved through retention and in-situ repair work.
- Preserve the original wood-frame structure of the historic building.

- Replace any damaged siding to match existing in material, size, profile and thickness. Utilize salvaged shingles from garage, where possible.
- At time of repainting, clean siding using approved heritage cleaning procedures.

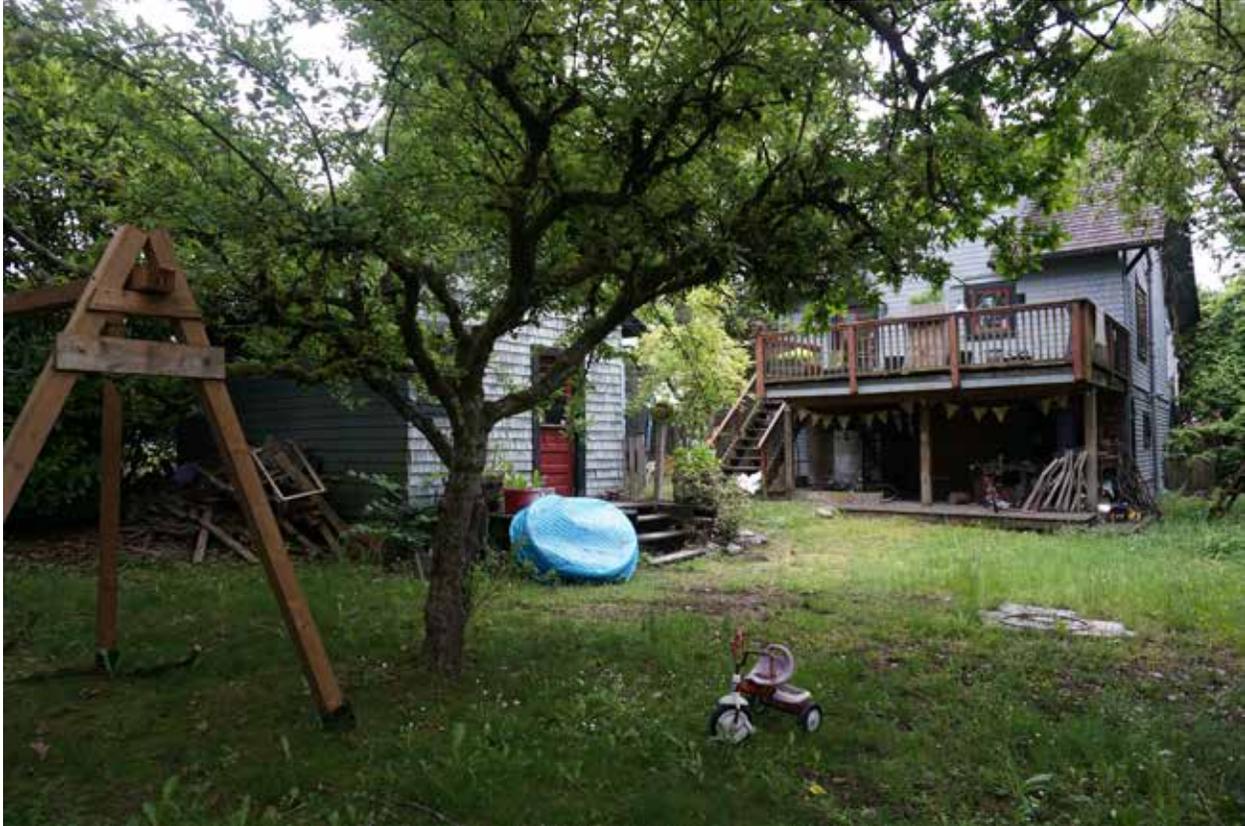
The house features original painted wood trim, which is in good condition and will be preserved. In locations where trim may be damaged or missing, new wood trim to match original in kind will be installed and painted to match existing.

Conservation Strategy: Preservation

- Any existing trim should be preserved, and new material that is visually physically compatible with the original should be reinstated when original fabric is missing. Combed and/or textured lumber is not acceptable. Hardi-plank or other cementitious boards are not acceptable

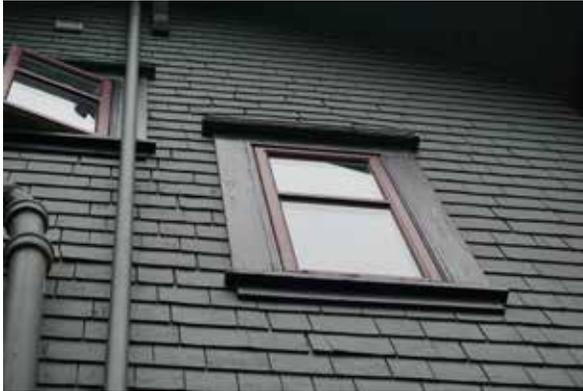
All windows on the MacLeod residence have previously been rehabilitated and appear to be in good condition. As part of the scope of work, windows will be preserved and repaired, as required. Any alterations or proposed new windows to be reviewed by heritage consultant.

Conservation Strategy: Preservation

- Inspect for condition and complete detailed inventory to determine condition of all windows.
- Retain existing window sashes; repair as required; install replacement matching sashes where missing or beyond repair.
- Preserve and repair as required, using in kind repair techniques where feasible.
- Prime and repaint as required in appropriate colour, based on colour schedule devised by Heritage Consultant.

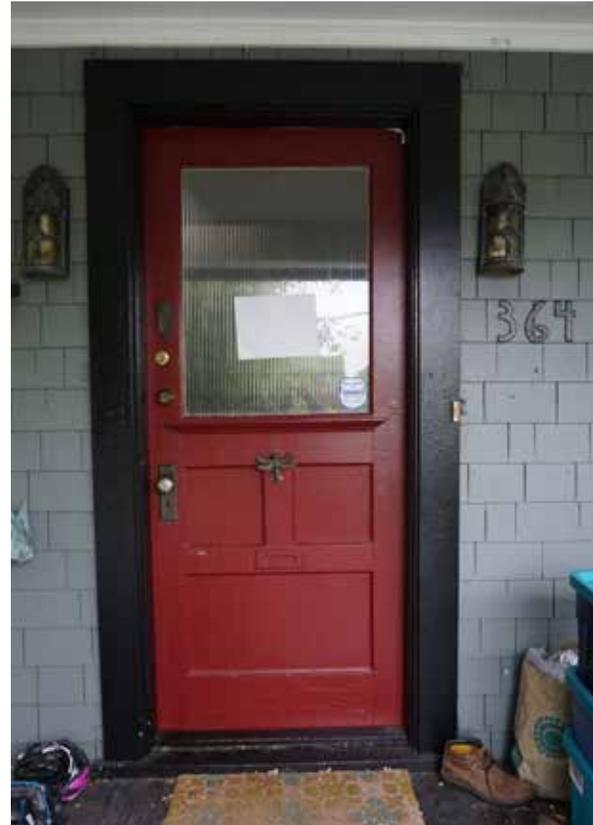
All existing doors will be preserved with the exception of the rear patio door, which may be converted into a window.

- Retain the door openings in their existing locations, and preserve and repair all existing doors.
- Rehabilitate rear main-level door following removal of deck. Replace with window, as desired. Consider utilizing original window salvaged from garage.
- Any new doors should be visually compatible with the historic character of the building.

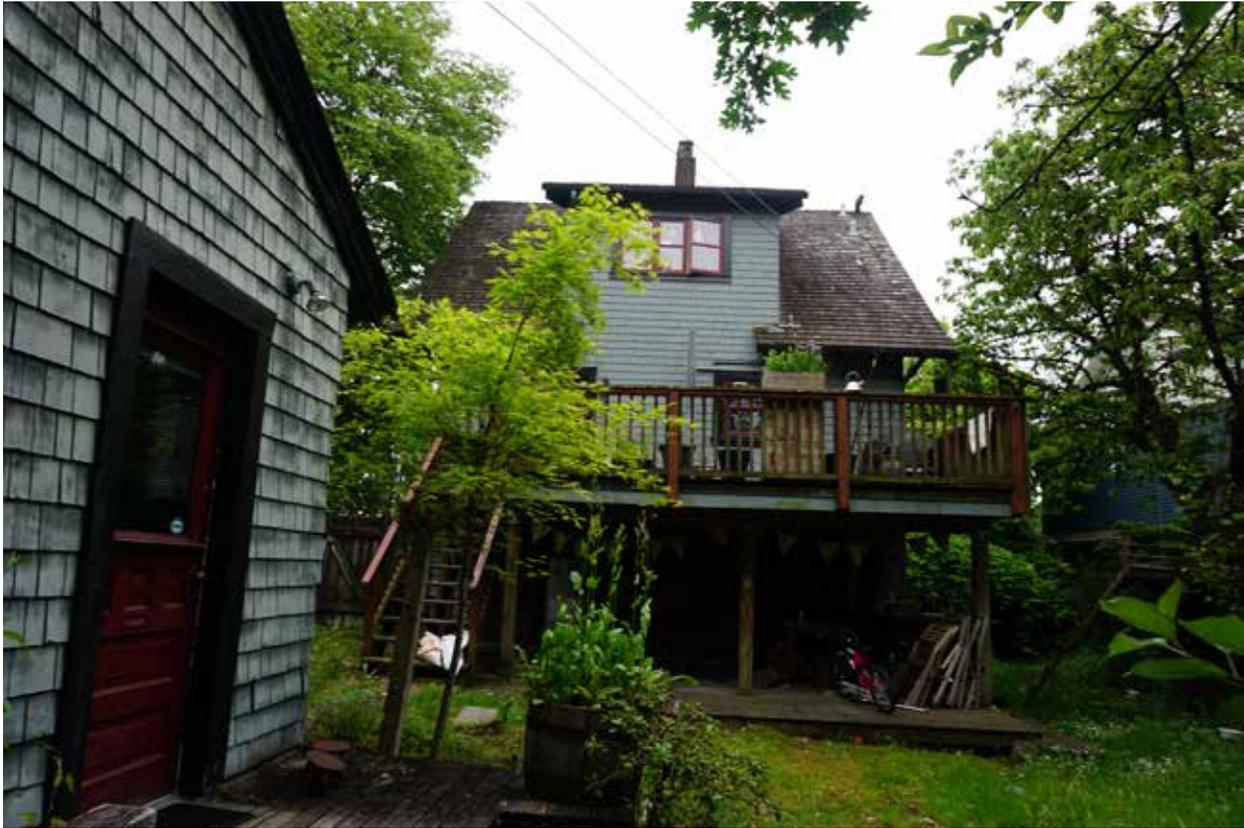
The MacLeod Residence features a prominent side-gabled roof with front and rear shed-roofed dormers. The original roof configuration will be retained, including all original trim and detailing. If desired, cedar shingles may be reinstated at time of roof replacement.

Conservation Recommendation: Preservation

- Preserve the roof structure in its current configuration, as expressed by its prominent side-gabled configuration with front and rear shed-roofed dormers.
- If required, roofing membrane and cladding system may be rehabilitated. At time of roofing replacement in the future, cedar shingles are the preferred material, but Duroid shingles or Aged Cedar Enviroshingles™ are also acceptable.

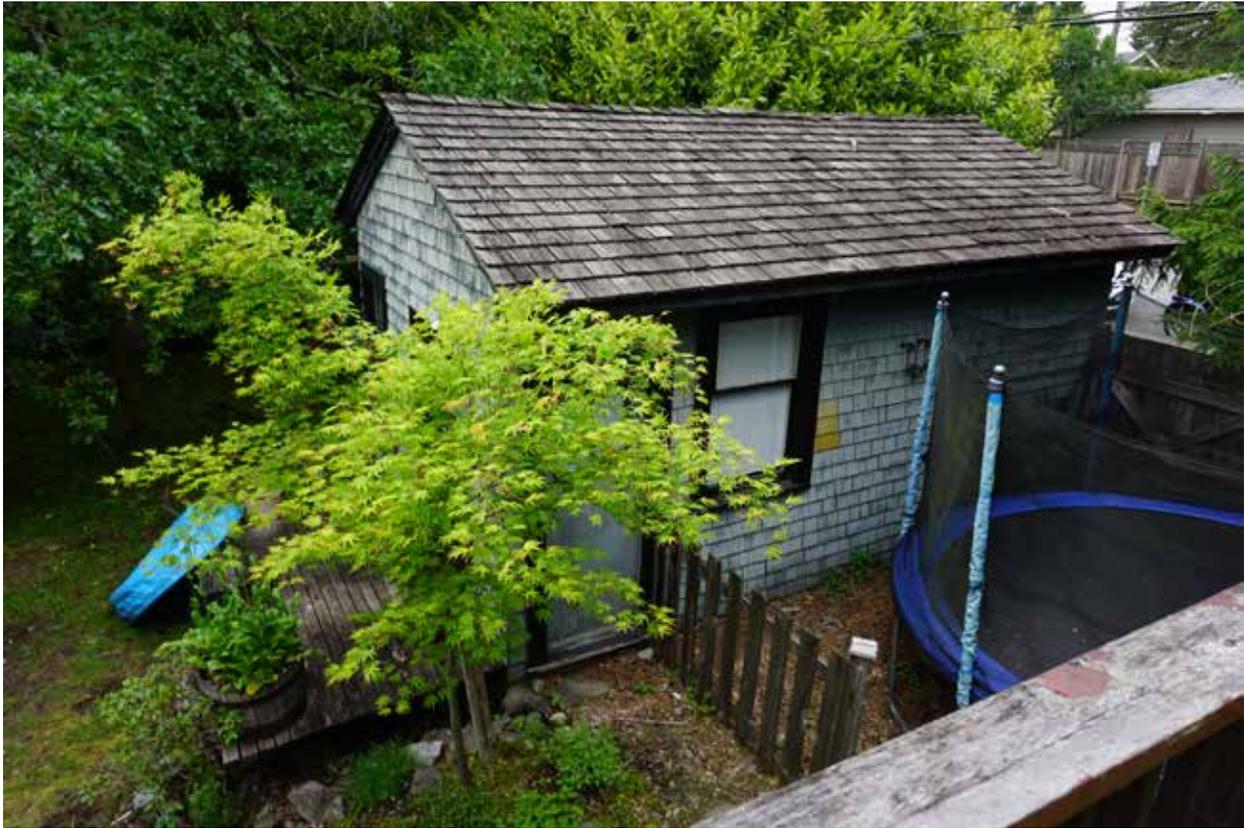
A new duplex infill house is proposed for the rear of the site, facing Ridgeway Avenue. The new construction is distinguishable in form from the main house and features a compatible material palette.
