# THAIN CREEK RESTORATION PROJECT OVERVIEW

# THAIN CREEK RESTORATION

# THAIN CREEK RESTORATION DESIGN OVERVIEW

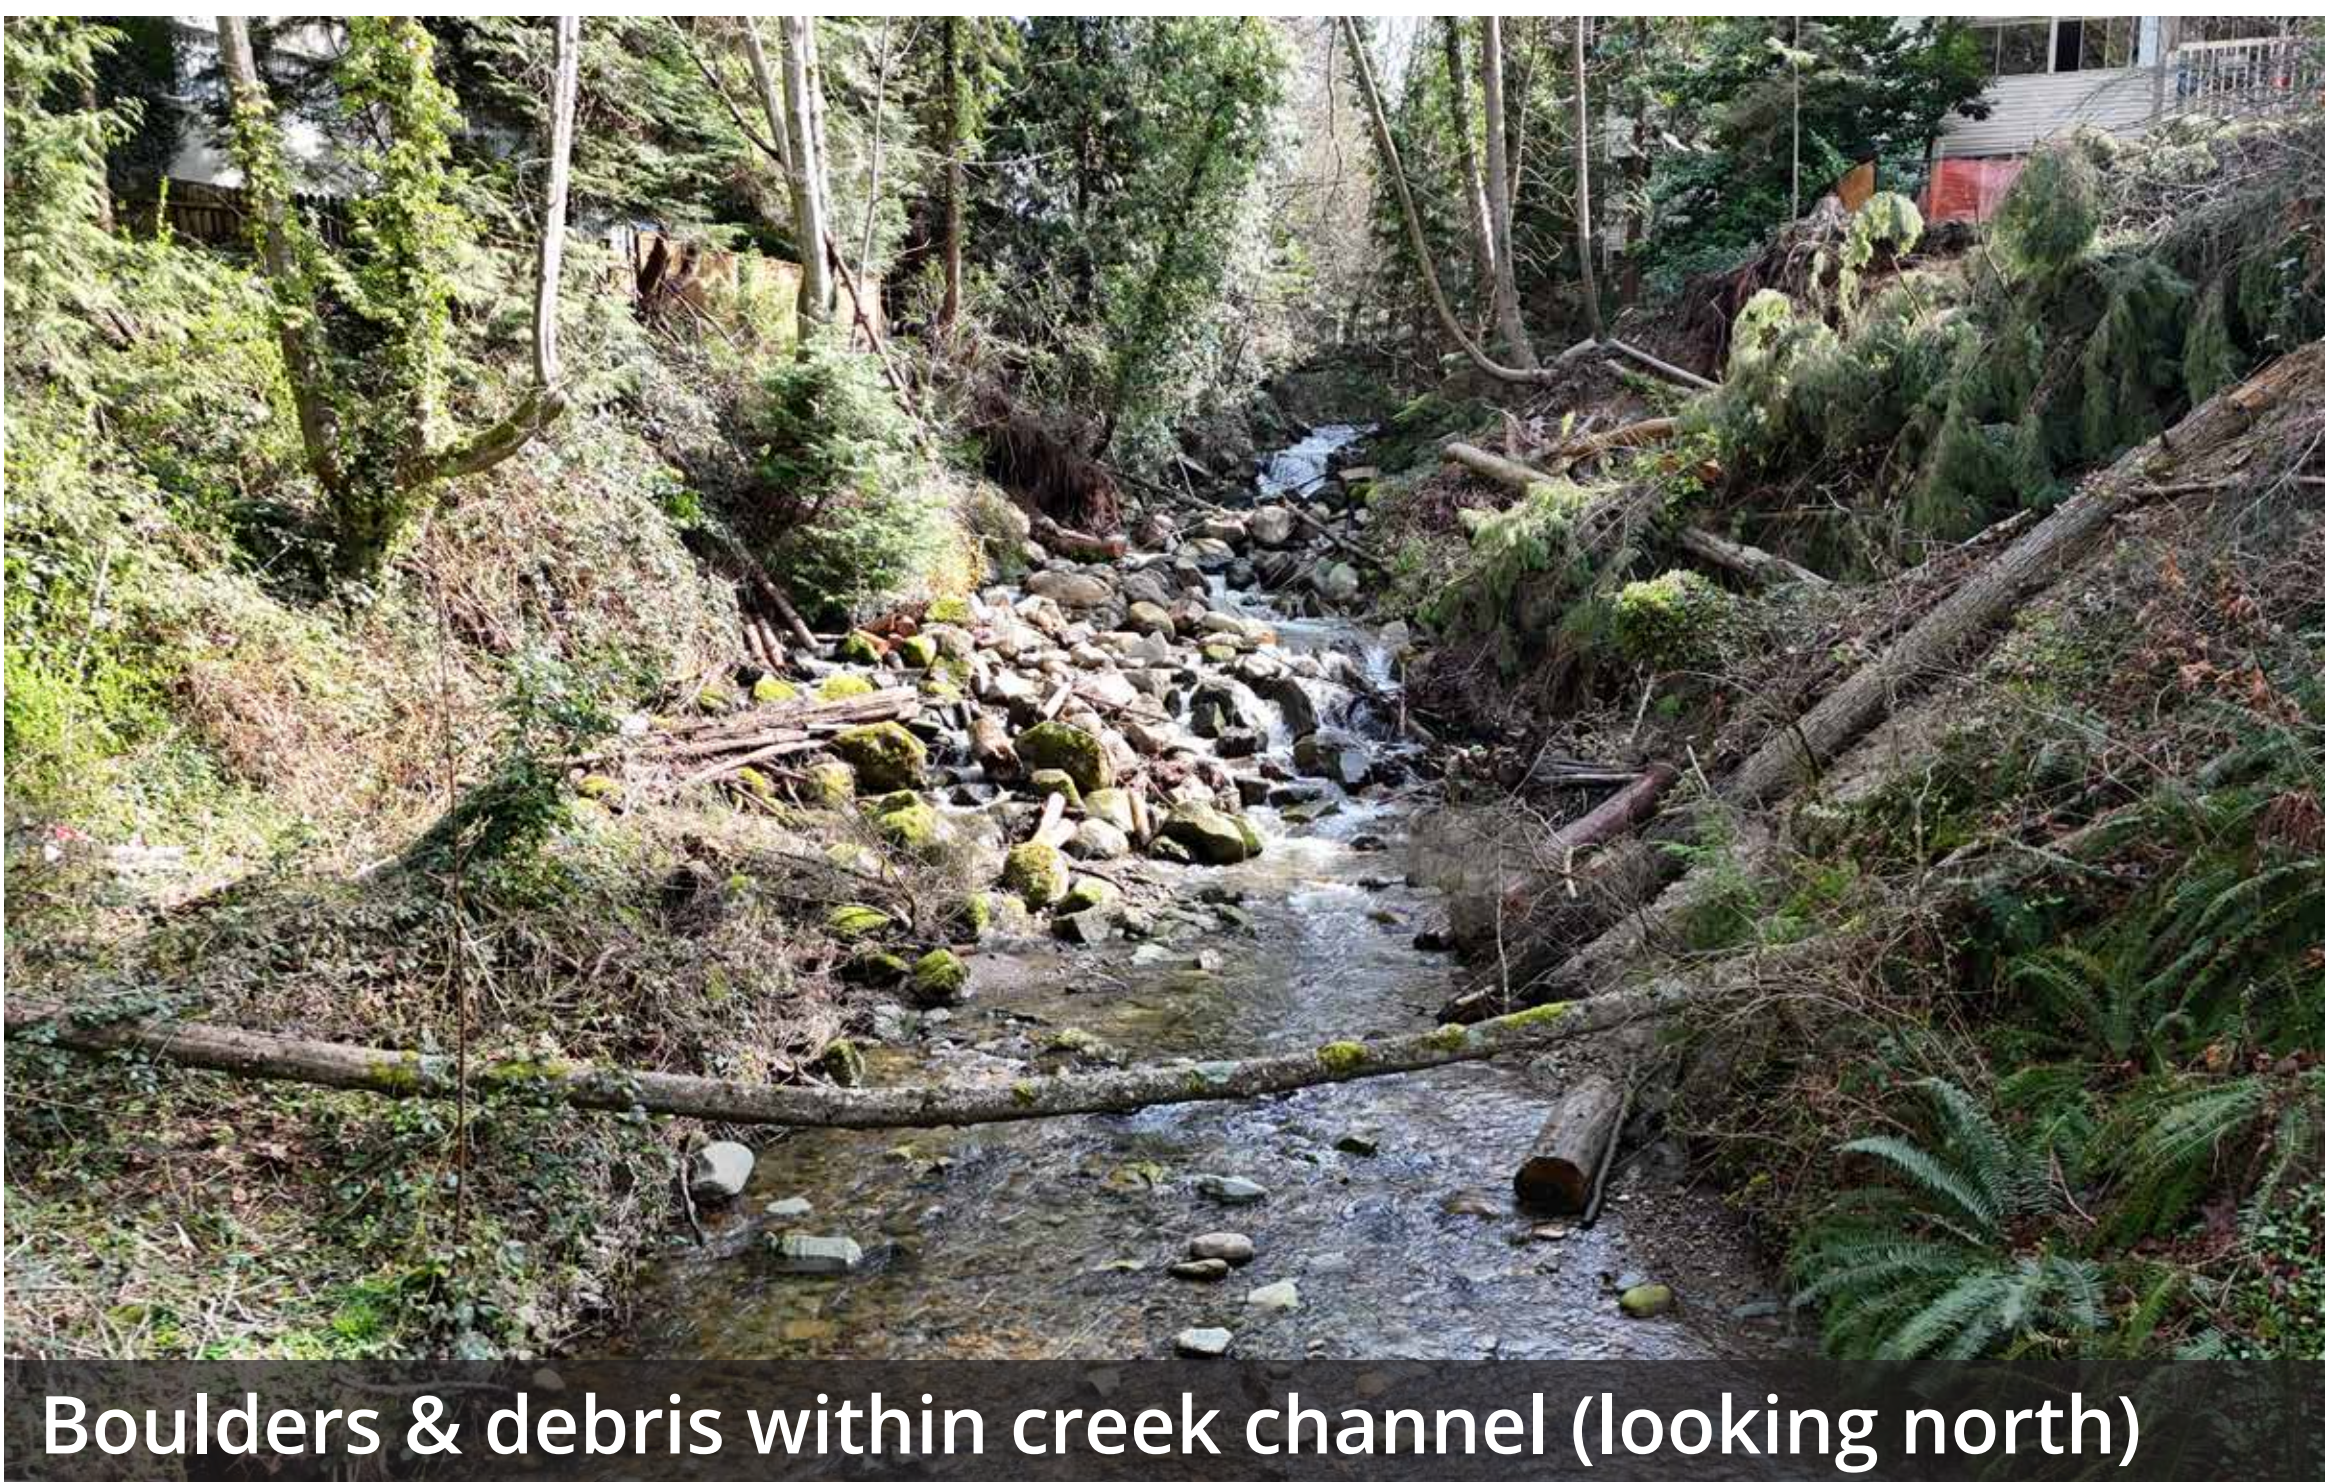
Boulders & debris within creek channel (looking north)

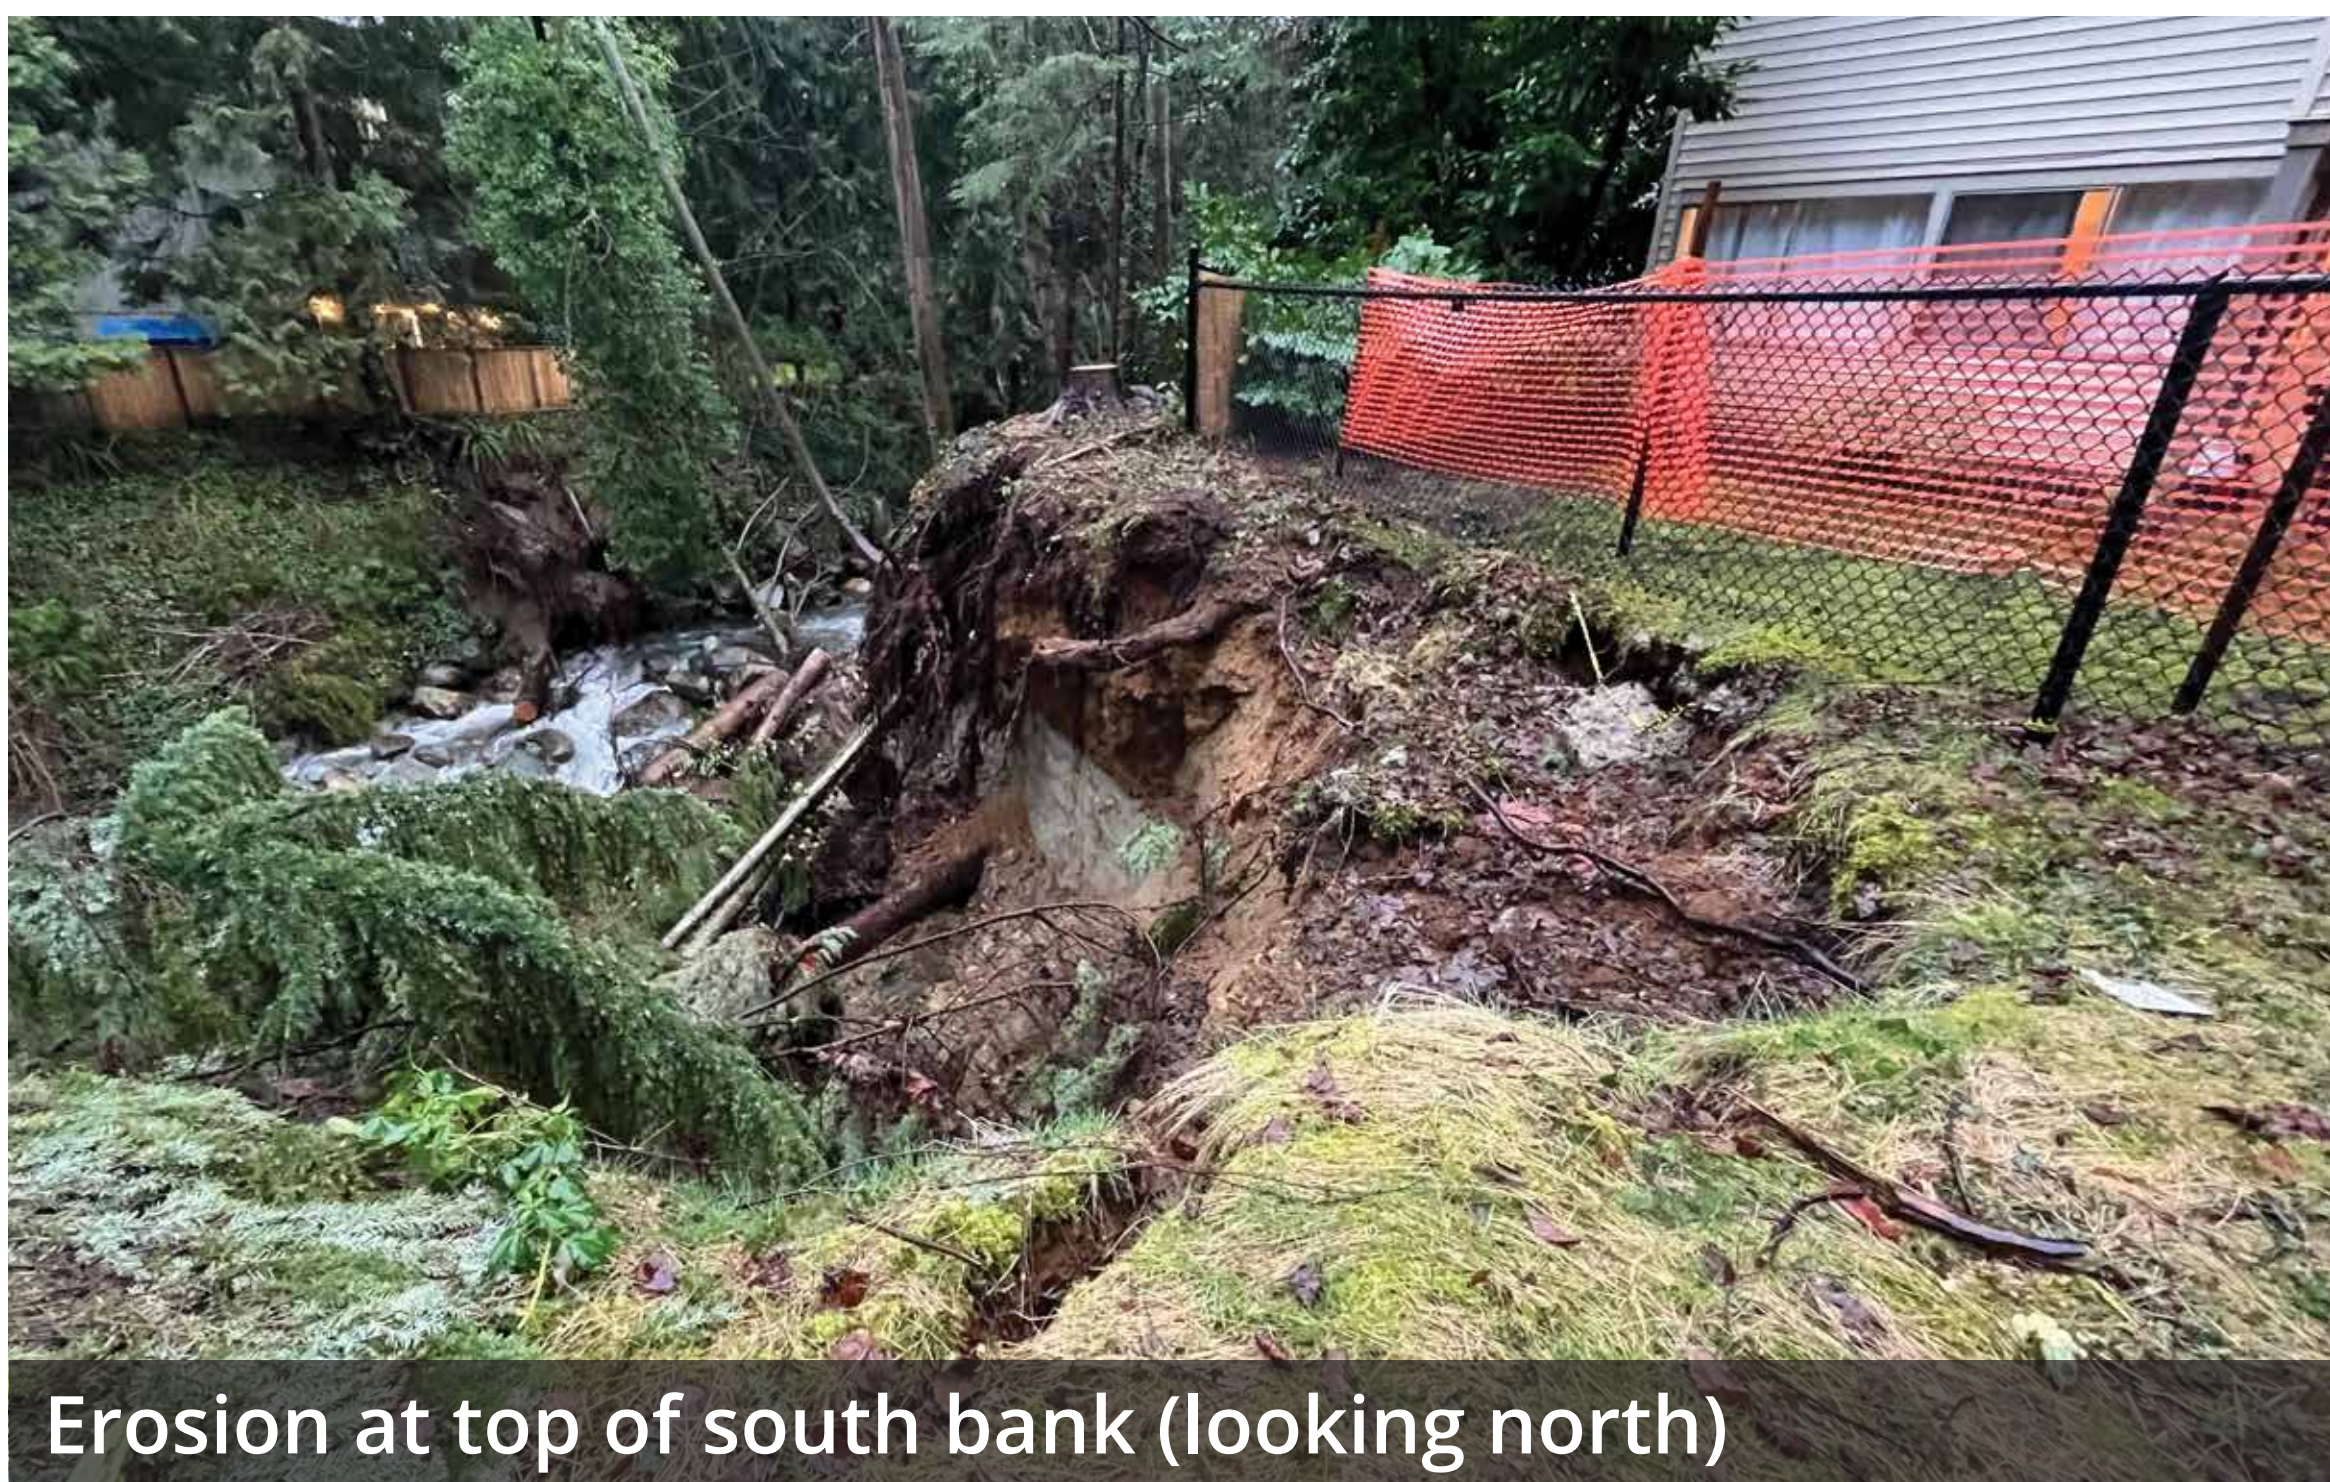
Erosion at top of south bank (looking north)

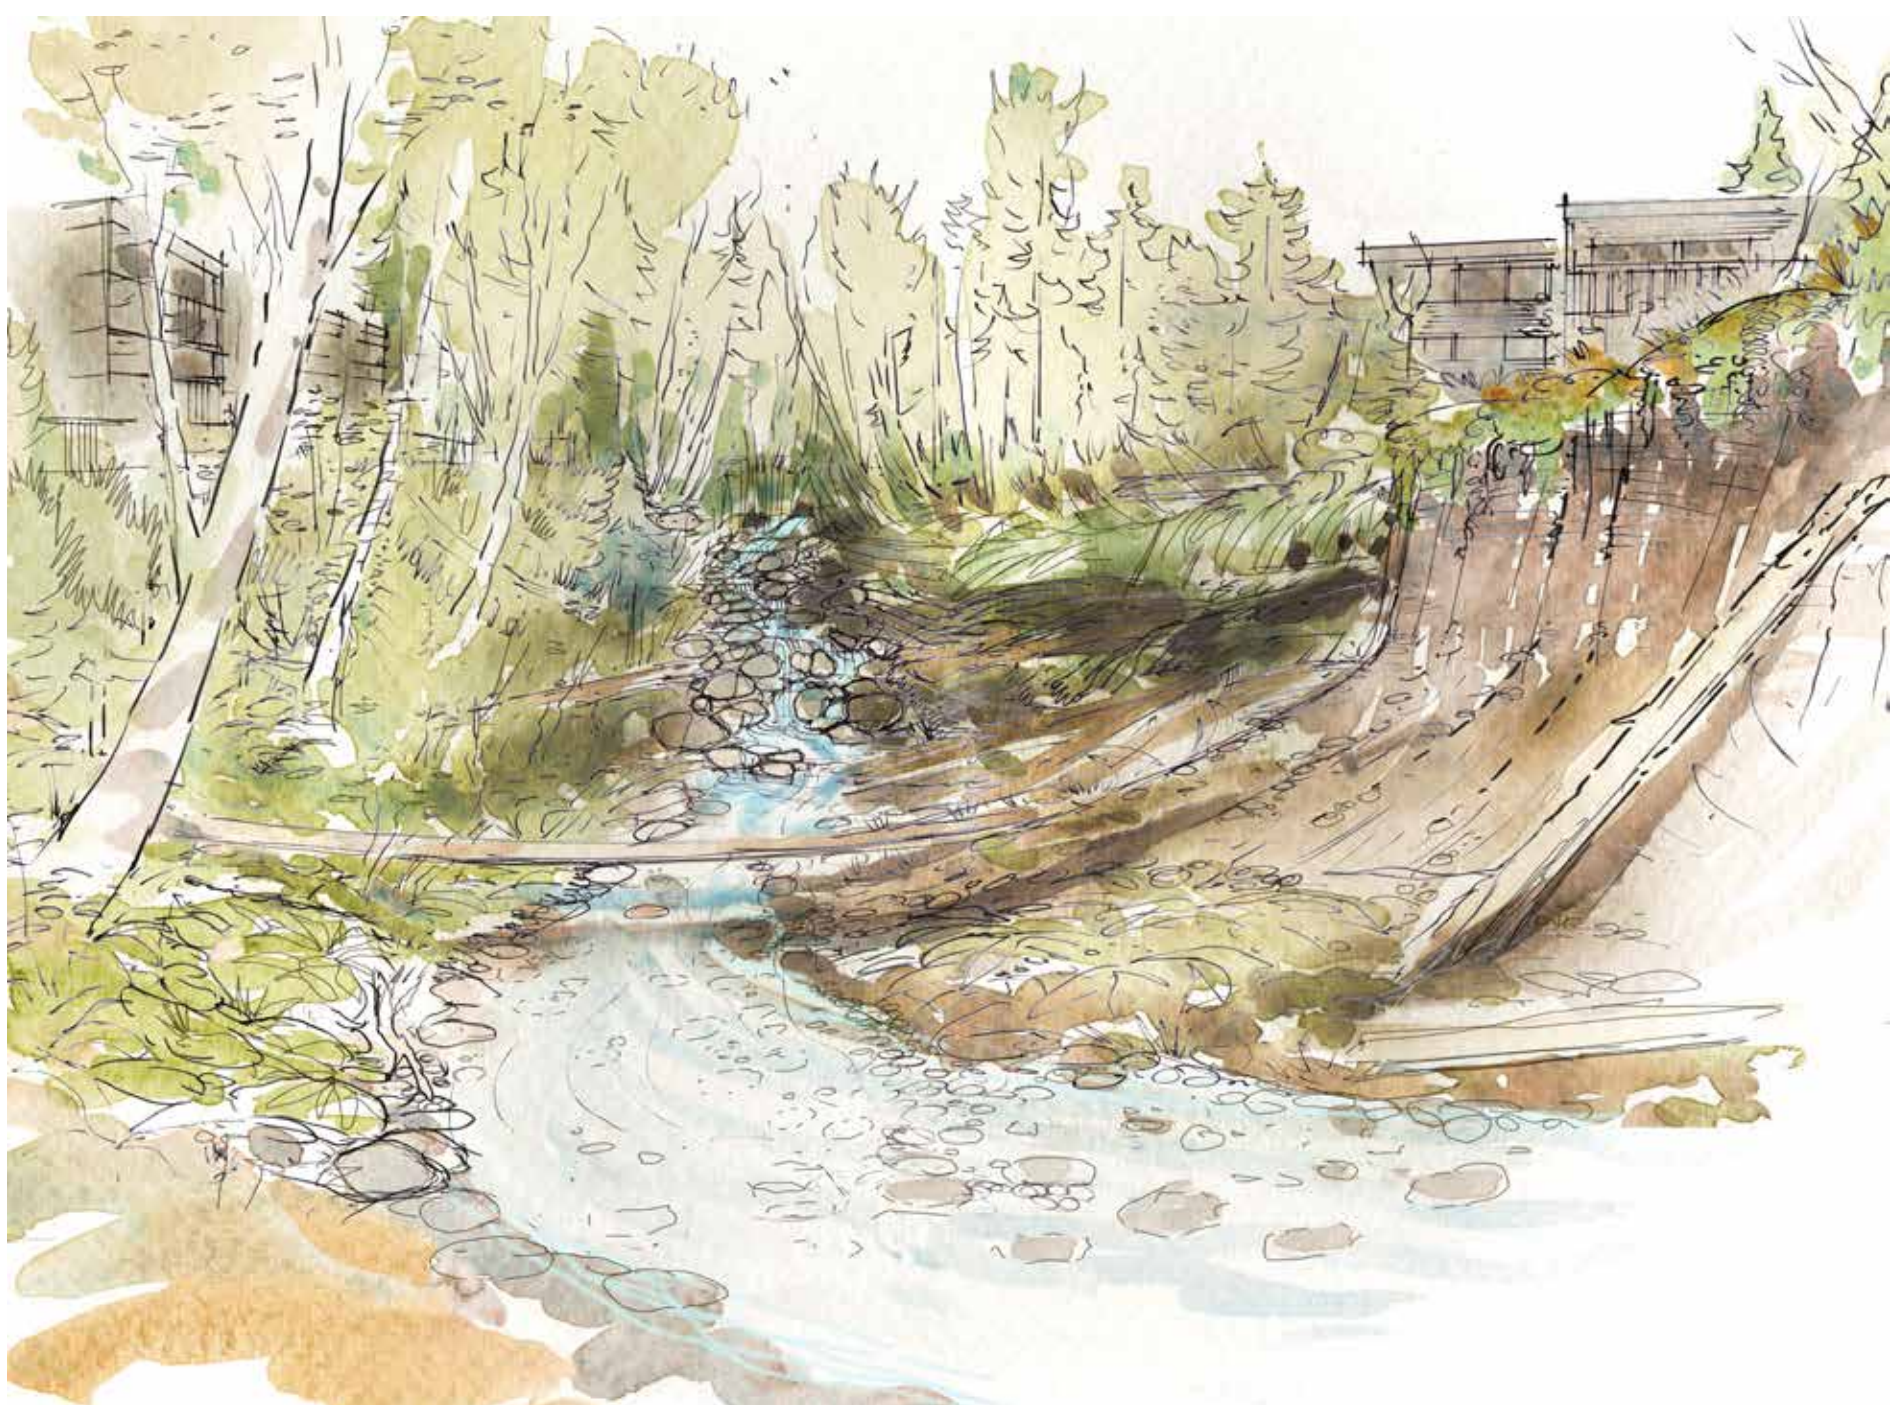
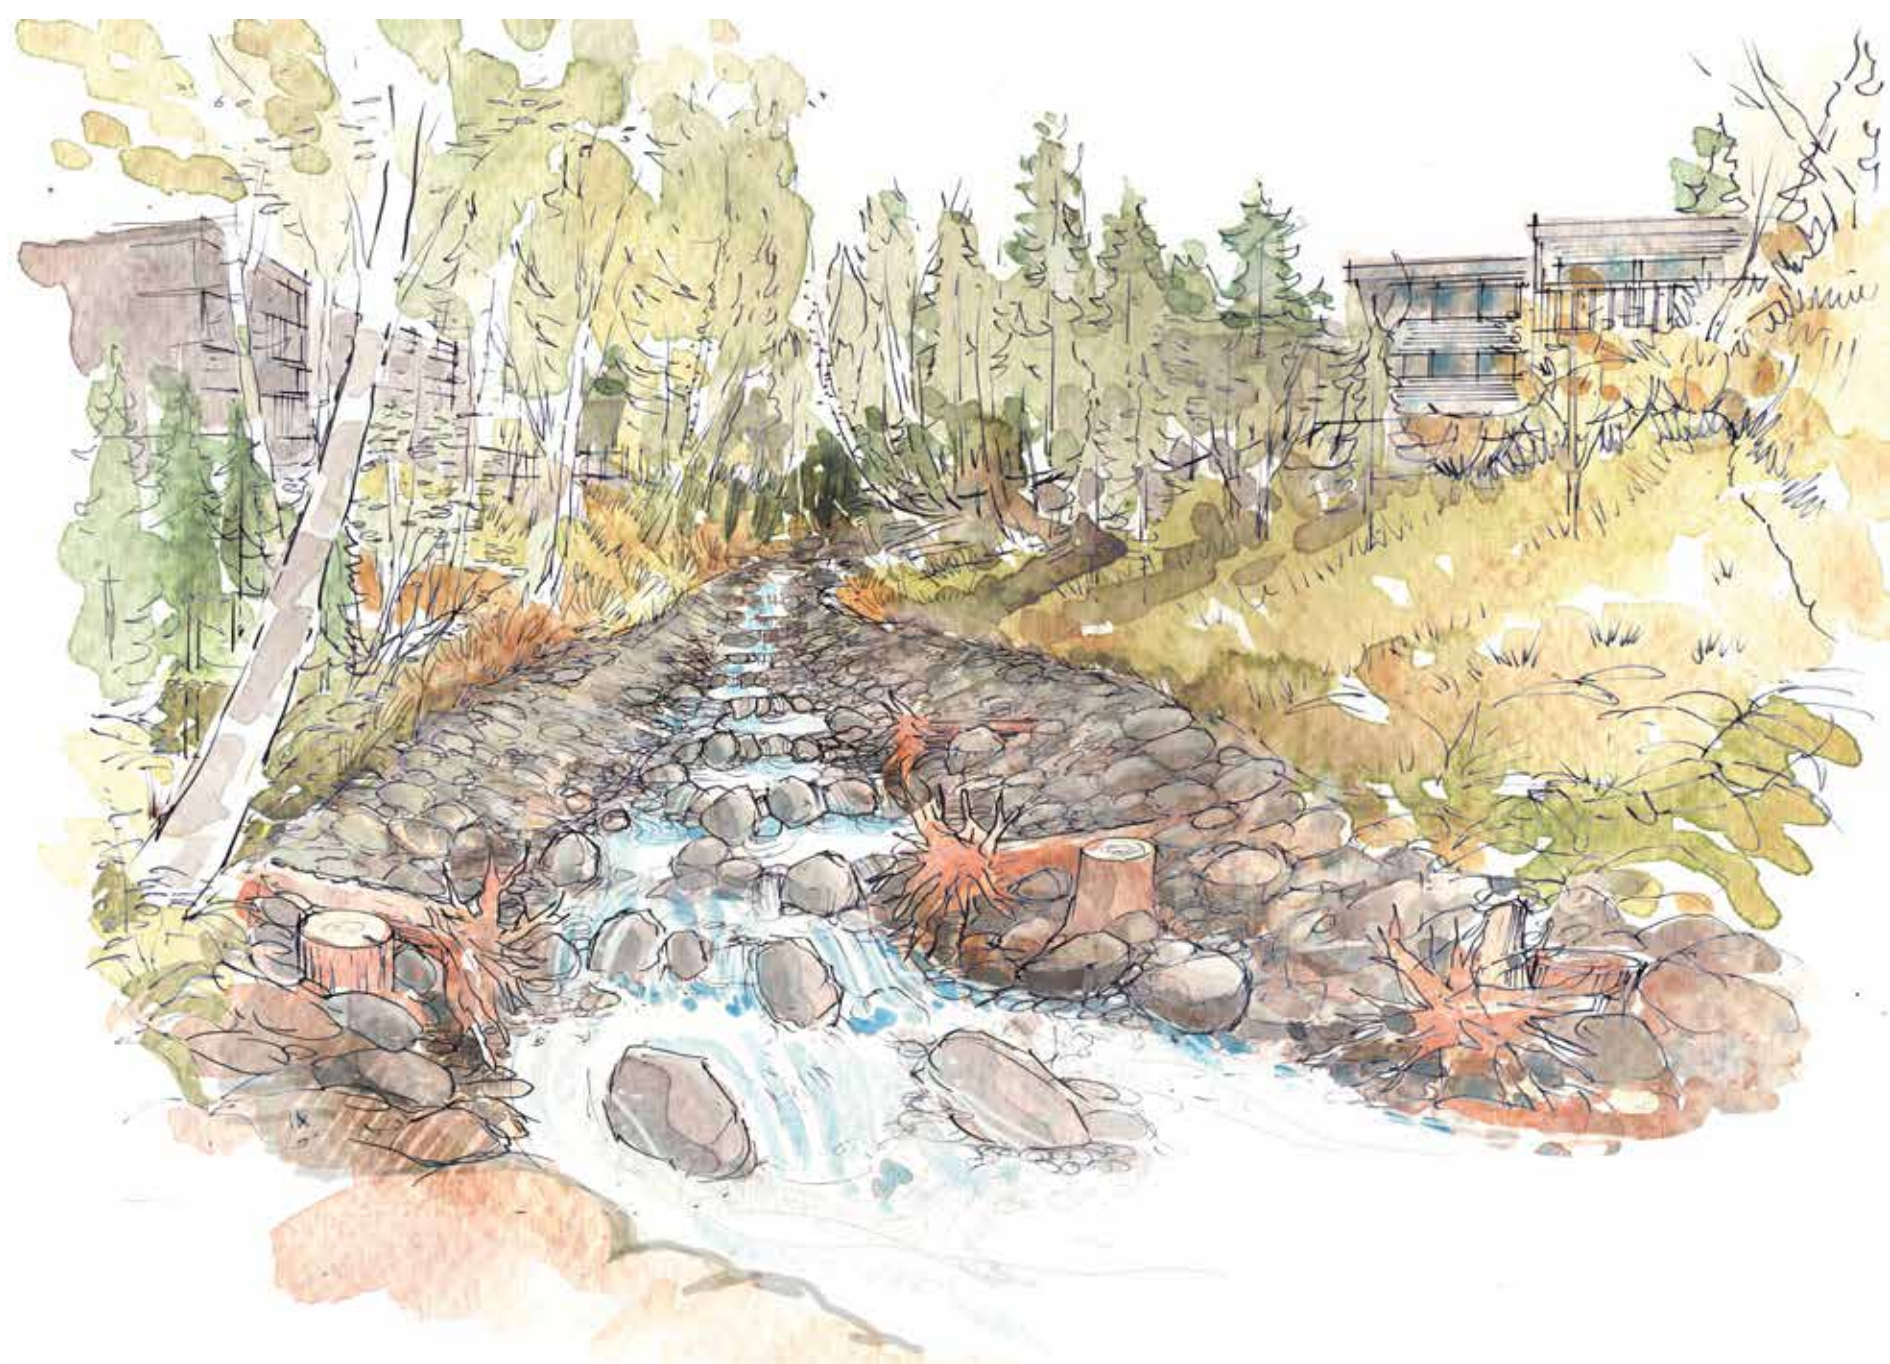
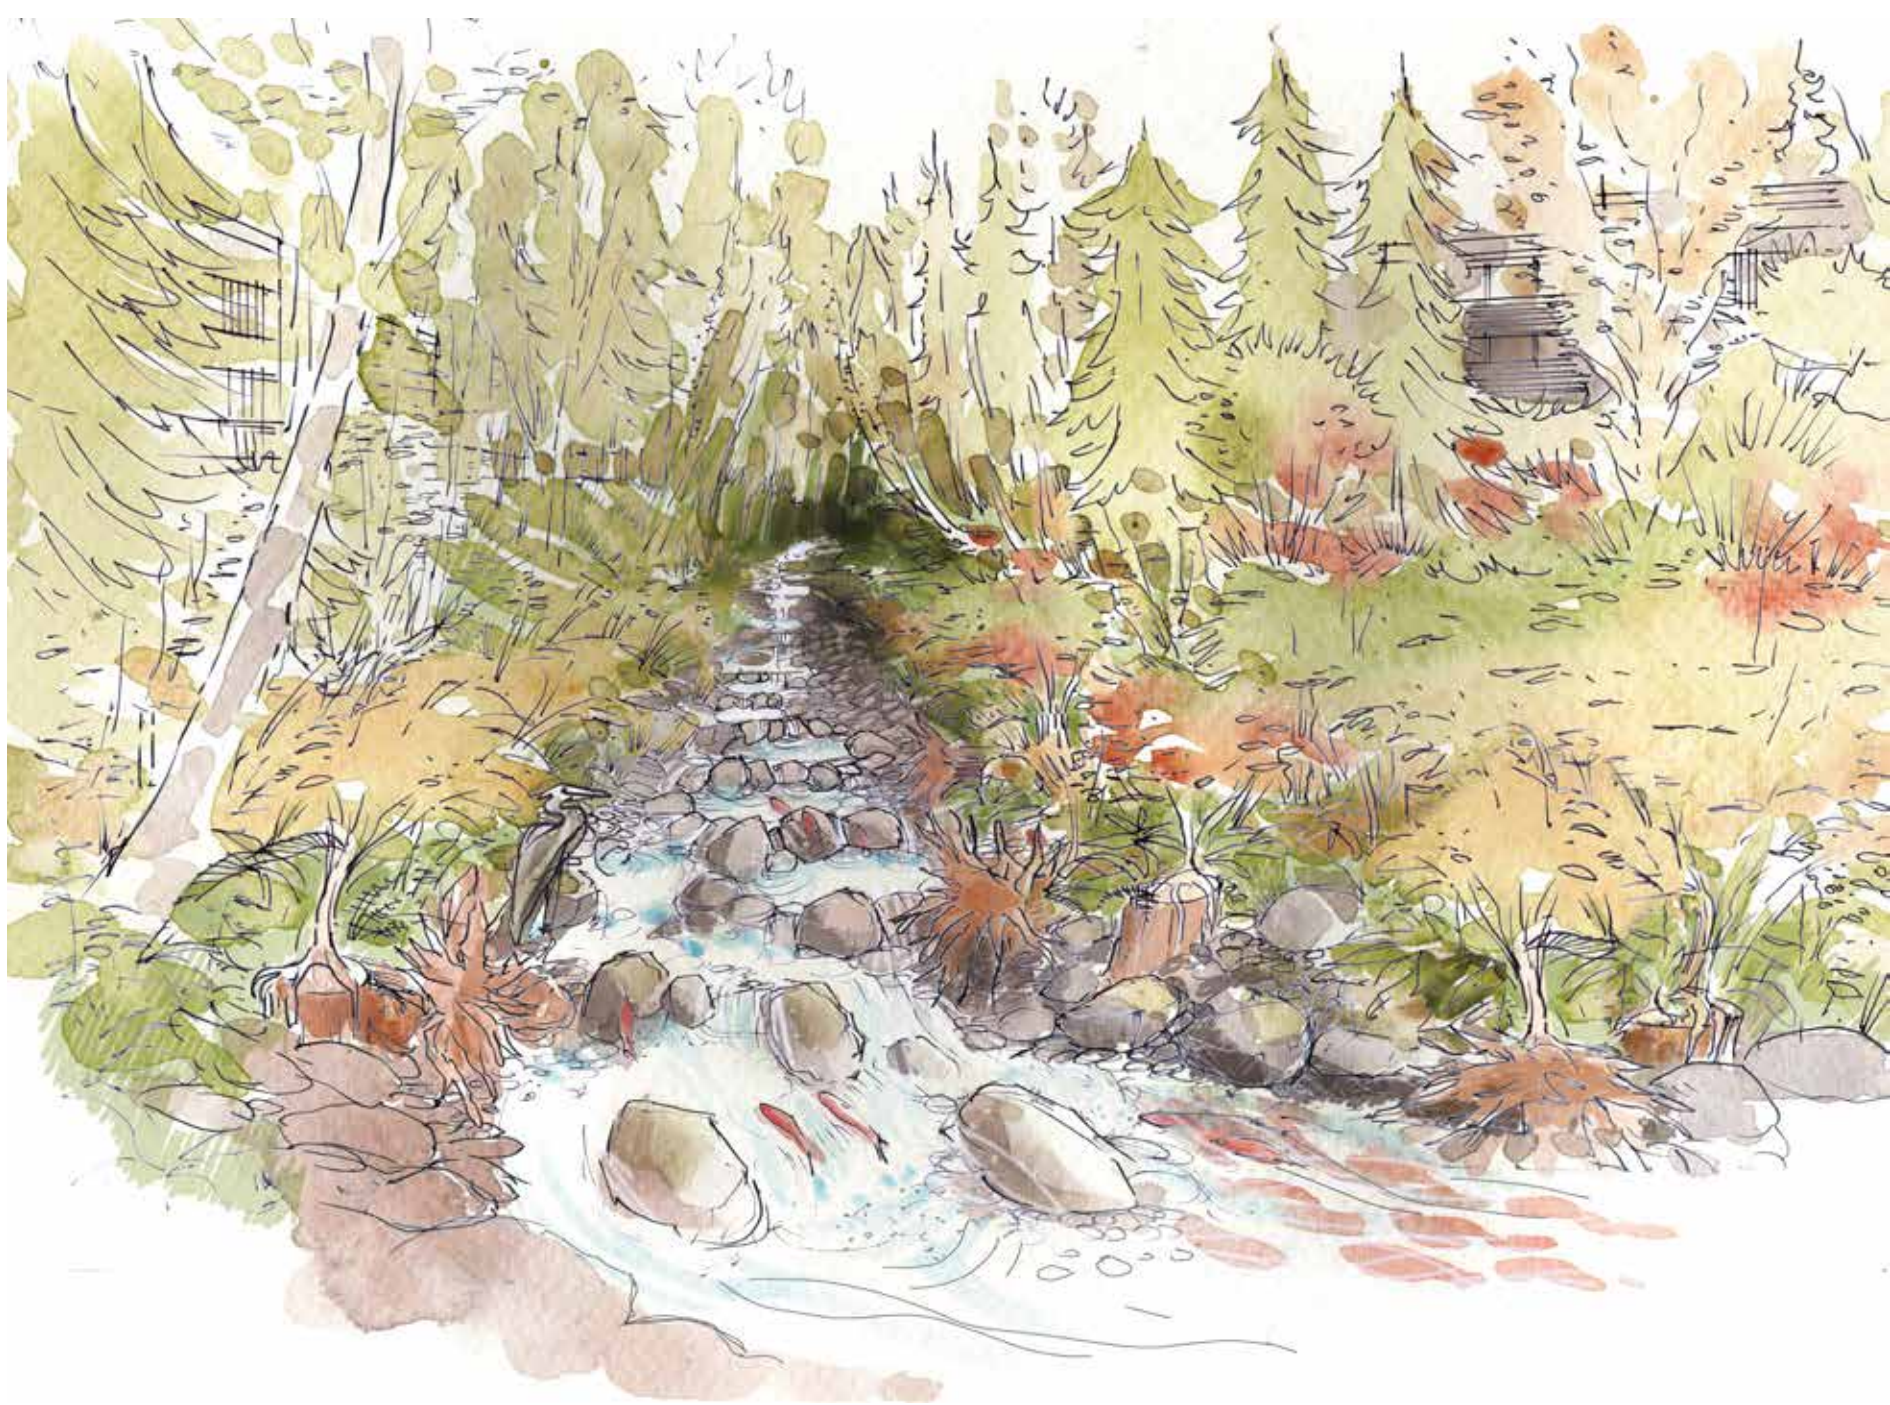
## Restoration Timeline

Eroded slope with unstable creek banks and boulder pile in the channel impeding fish passage

Stabilized channel with newly planted vegetation

Lush, naturalized streamside with well-established growth
