**Phase 2 Geotechnical Stability Study  
Detailed Risk Analysis  
The City of North Vancouver, BC**

**Document No. T30-2009  
GES Project No. 10002**

Submission Date: December 2011

Submitted by:  
**GES Geotech Inc.**

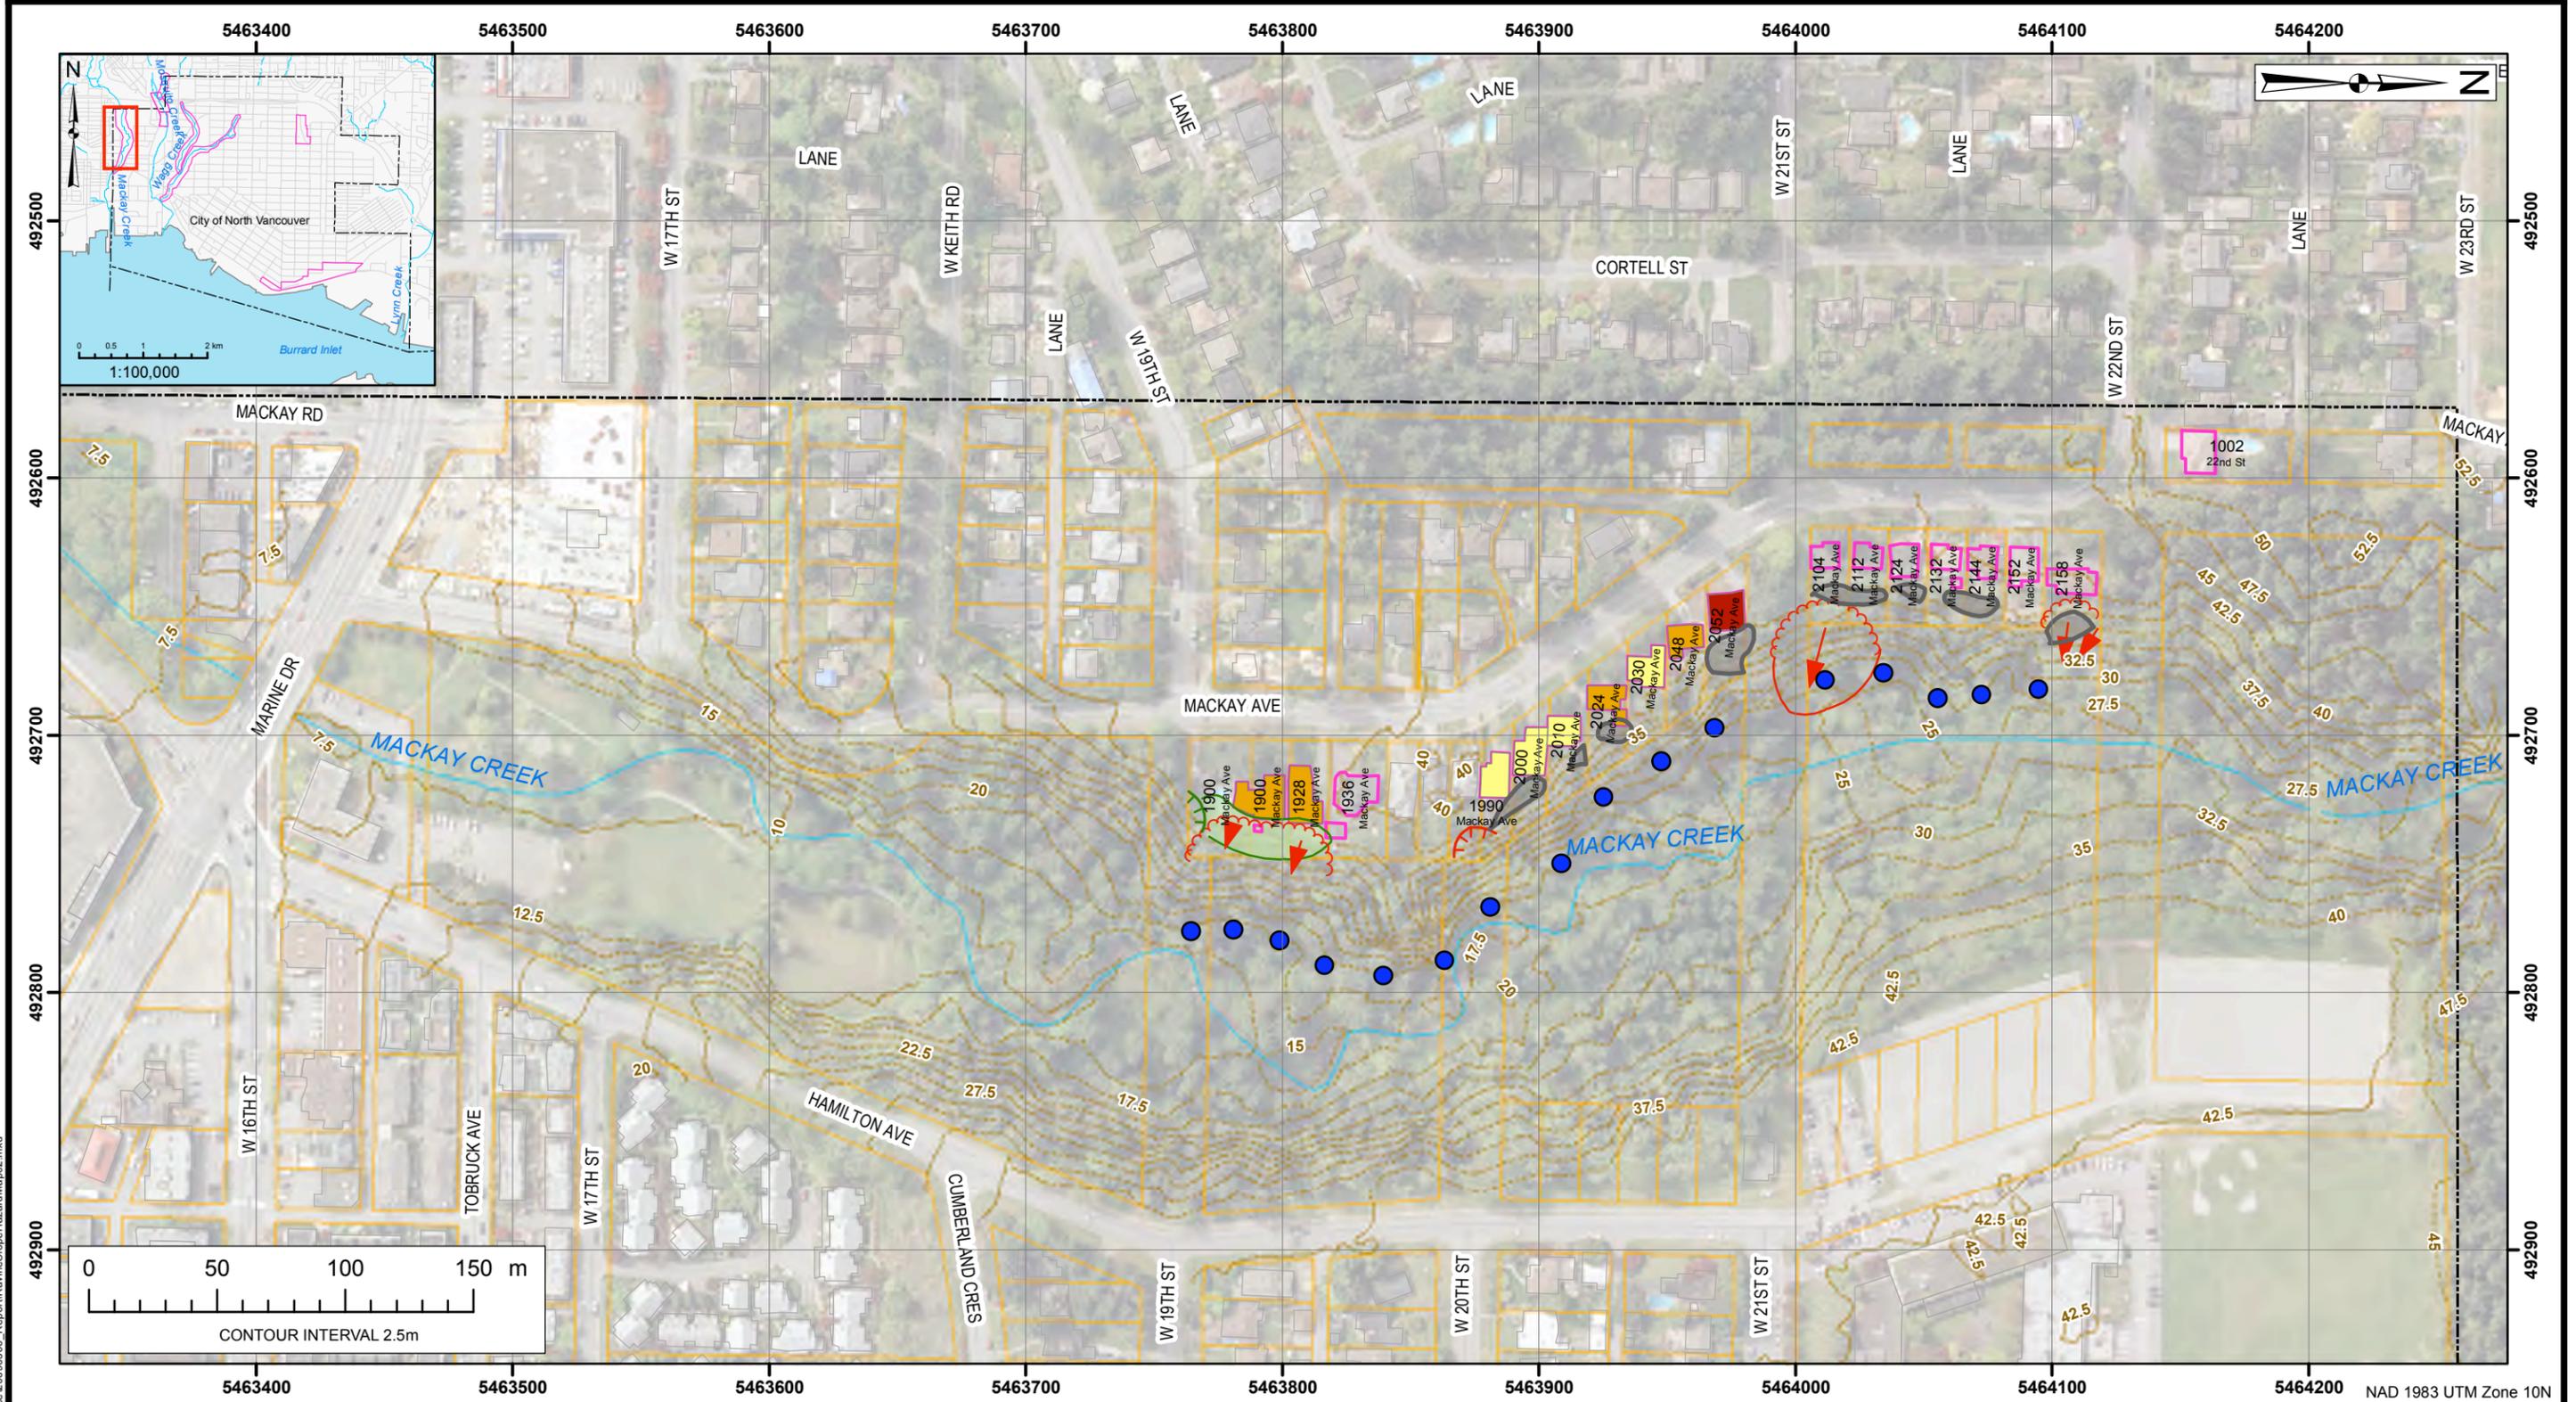
PROJECT: Geotechnical Stability Study, Preliminary Partial Risk Analysis		
TITLE: Partial Risk Map Mackay Creek		
PROJECT No.: 0600-001	DWG No.: 2	REV.:

Based on our site review at MacKay Creek and our observation of an exposed area where a small landslide scarp exists to the north of the property at 2158 MacKay Avenue (See Appendix A, Dwg. 2, BGC drawing) the subsurface soil conditions consist of Capilano Formation Sediments that comprise deep water marine silts and clays overlain by sand to coarse cobble channel-fill deltaic sediments. Our site observation shows that there is layer a of cobble and boulder (close to ground surface at about El 40 m) with sand and gravel as shown in the following photograph. Sand and gravel content increases with depth and becomes the dominant soil at depth.
