Heritage Conservation Plan

311 West 14th Street, North Vancouver, BC :: The Follis House ~ 1907

Prepared by Elana Zysblat, CAHP :: Ance Building Services :: August 2022
Research & Analysis by Jurian ter Horst, MA :: ter Horst Research

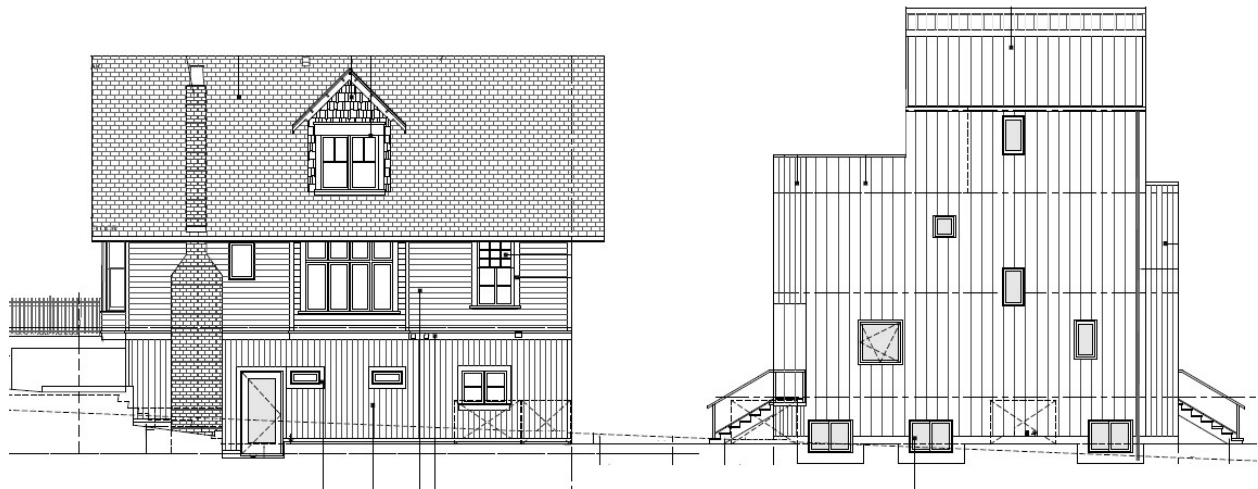
Drawing of the proposed development (west elevation) showing the heritage house on the left and the proposed infill (duplex) on the right. Source: dlp Architecture Inc.

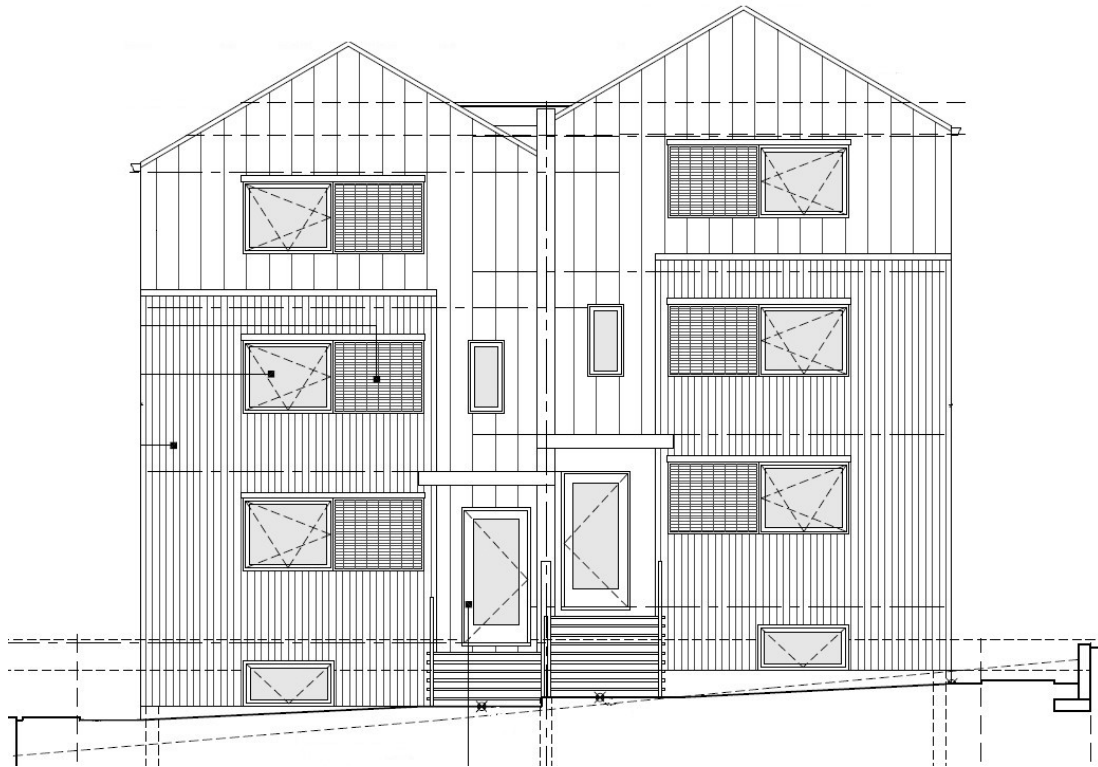
Drawing of the proposed development (south elevation/facade). Source: dlp Architecture Inc.

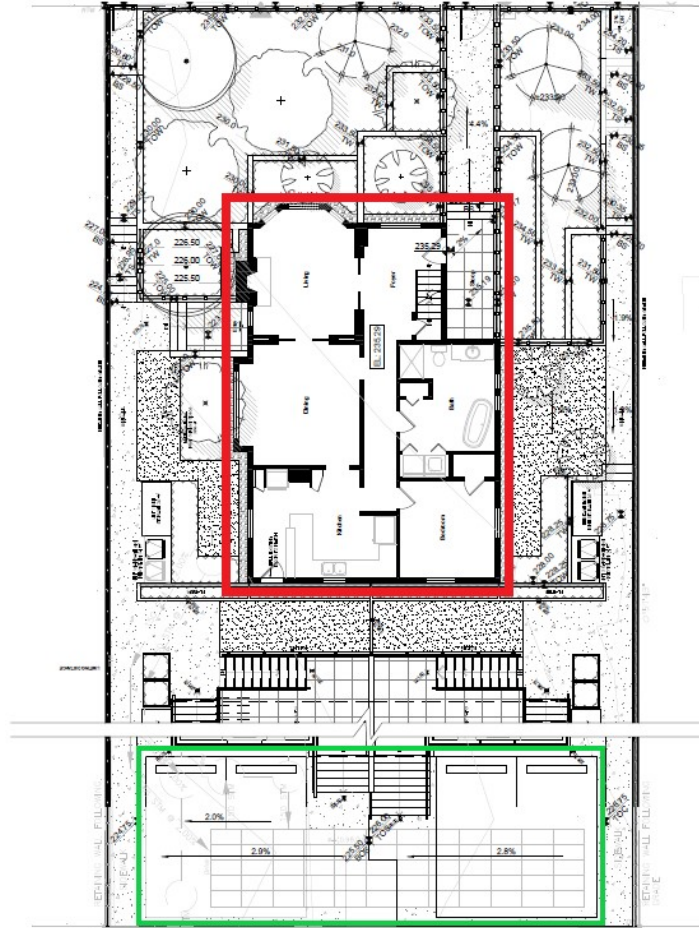
Proposed site plan with the heritage house outlined in red and the proposed development outlined in green. Source: Convergence Drafting Services Inc.
