Mosquito Creek Ravine East Bank Detail Risk Assessment

Study Area

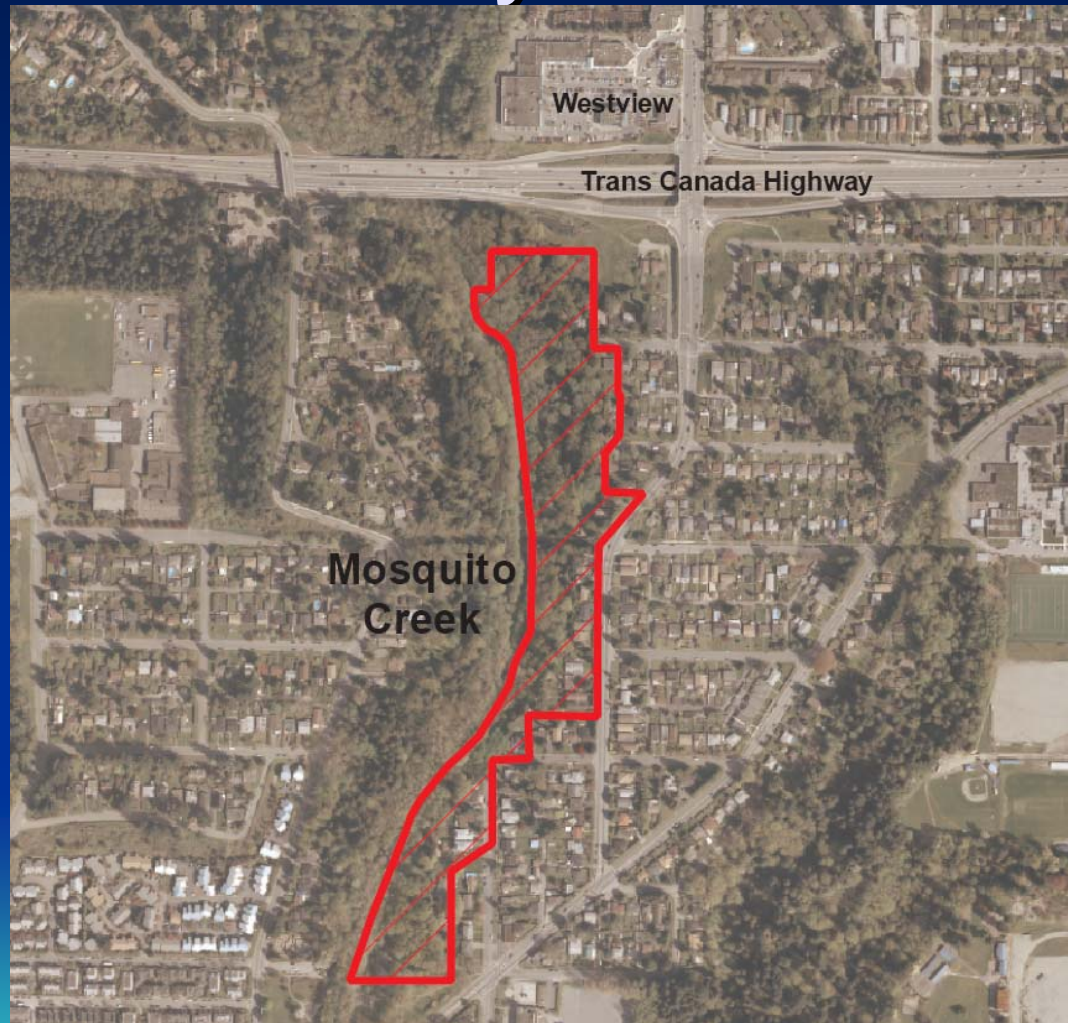
Scale is not known and north is to the top of the slide.

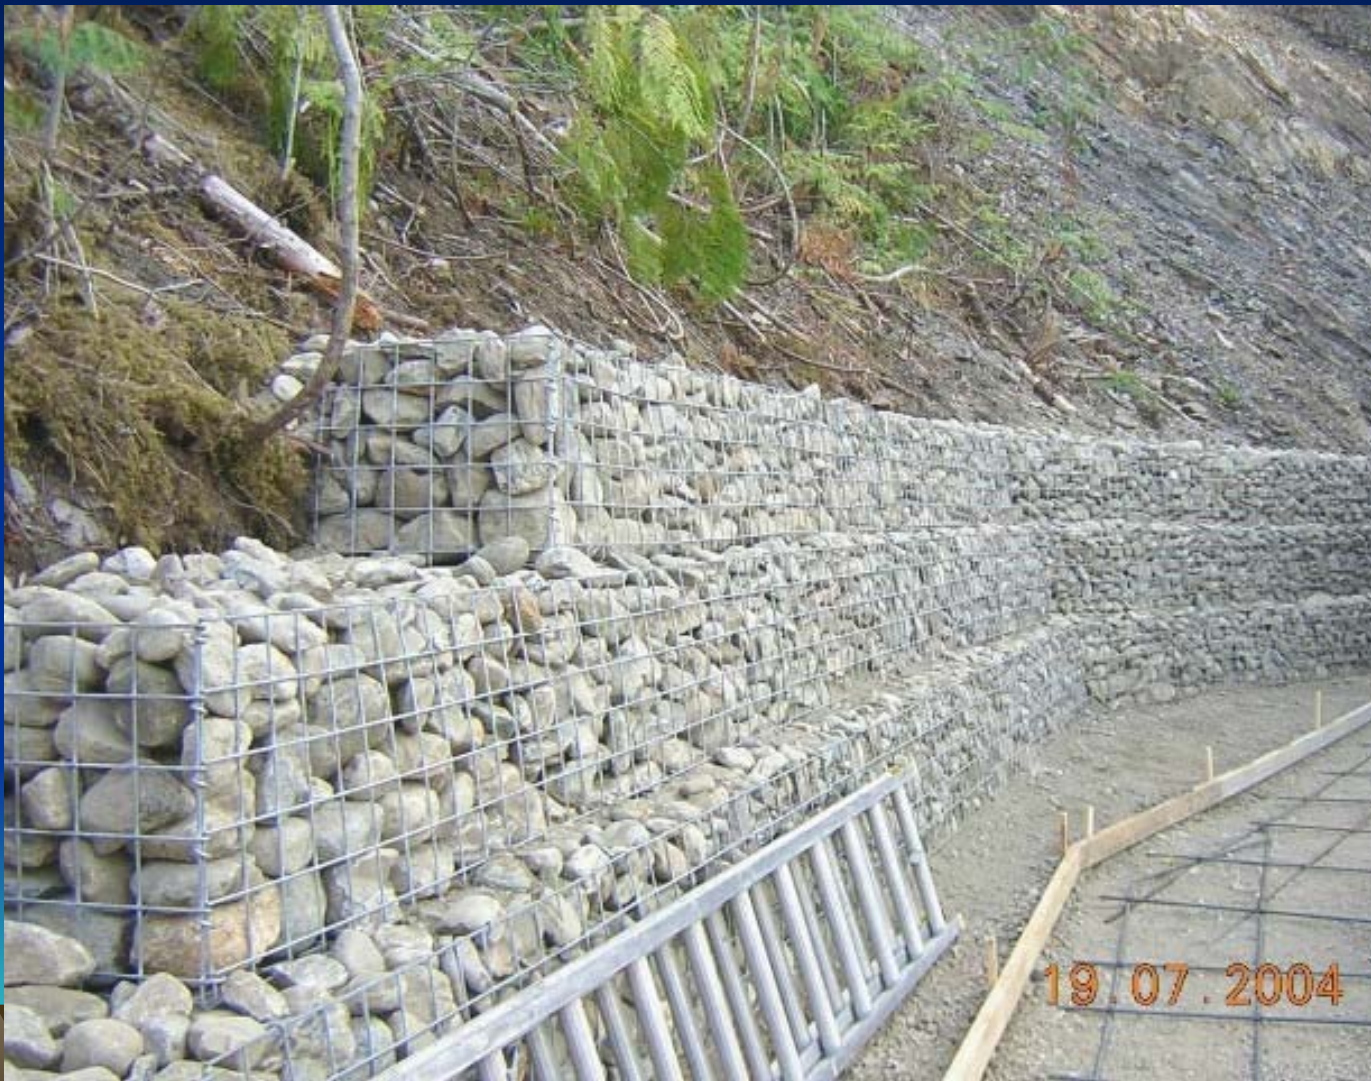
Conceptual designs

Tensor Mat
and topsoil

Tensor secondary
reinforcement

Tensor primary
reinforcement

- Lots that have a high specific risk to the structure or greater must be reviewed by a geotechnical engineer and stabilization measures developed to reduce the specific risk to moderate or lower.
- Conceptual options have been presented for the lots that require risk mitigation.
