Drinking Water Quality – 2024 Annual Report

FEBRUARY 2025 | ENGINEERING, PARKS AND ENVIRONMENT

PREPARED BY WES MASON SECTION MANAGER, UTILITIES

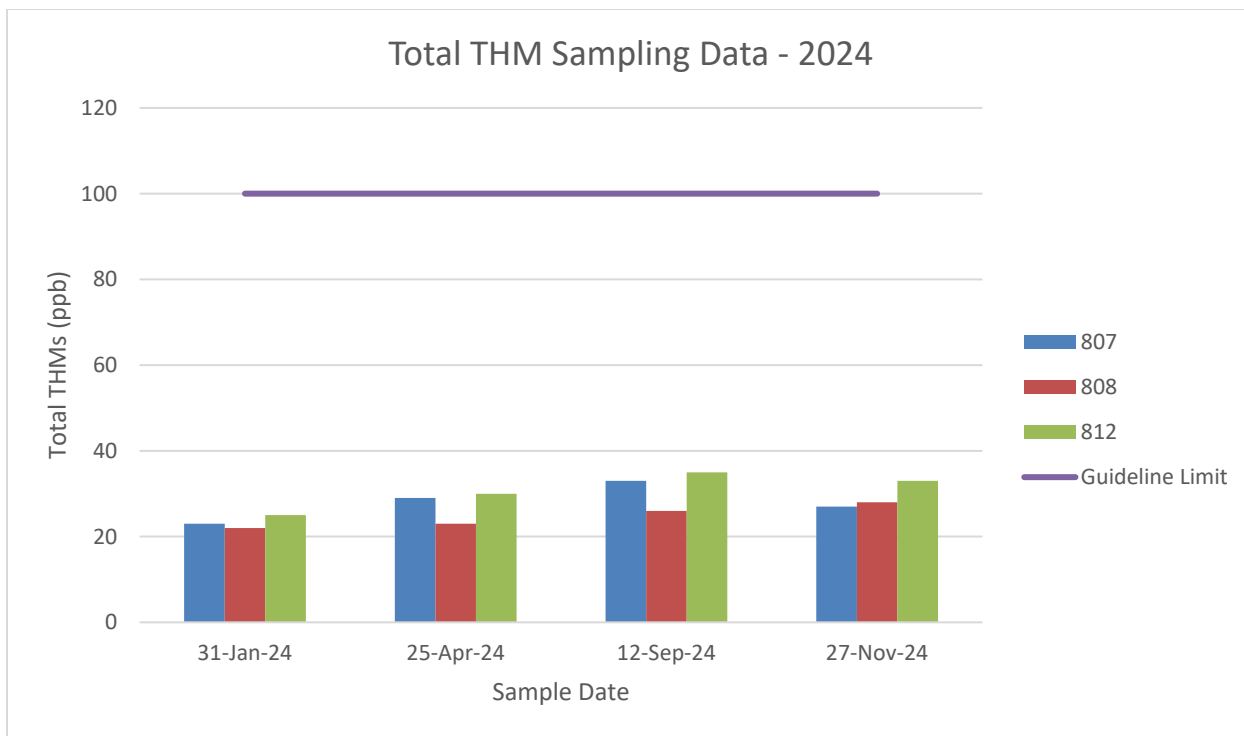
The following two figures summarize the total THM and HAA concentrations graphically by station and sampling period. Spatially the results for total THMs for all sites were very comparable, with little difference between the three sites. The only consistent observation is that THM concentrations at Station 812 were consistently higher than Stations 807 or 808. All the total THM concentrations are substantially lower than the allowable guideline value.

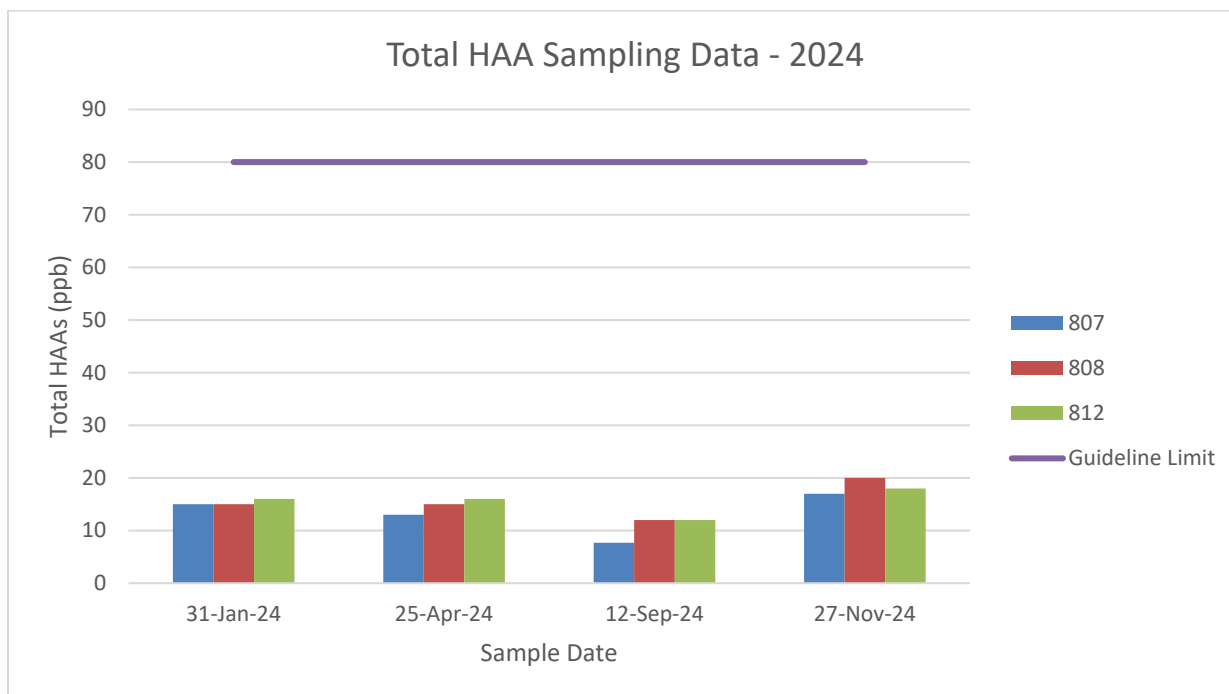
The following figure plots total HAA by period and sampling station, where total HAA was typically slightly lower at sampling station 807 (1900 Blk Hamilton). There is otherwise very little variation in the results and total HAA concentrations are substantially lower than the allowable guideline value.

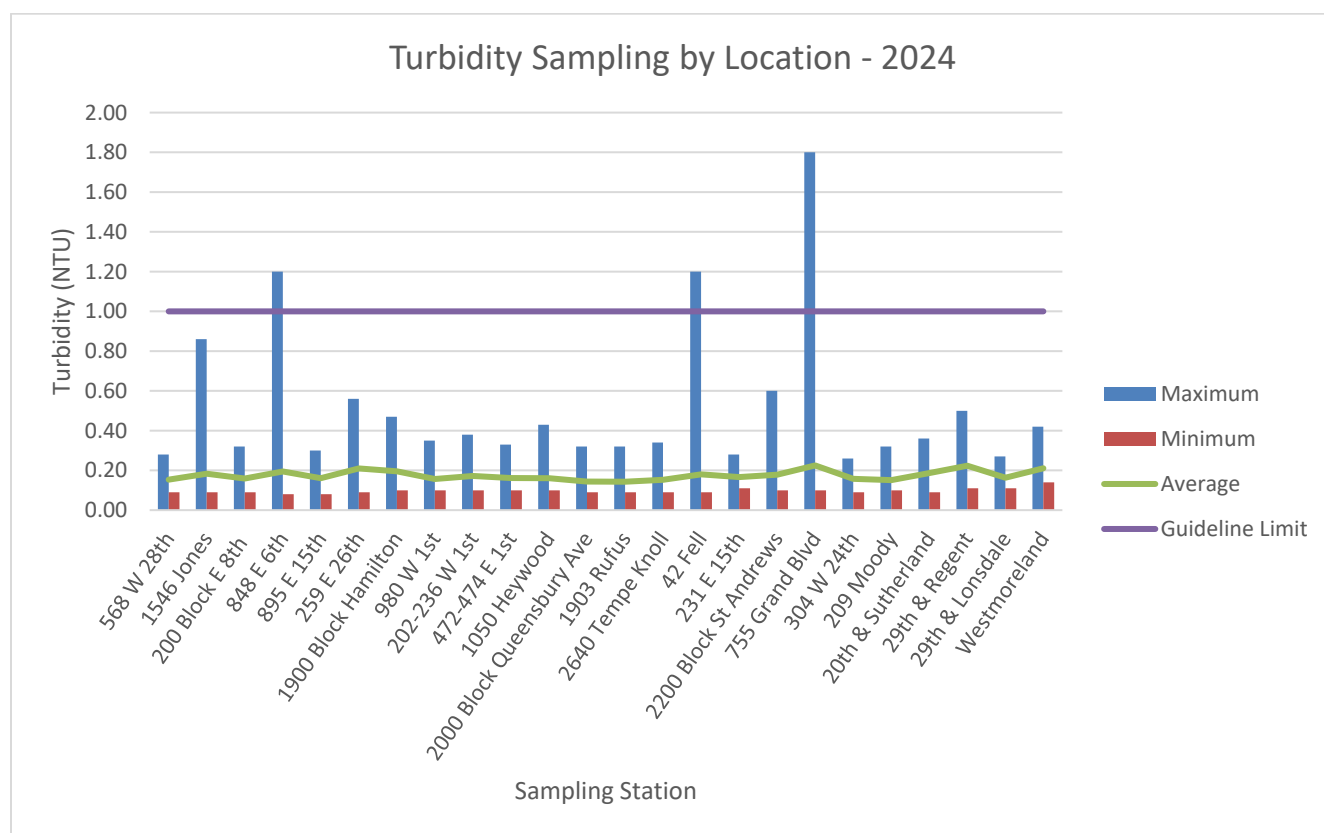
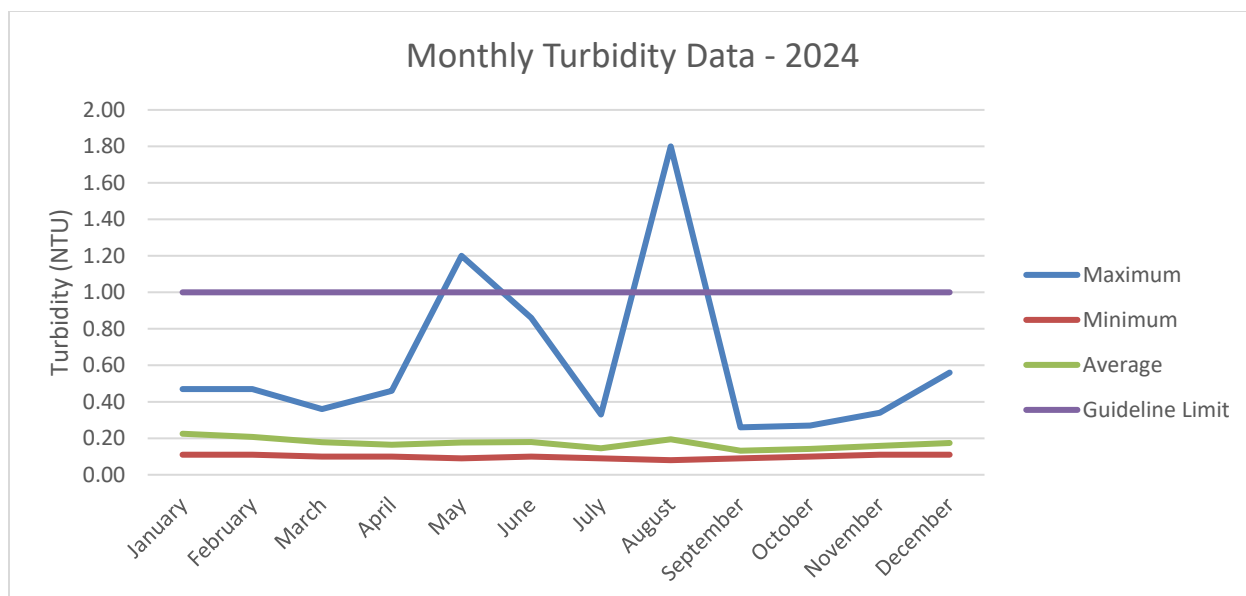
The event at 231 East 15th Street was due to a contractor flushing his new 200mm service line fully at 250 East 15th Street. It was dealt with promptly and cleared up quickly. This unfortunately caused the Turbidity spike at 755 Grand BLVD.

The figures above summarize the turbidity data by station and by month. The 1 high spike in turbidity was from the event at 231 East 15th Street. Appendix B provides a description of the sampling parameters, the allowable limits, and a detailed summary of the 2023 test results.

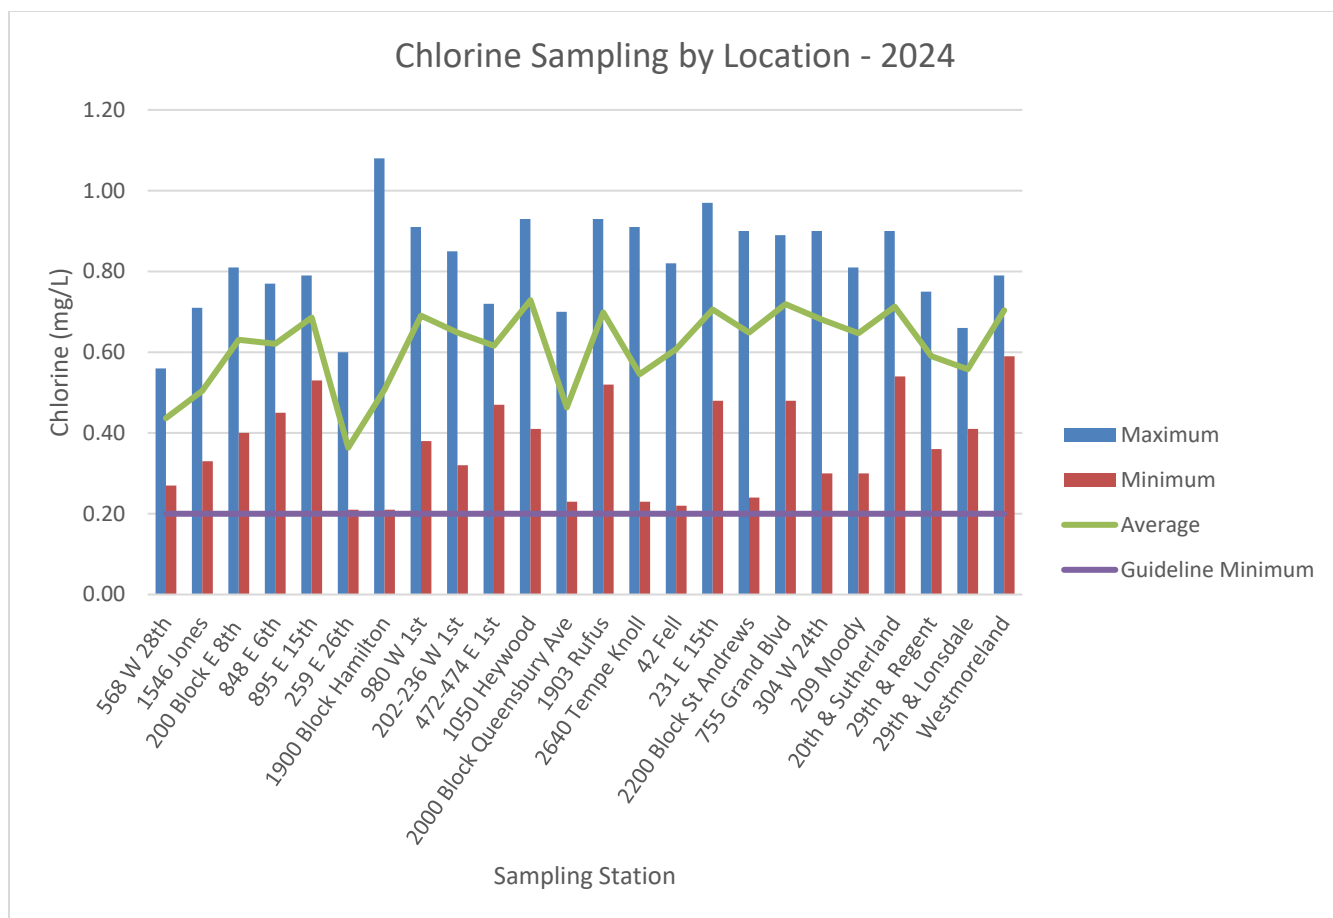
The figures below summarize the chlorine sampling data for 2024.

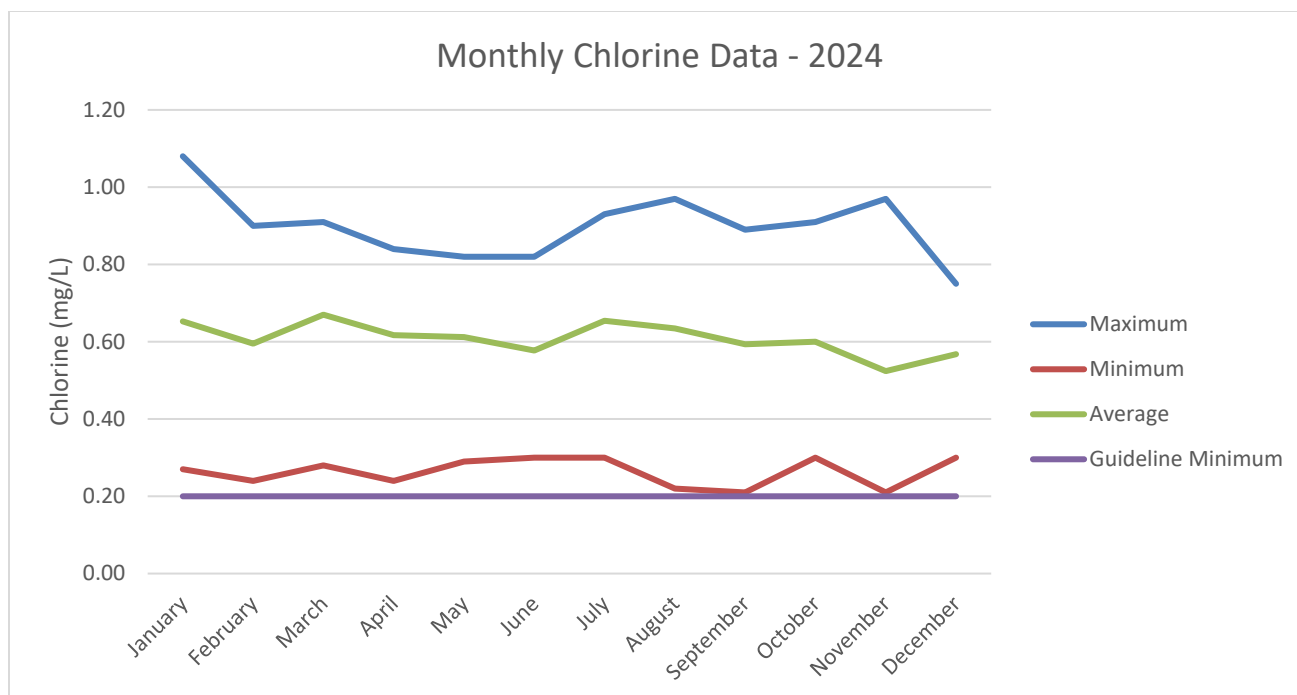
The following figure shows an aggregate of all 20 monitoring sites, which highlights a fairly consistent result throughout the year, with average free chlorine concentration trending downwards slightly towards the end of the year. Local factors such as water demands and pipe materials further reduce chlorine concentration measured as these key locations.

Although there were no chlorine concentration measurements that fell below the 0.2 mg/L guideline minimum, two stations had measurements that were close to the minimum allowable concentration at 0.21mg/L: 259 E 26th and 1900 Hamilton. 1900 Hamilton is located in a quiet residential area north of Marine Drive and west of Fell Avenue; water in this area is drawn from the nearby Westmoreland Metro Vancouver source, but due to older cast iron water mains and lower residential demands, it is likely that the chlorine concentrations were reduced more quickly than water was being consumed. To aid concentrations, a water flushing station was installed at this location and the flow is controlled with a solenoid to help move more water through this area.

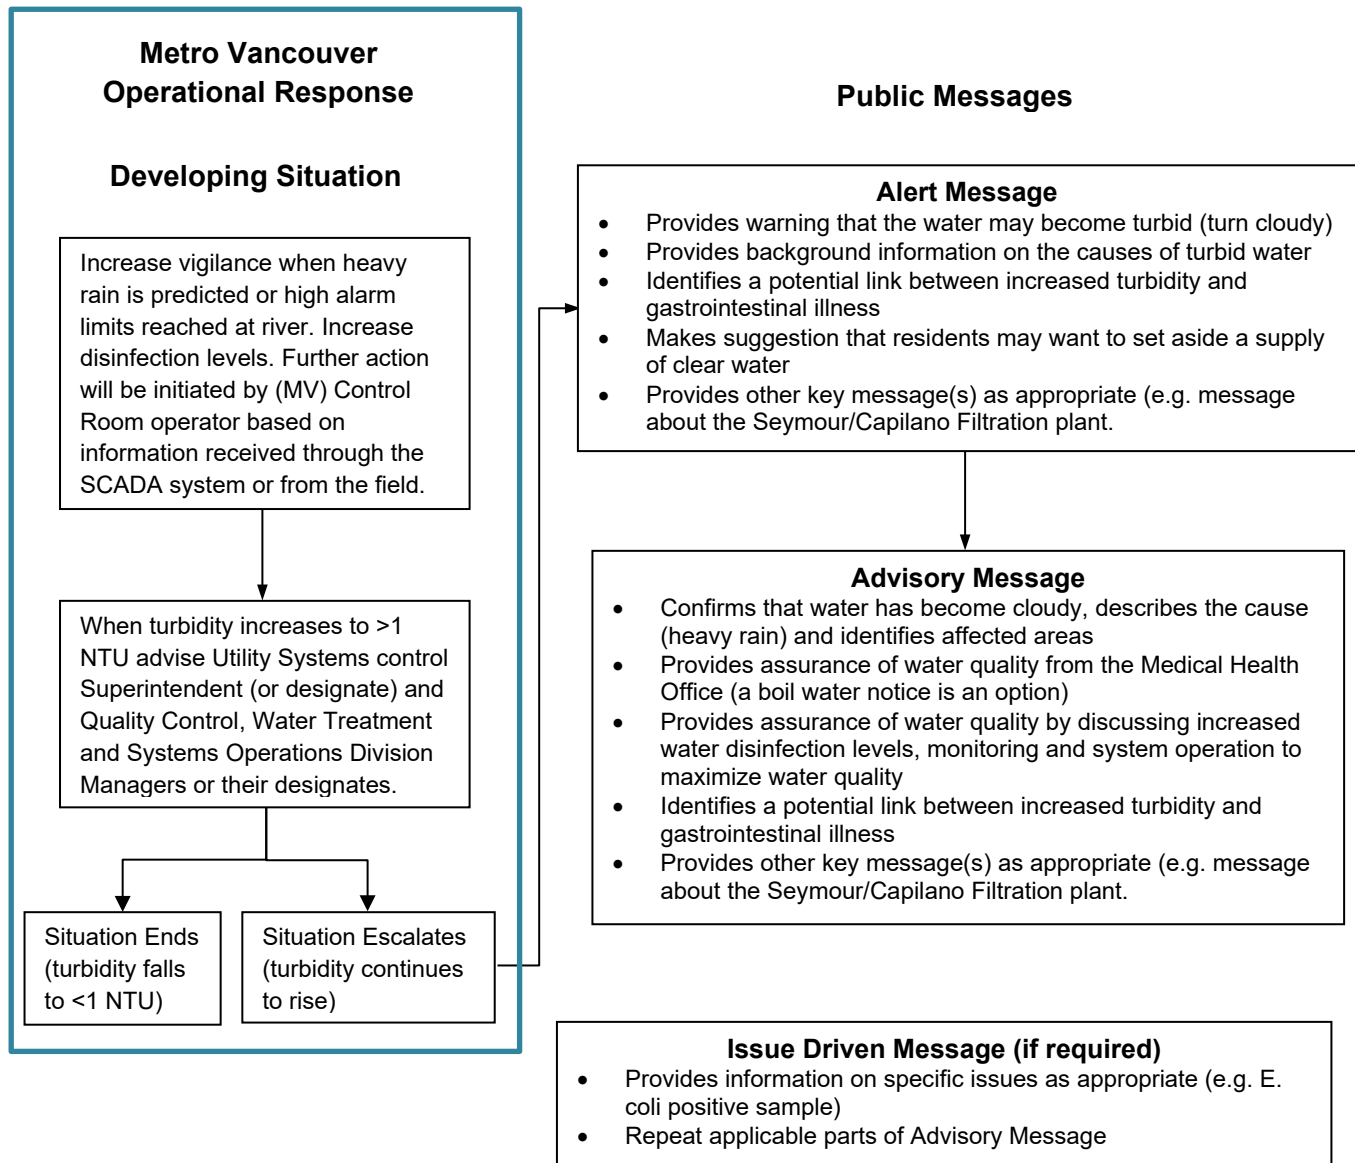
Guidelines for Source Water Turbidity Events

SOURCE WATER TURBIDITY EVENTS Metro Vancouver and Municipal Response Procedures
